Subject: **STALLING/HESITATION/LOW POWER/WHITE SMOKE
(CHECK LIFT PUMP/CONDITION: NEW OIL PRESSURE
SENDER/SWITCH AVAILABLE)**

Model and Year: **1992-93 C/K TRUCKS WITH 6.5L TURBO DIESEL
(RPO L65) OR 6.2L DIESEL (RPOS LH6 AND LL4)**

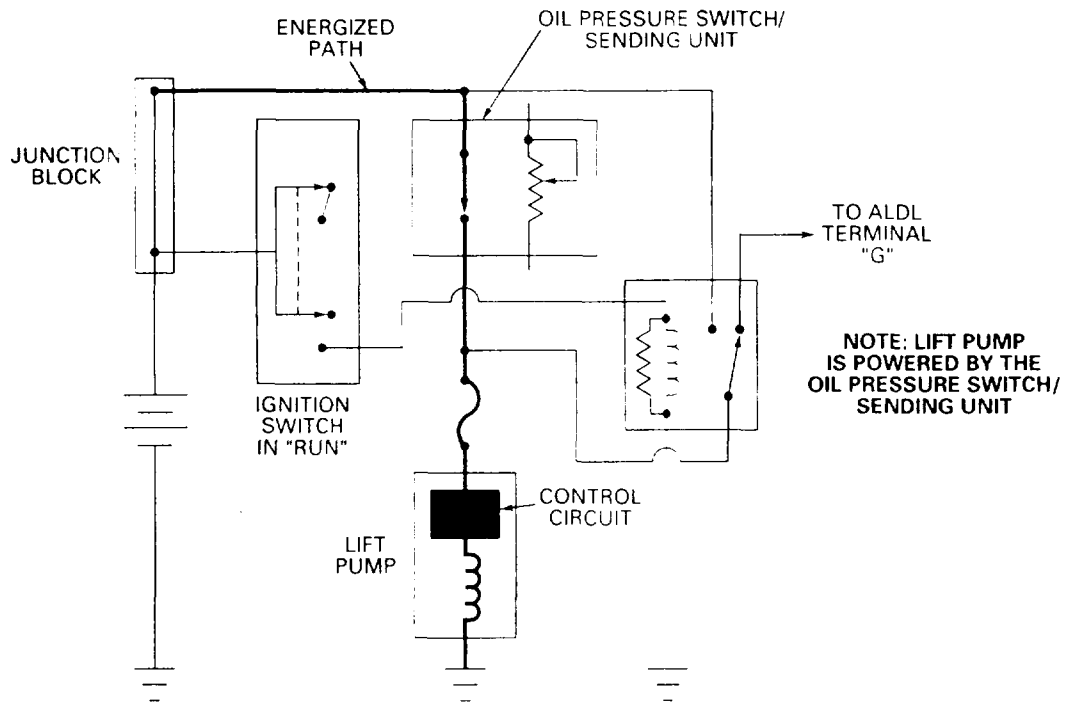
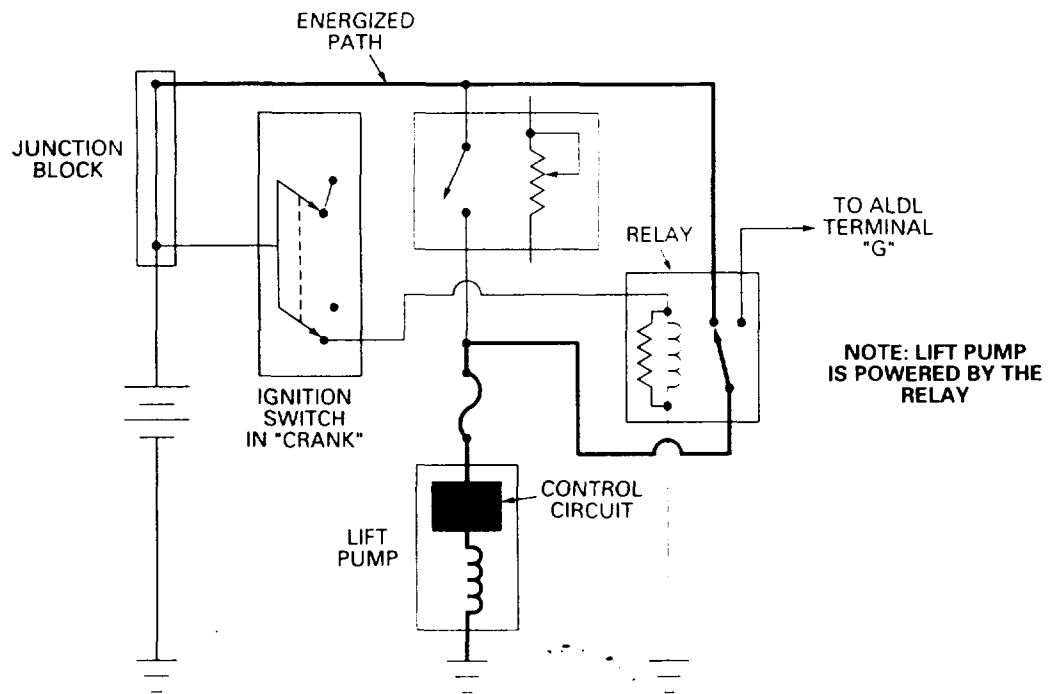
Figure 1 - Lift Pump Electrical Circuit

Improper electric lift pump operation, due to an inoperative lift pump electrical circuit OR a faulty pump. **THE MOST PROBABLE CAUSE IS A FAULT IN THE OIL PRESSURE SENDER/SWITCH CIRCUIT** which operates the lift pump during engine operation. The oil pressure sender/switch is located on the left bank, rear of the intake manifold. A new oil pressure sender/switch, P/N 10243574, will be available from GMSPO August 30, 1993. This new part provides increased switch contact durability, and was introduced into vehicle production late in the 1993 model year.

The two circuits powering the lift pump are shown in Figure 1; both circuits need to be checked. Intermittent supply circuit problems may require monitoring the voltage at the lift pump during vehicle operation. This can be accomplished on vehicles equipped with Data Link Connectors (DLC) by probing for voltage at terminal G while the engine is running (charging system functioning properly and batteries fully charged). A difference of more than 1.5 volts between terminal G and battery voltage indicates a problem in the oil pressure switch circuit.

Once diagnosed, the problem is resolved by either replacing the faulty oil pressure sender/switch, the faulty lift pump, or repairing the wiring.
