No Start, No Wait To Start....Bad Grounds! But also “How To Replace Ignition Switch and Remove Aftermarket Security System”

By LCGarage, member TheDieselPlace.com

It's been weeks not able to start truck. I've been here reading, and on the weekends applying what I've learned from TheDieselPlace 6.5L forum to my 1997 GMC K3500, which is now running. This write up give details of my repair in three sections

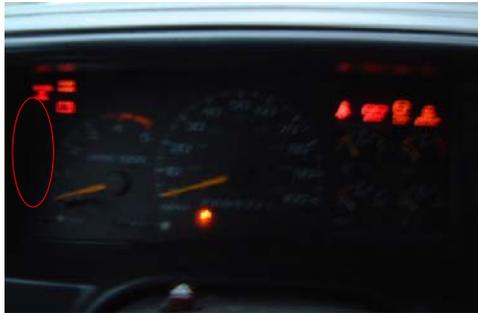
Figure 2a. Missing Dash Lights

1b. Do you have a Wait To Start Light & duration lit? **NO** see figure 2a. below

“No Start, No PCM power”

Attempt to read codes only showed reader connection error. The code reader was not getting signal from PCM. It was clear that the power control module (PCM) was **NOT getting power (or gnd)** or had suddenly died completely.

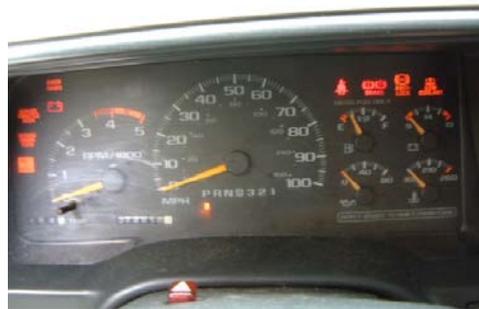
Figure 2b. Shown with SES STS and WTS

“Starts, PCM powered”

Result: all lights are working and the truck started right up! See as shown in figure 2b. Water In fuel was on but not on during 2nd key when photo was taken.

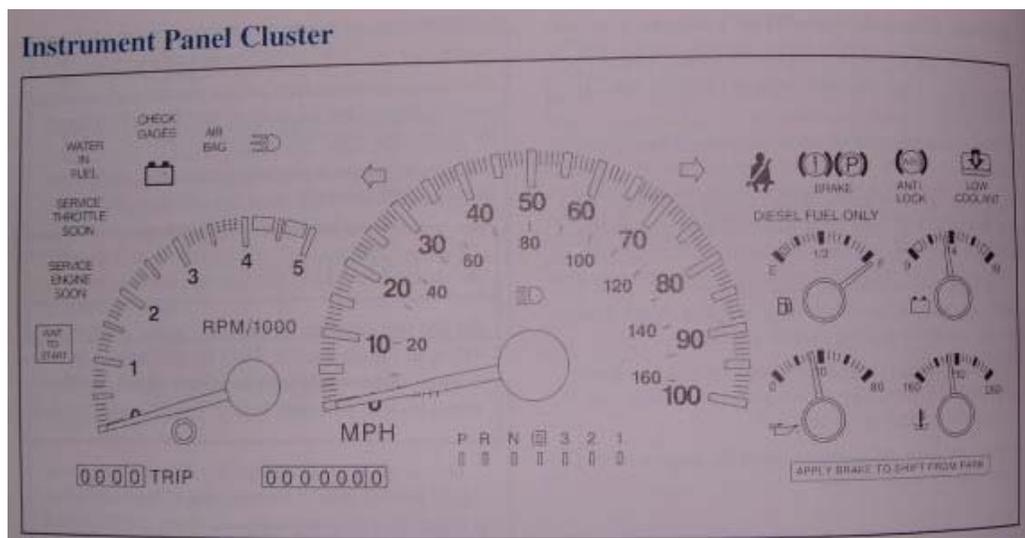
Figure 2c. Instrument Panel Cluster Indicator Light Locations

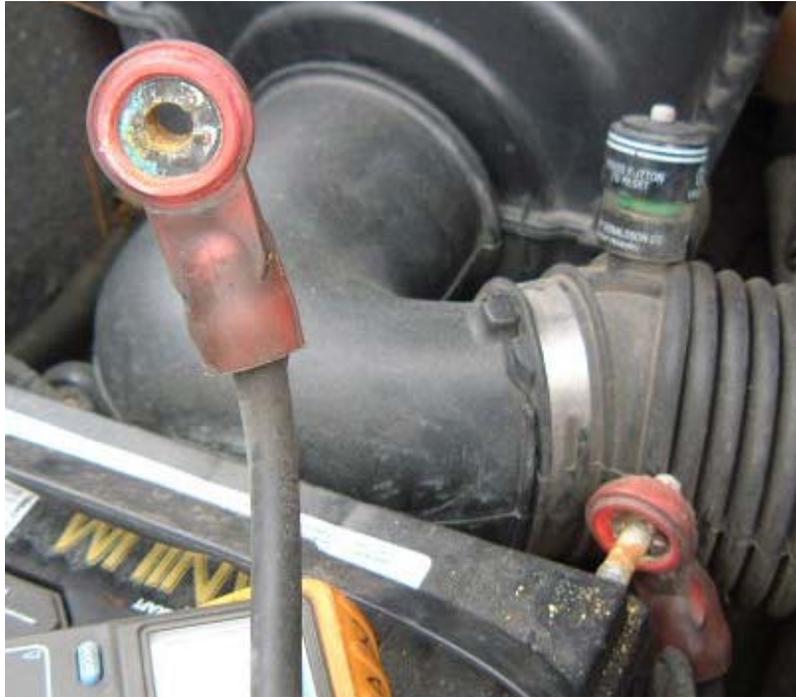
Figure 3 Battery Cable Corrosion

The battery terminal were cleaned first. They looked good from the outside, but showed significant corrosion BETWEEN the connectors.

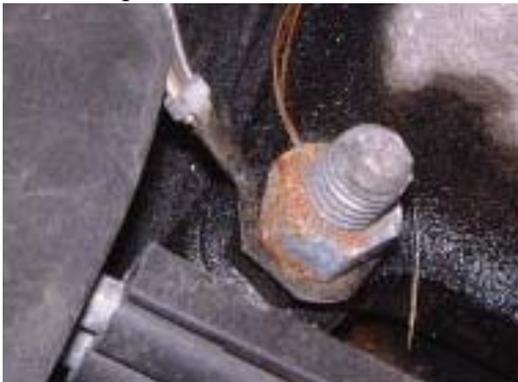
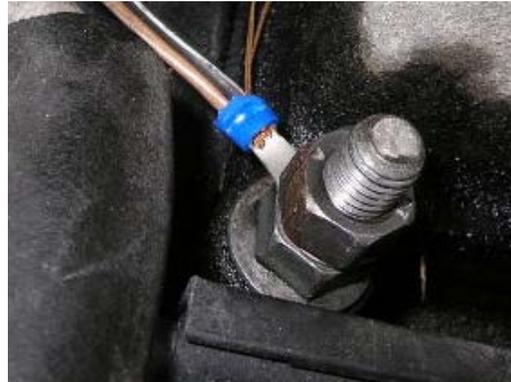
The engine grounds were cleaned next. Figure 4. show ground to engine terminal which had to be replaced when it broke off.

Figure 4a. Auxiliary Ground To Engine

Figure 4b Cleaned And New Terminal

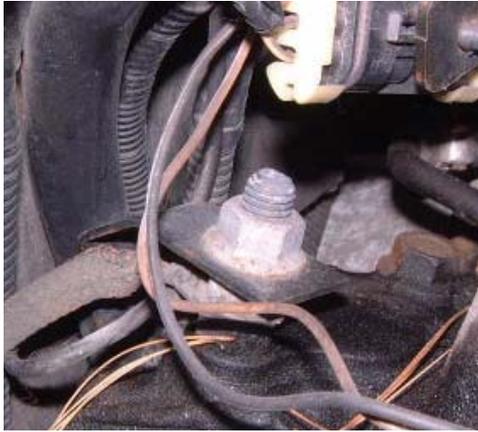
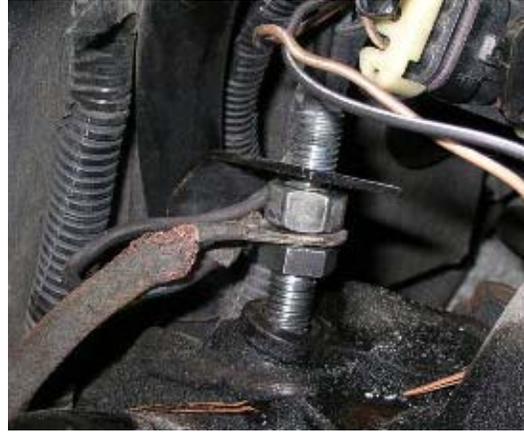
Rear engine passenger ground was cleaned next. The transmission check fill tube bracket is above it. Figure 5. shows this can be done without removing tube, but did require a “thin” open end wrench to fit between terminal and engine to keep from breaking ground ribbon off.

Figure 5a. Rear Engine Ground

Figure 5b BEFORE Tightening

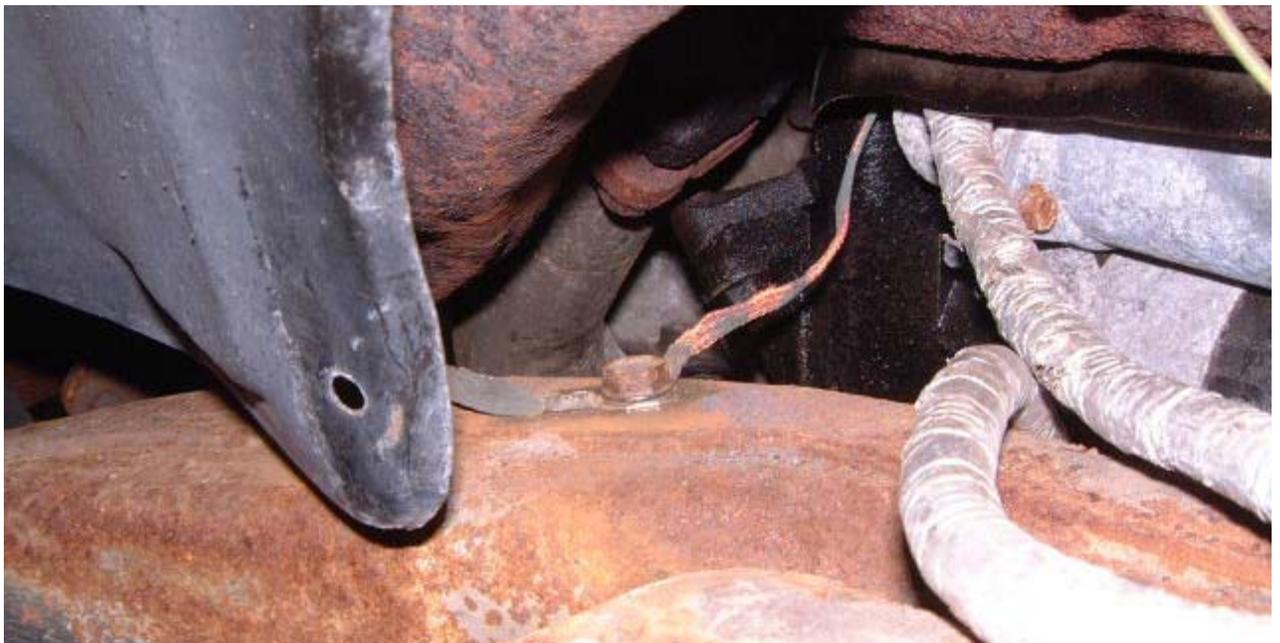
Frame ground was cleaned next. Figure 6. shows top of frame with engine and fender ribbon grounds go. The rubber fender splash shield was taken off to get at and find ground.

Figure 5. Right Front Frame Ground

Cleaning and or Replacing Grounds fixed the problem! That really did it, but because I had changed the ignition switch first, the aftermarket security system needed to be reconnected OR removed.

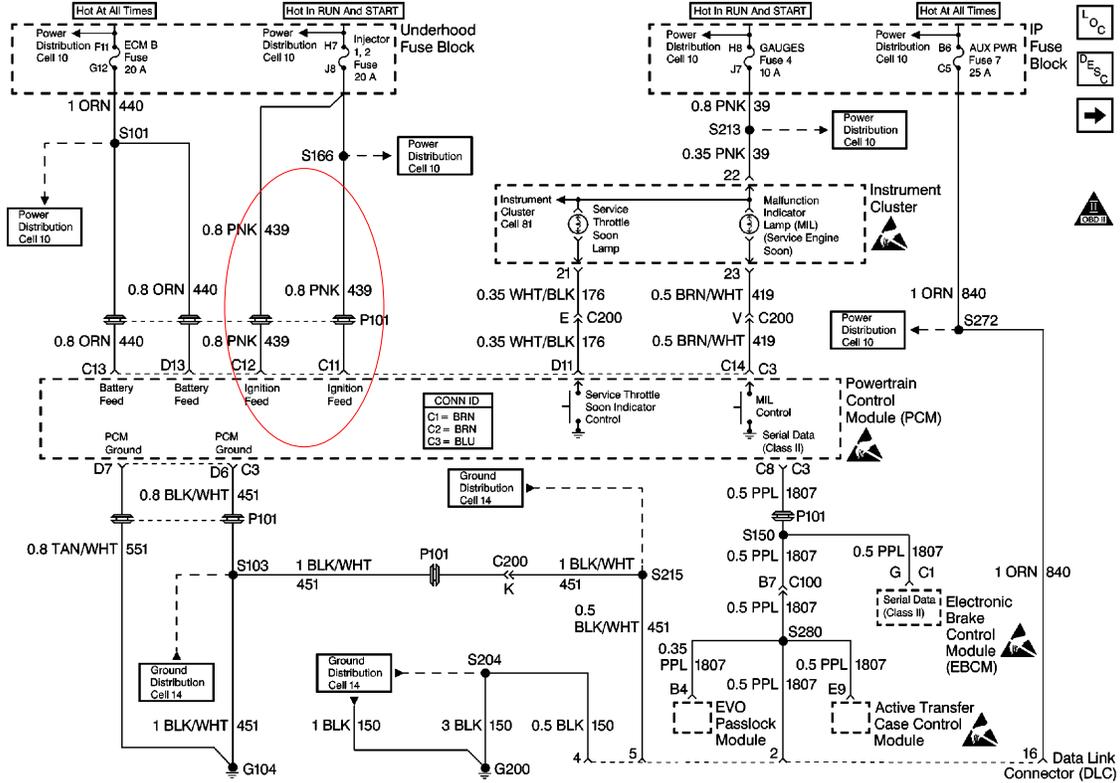
The security system, where keypad controlled a relay tied into main +12V (red) and ign (pnk) wire on the ignition switch, was cut out when the new ignition switch was installed. That left the ignition disabled due to break in both ignition feed wires (pink).

Figure 6. Ignition Schematic (Add Kill Switch Where Shown)

This was obvious once the glove compartment door was removed and PCM wires inspected. Connecting the two ignition feed wires (pink) restored the circuit completely removing ignition kill. You *could* reverse this to add a manual kill switch.

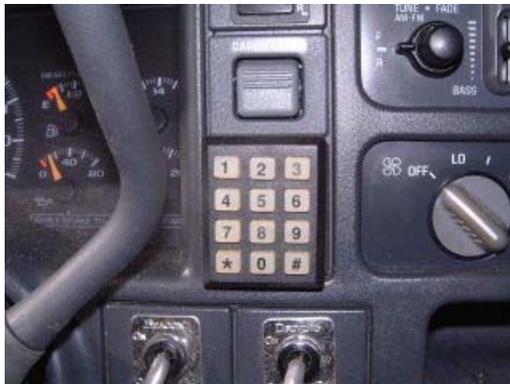
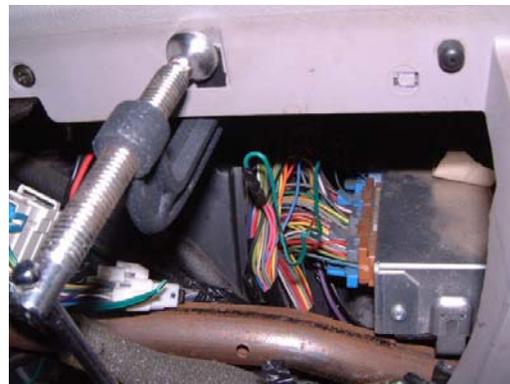
Figure 7a. Security Keypad

Figure 7b. Ignition Kill Removed
(C-clamp on button to keep light off)

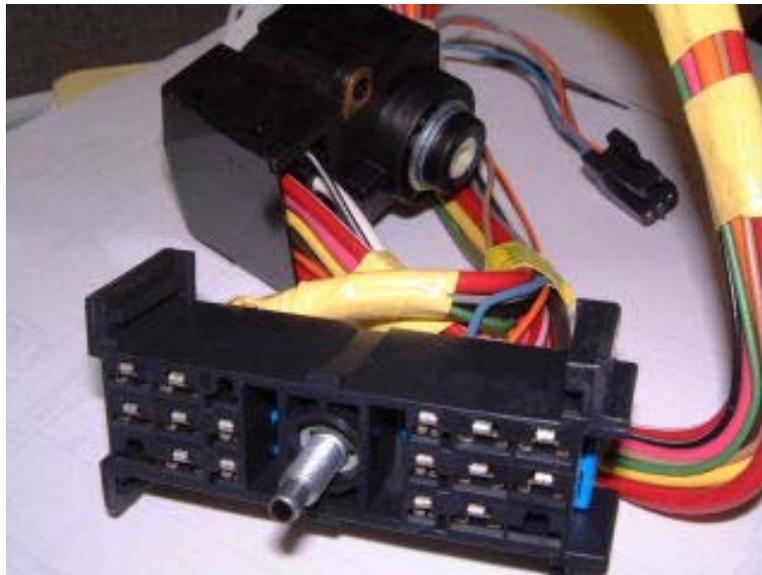
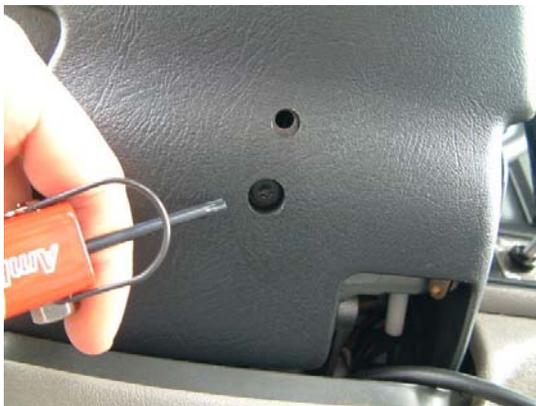
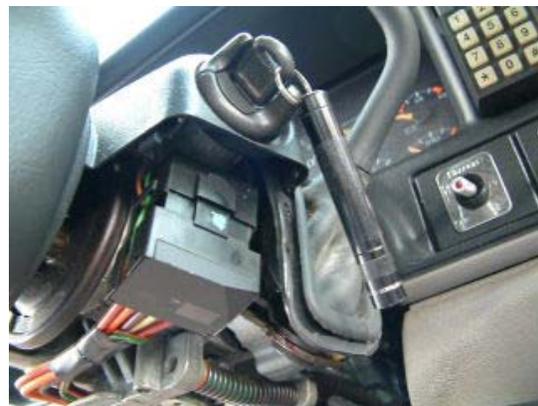
Changing the Ignition switch (figure 8 and 9b) required the removal of the bottom steering wheel cover, as shown in Figure 9a.

Figure 8 New Ignition Starter Switch

Figure 9a Bottom Cover

Figure 9b Ignition Switch

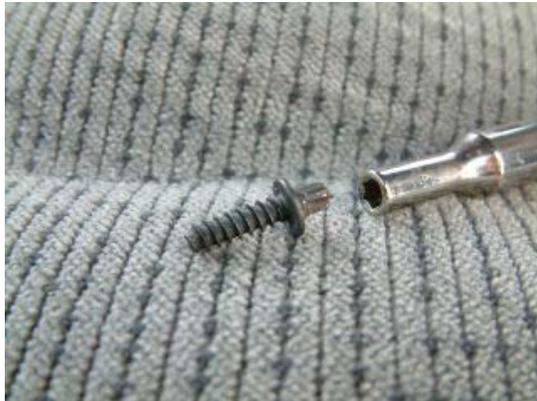
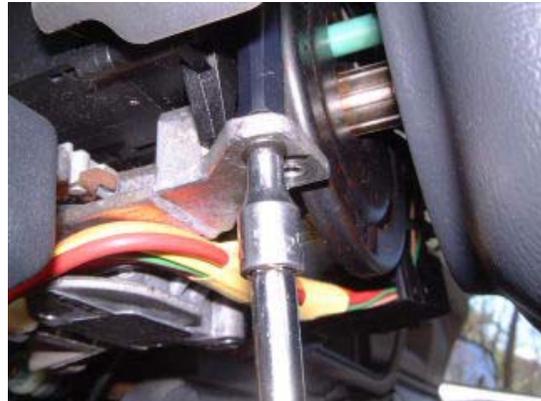
Then removing the top cover required loosening of two external torx screws, a socket set I did not have. Improvising, Figure 10 shows how a 5/32" ¼ drive socket worked in place of the "right tool".

Figure 10a Torx Screw and 5/32" Socket

Figure 10b Removing Torx Screw

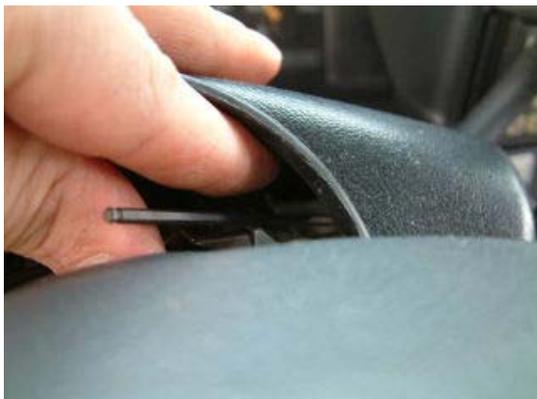
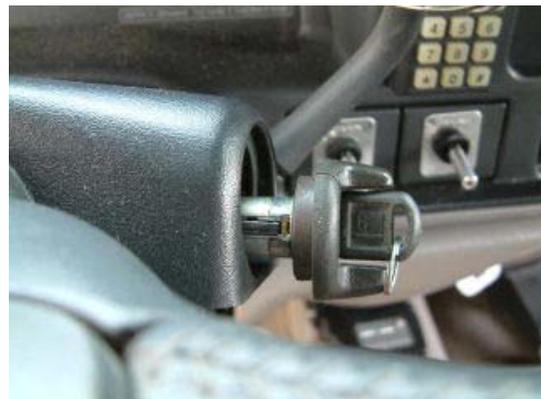
Removing the top cover required removal of key cylinder as shown in figure 10. This was strait forward, but you do have to know this -the key has to be turned to START before latch can be depressed. When released to RUN, the cylinder will "pop" out. This procedure is shown with cover removed for detail in Figure 11.

Figure 10a Allen Wrench Under Cover

Figure 10b Key Cylinder Popped Out

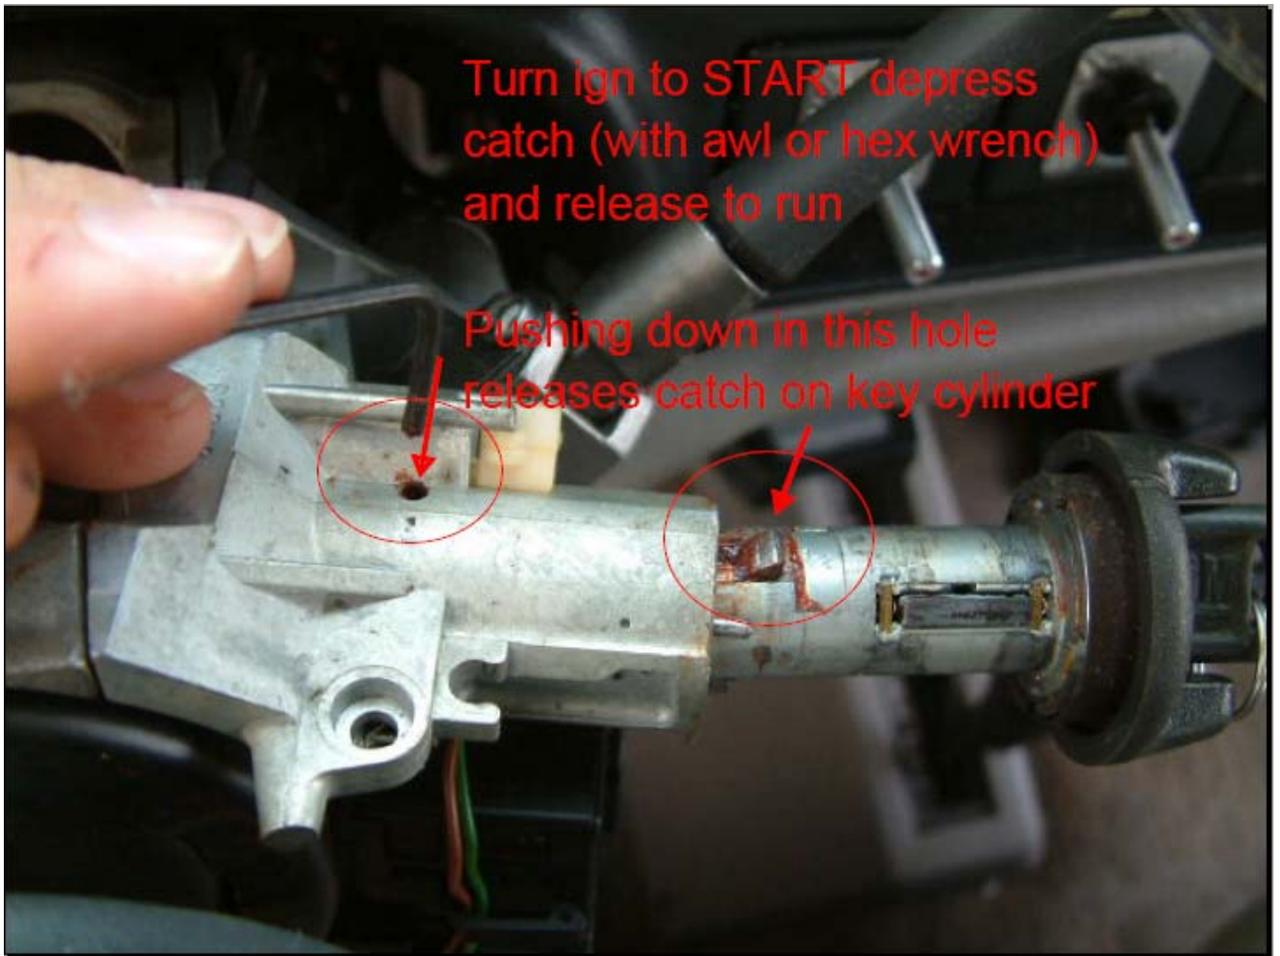
Figure 11. Key Cylinder Release (Shown With Top Cover Removed)

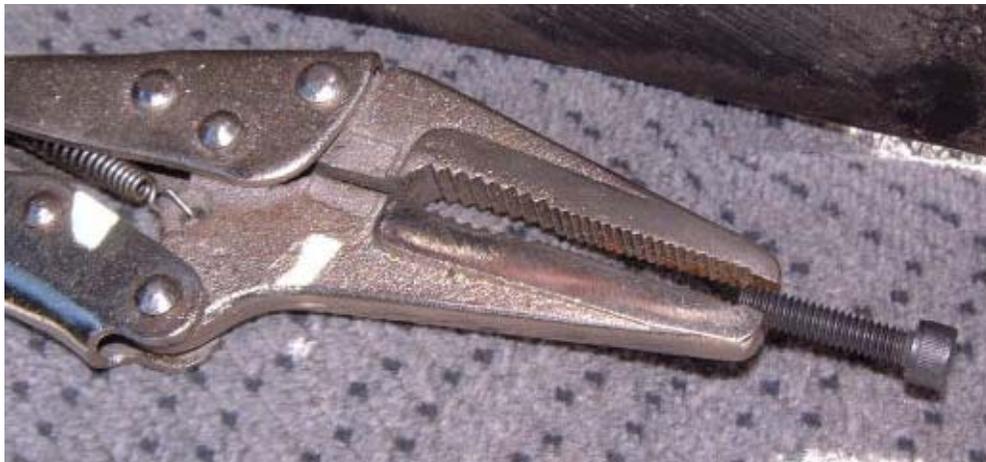
The top cover can now be taken off. The ignition switch is secured with even smaller torx screws. Again instead of getting the right tool I was able to use a #6 Hex head socket cap screw in a pair of vise grips. This setup is shown in figure 12.

Figure 12. #6 Socket Cap Head Screw In Vise Grips

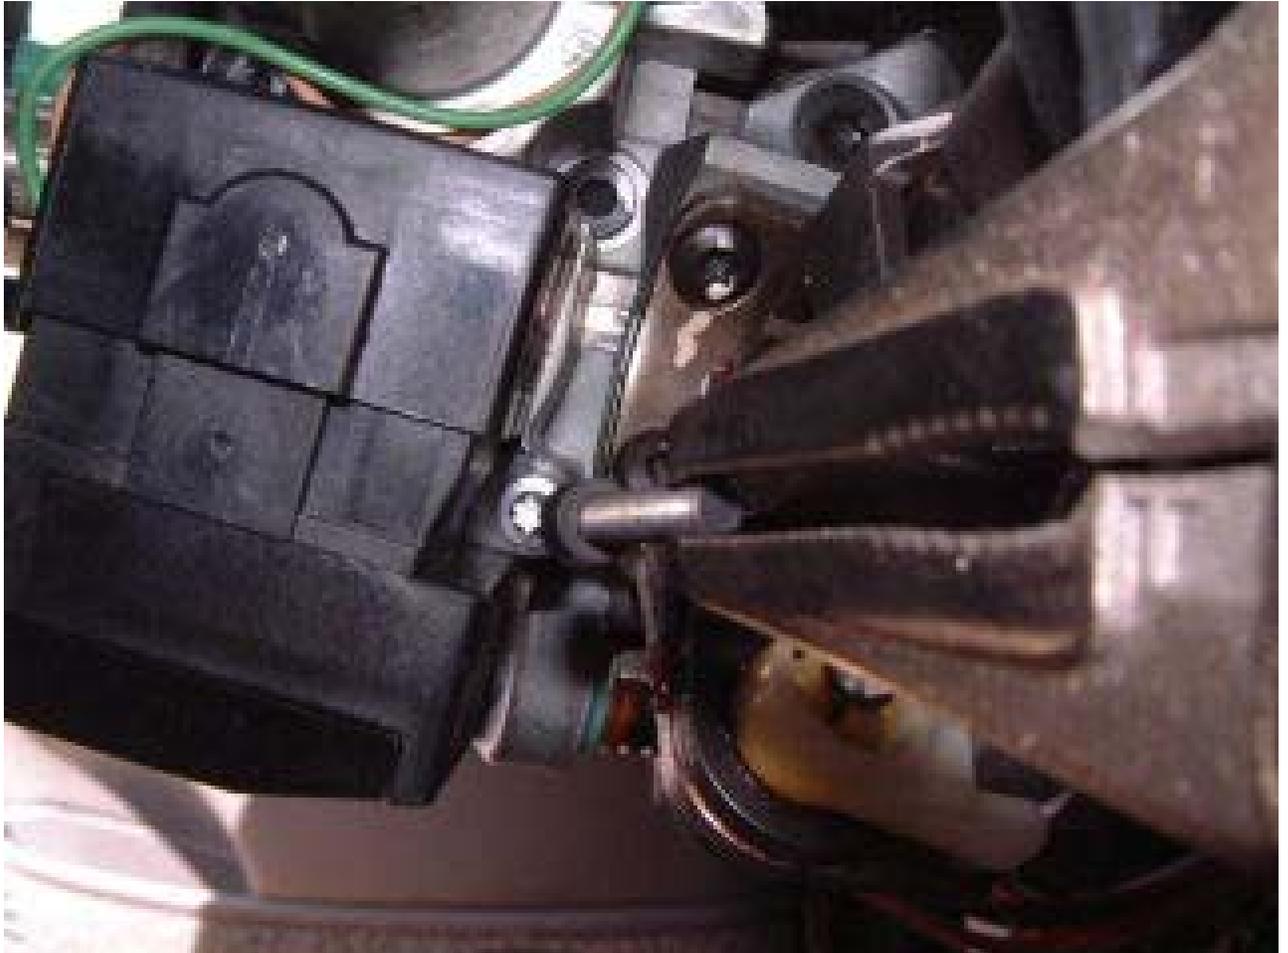
A longer screw ~2" would have worked even better, to give more turning room as shown in Figure 13.

Figure 13. Ignition Switch Screw Removal
