2008 Chevrolet Silverado 1500

2008 HVAC Heating, Ventilation, and Air Conditioning - Cab & Chassis Sierra, Cab & Chassis Silverado, Sierra & Silverado

SPECIFICATIONS

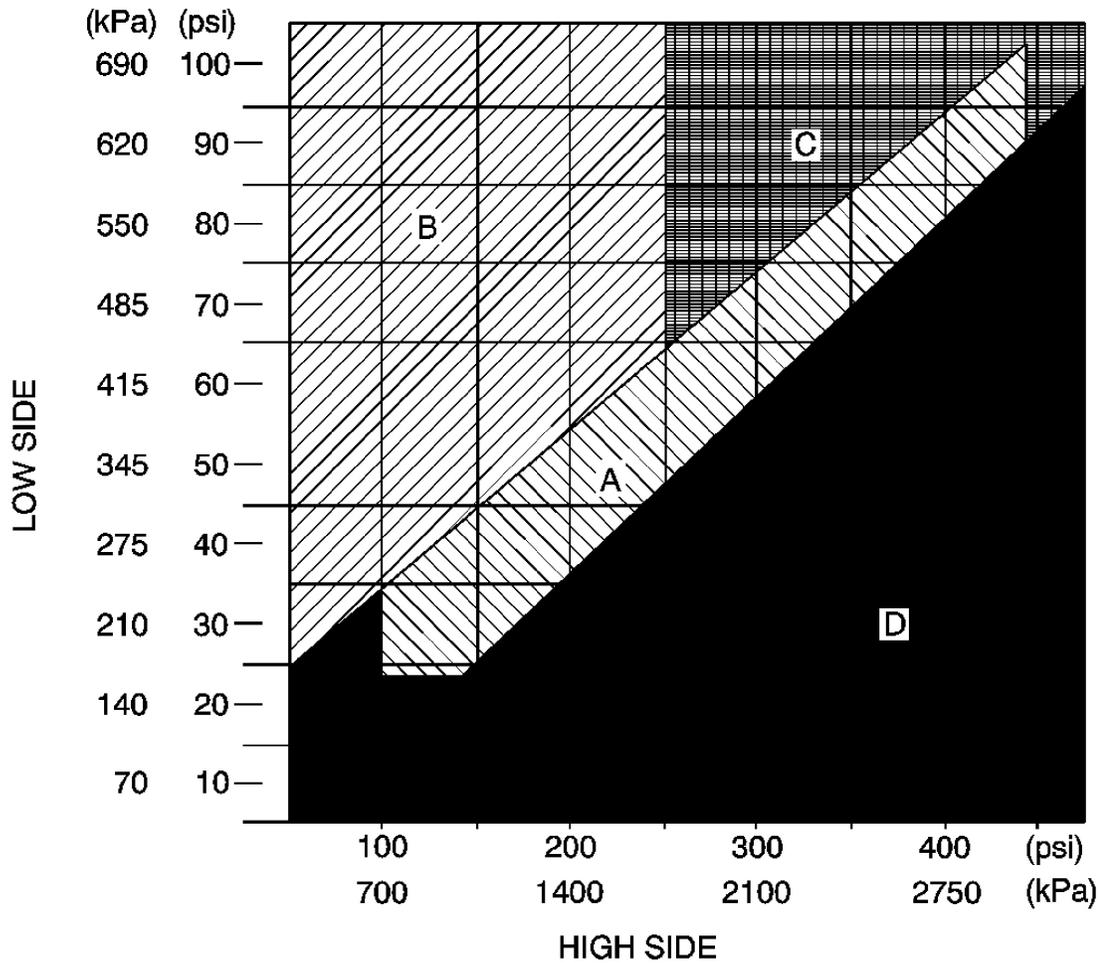
Fig. 1: A/C System Pressure (6.6L)

Ambient Air Temperature	Relative Humidity	Service Port Pressure		Maximum Discharge Air Temperature
		Low Side	High Side	
13-18°C (55-65°F)	0-100%	150-279 kPa (22-41 psi)	420-1140 kPa (61-165 psi)	9°C (48°F)
19-24°C (66-75°F)	Below 40%	150-298 kPa (22-43 psi)	531-1240 kPa (77-180 psi)	11°C (52°F)
	Above 40%	176-366 kPa (26-53 psi)	760-1510 kPa (110-219 psi)	14°C (57°F)
		216-359 kPa (31-52 psi)	990-1550 kPa (143-224 psi)

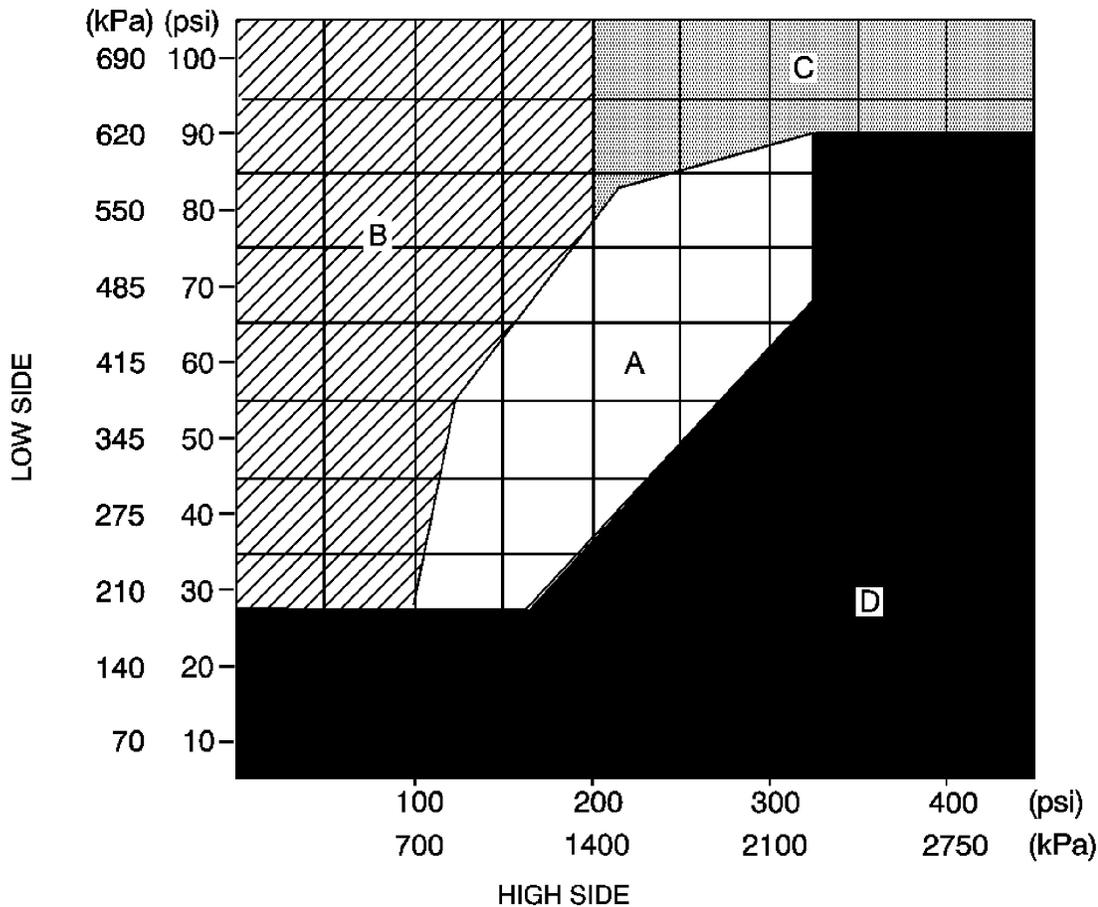
Fig. 2: A/C System Pressure Zone Classification - Gas Engine With Engine Driven Cooling Fan

Ambient Air Temperature	Relative Humidity	Service Port Pressure		Maximum Discharge Air Temperature
		Low Side	High Side	
13-18°C (55-65°F)	0-100%	165-257 kPa (24-37 psi)	830-1180 kPa (120-171 psi)	10°C (50°F)
19-24°C (66-75°F)	Below 40%	185-290 kPa (27-42 psi)	1010-1340 kPa (147-194 psi)	11°C (52°F)
	Above 40%	202-313 kPa (29-45 psi)	990-1370 kPa (144-199 psi)	13°C (55°F)
	Below 35%	225-319 kPa (33-46 psi)	1180-1470 kPa (171-212 psi)	14°C (57°F)

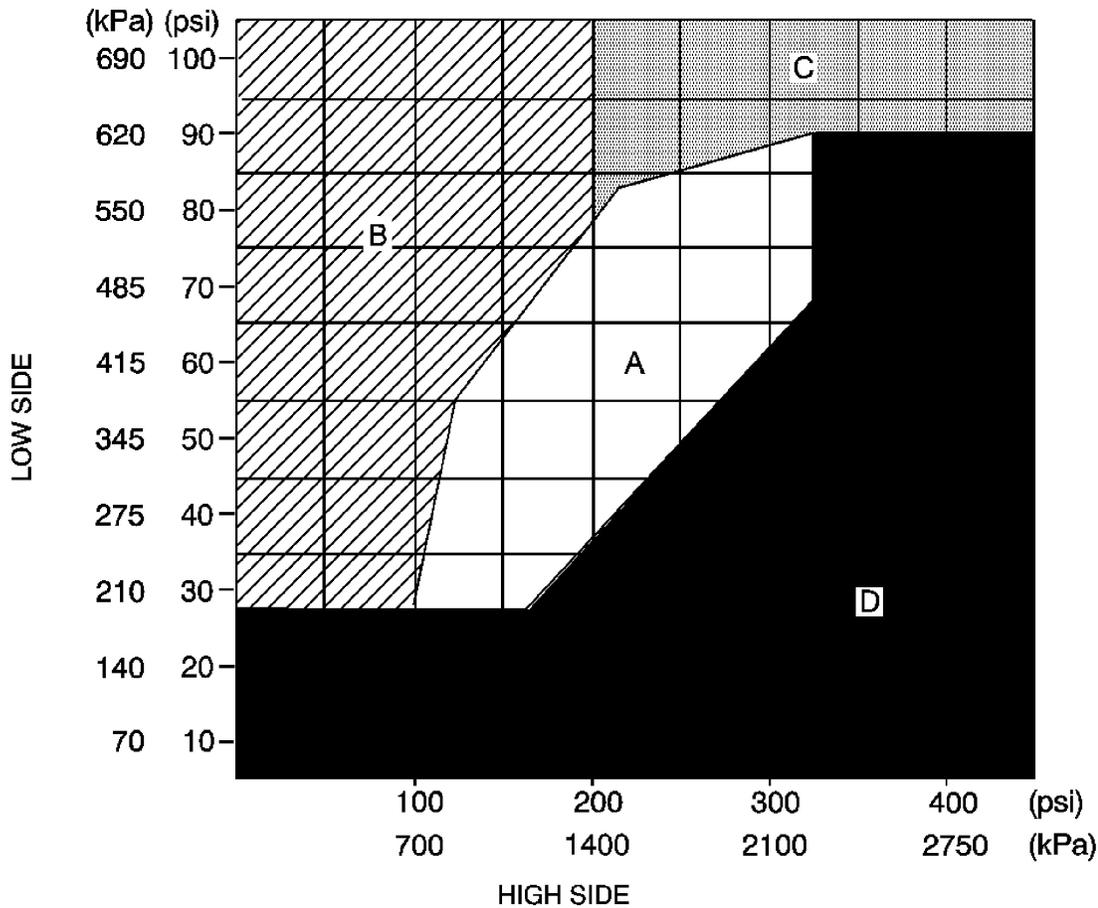
Fig. 3: A/C System Pressure Zone Classification - Gas Engine With Engine Driven Cooling Fan
 Courtesy of GENERAL MOTORS CORP.

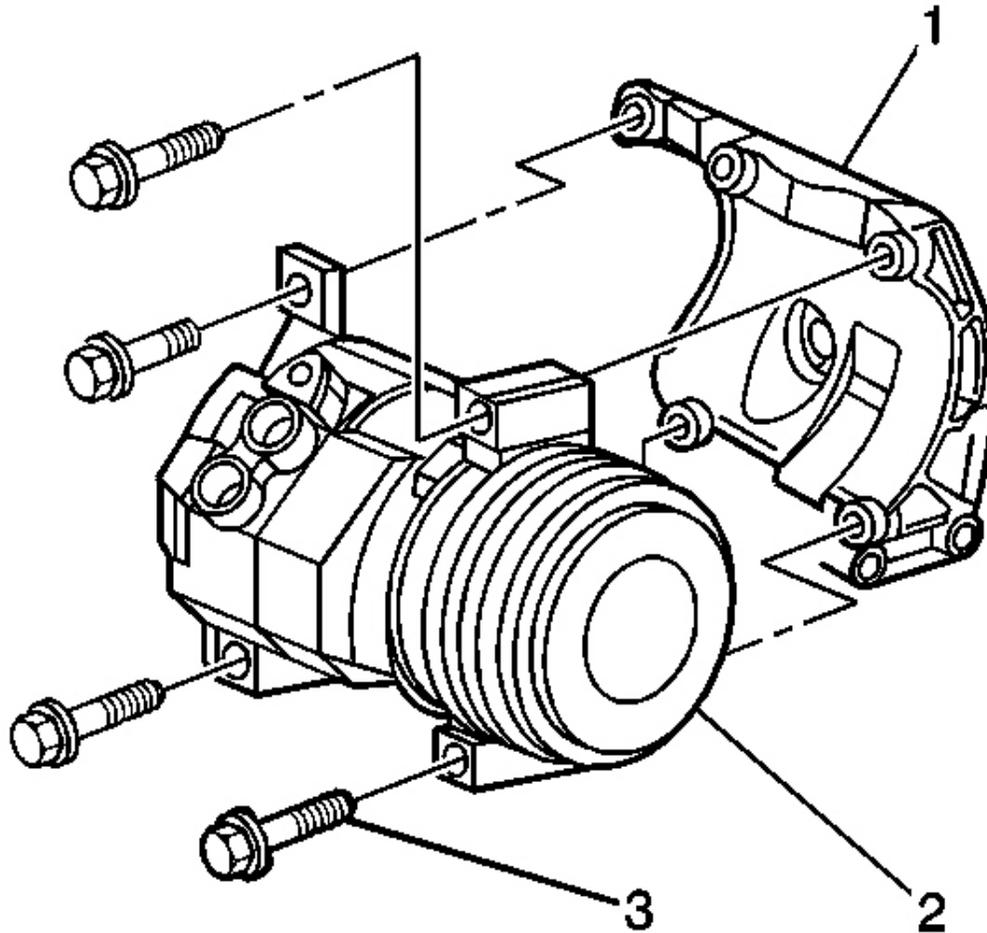
Fig. 8: View of A/C Compressor & Bolts
Courtesy of GENERAL MOTORS CORP.

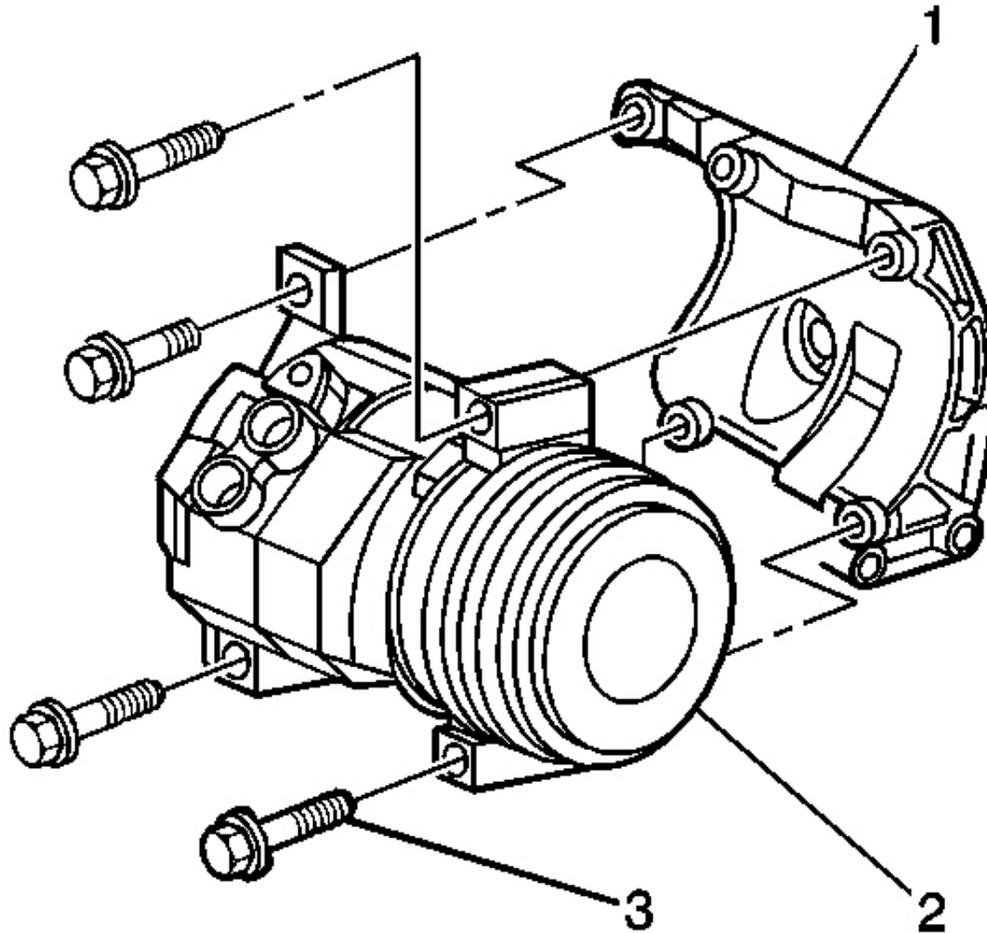
Fig. 9: View of A/C Compressor & Bolts
Courtesy of GENERAL MOTORS CORP.

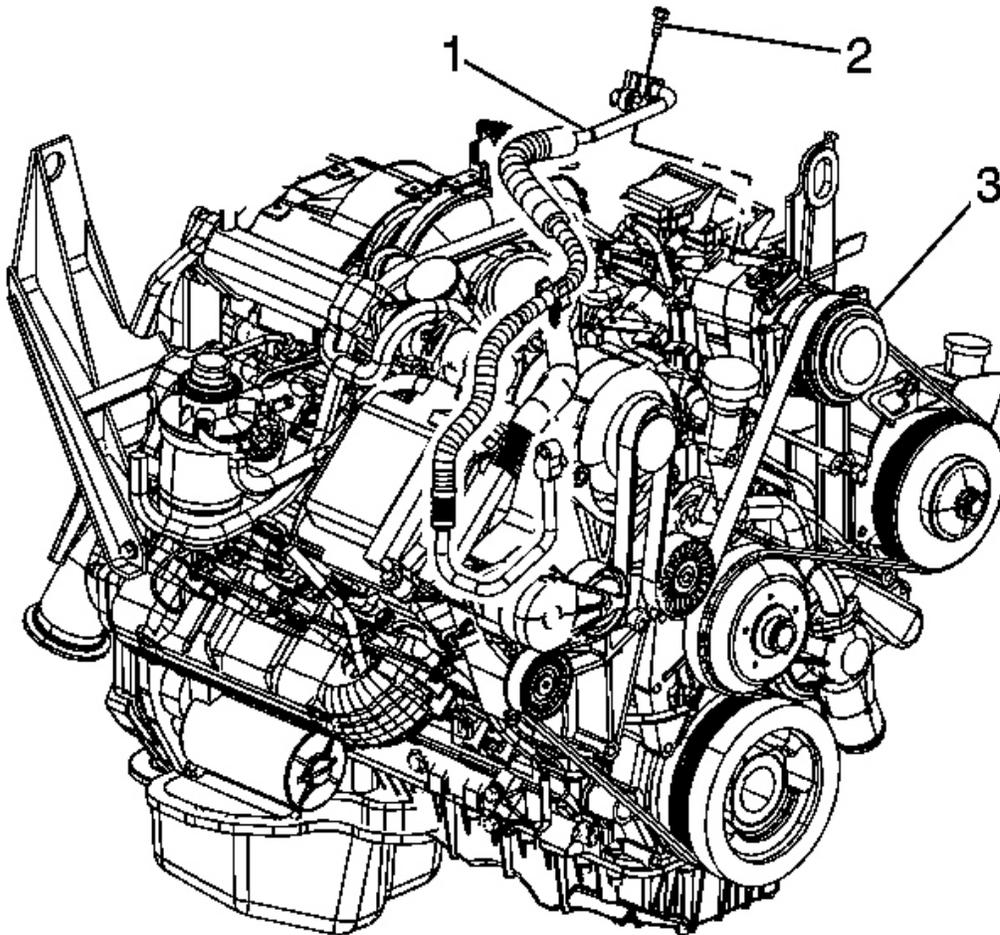
Fig. 11: A/C Discharge & Suction Hoses (LB7)
Courtesy of GENERAL MOTORS CORP.

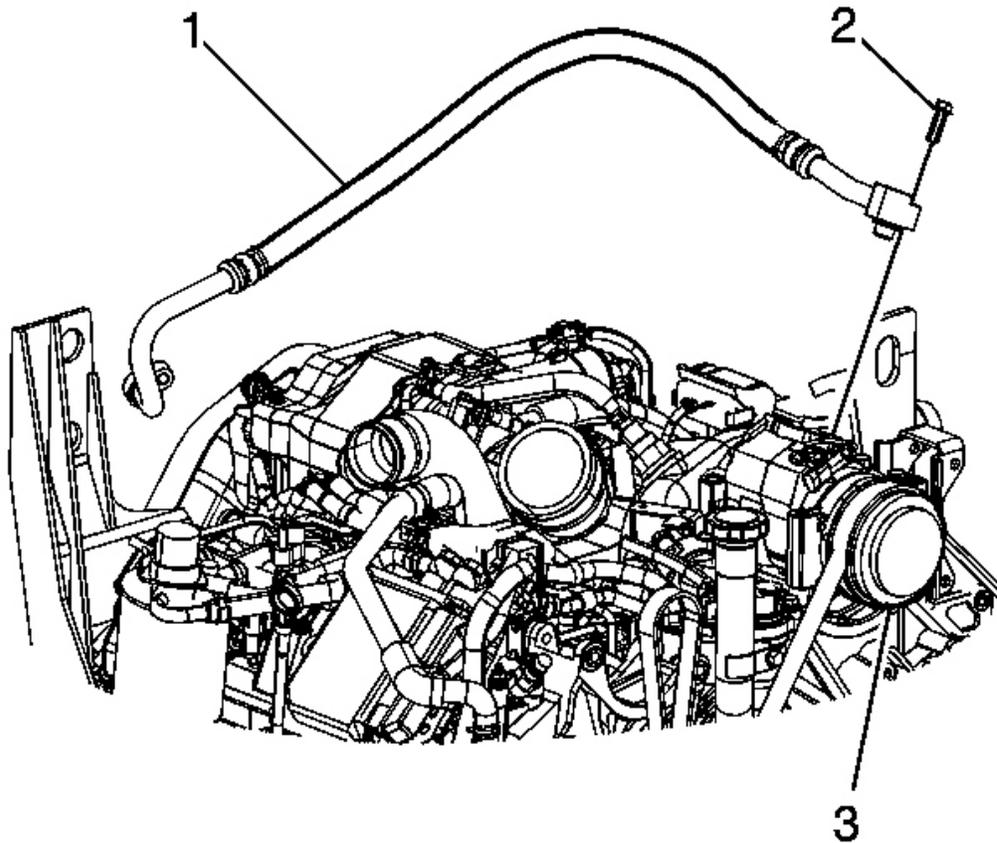
Fig. 12: View Of A/C Suction Hose (LB7)
Courtesy of GENERAL MOTORS CORP.

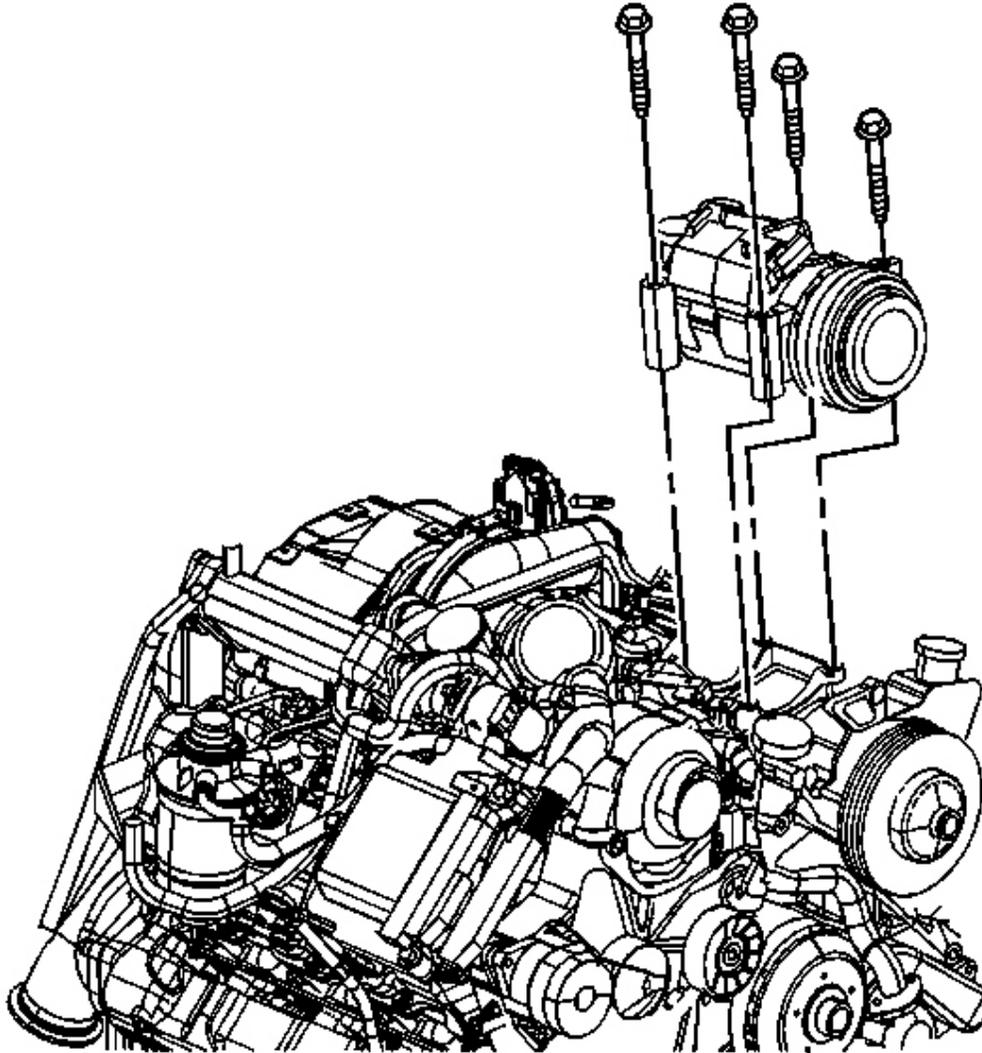
Fig. 13: View Of A/C Compressor (LB7)
Courtesy of GENERAL MOTORS CORP.

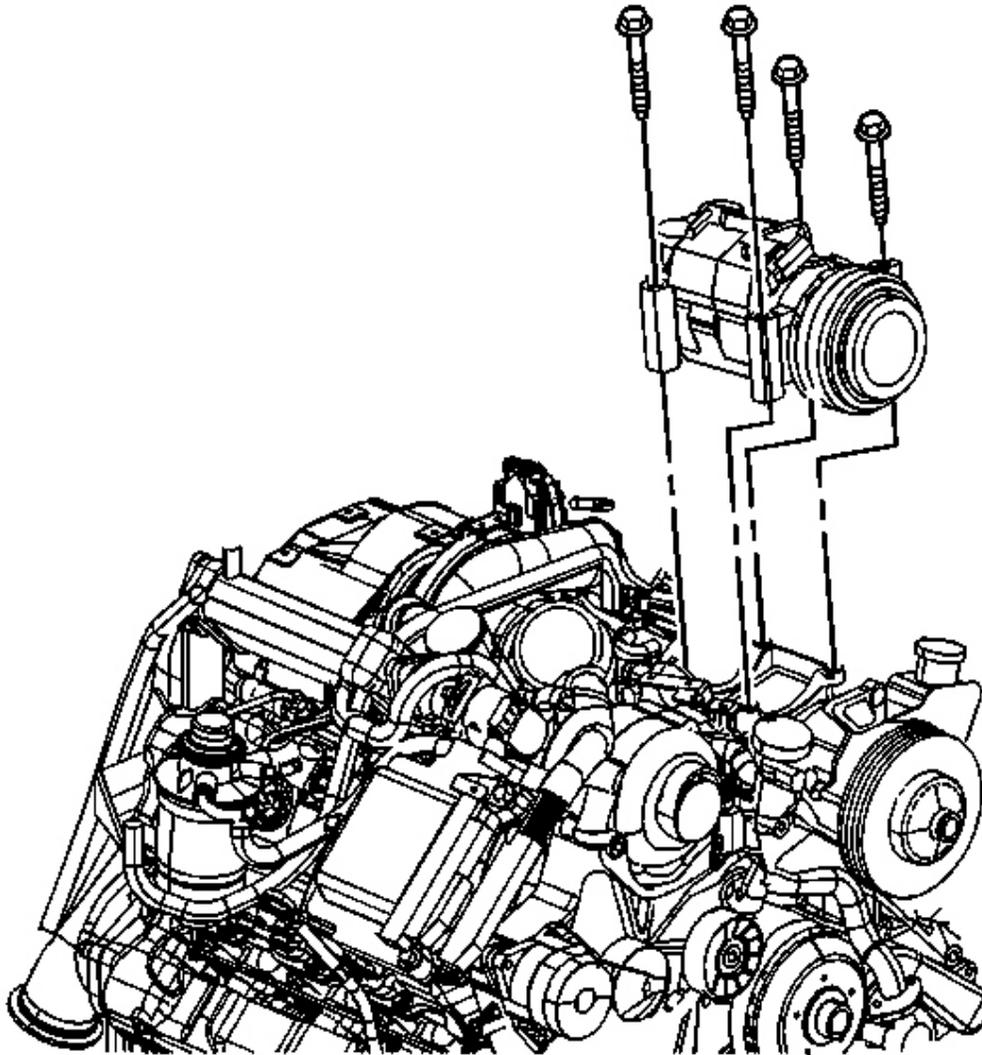
Fig. 14: View Of A/C Compressor (LB7)
Courtesy of GENERAL MOTORS CORP.

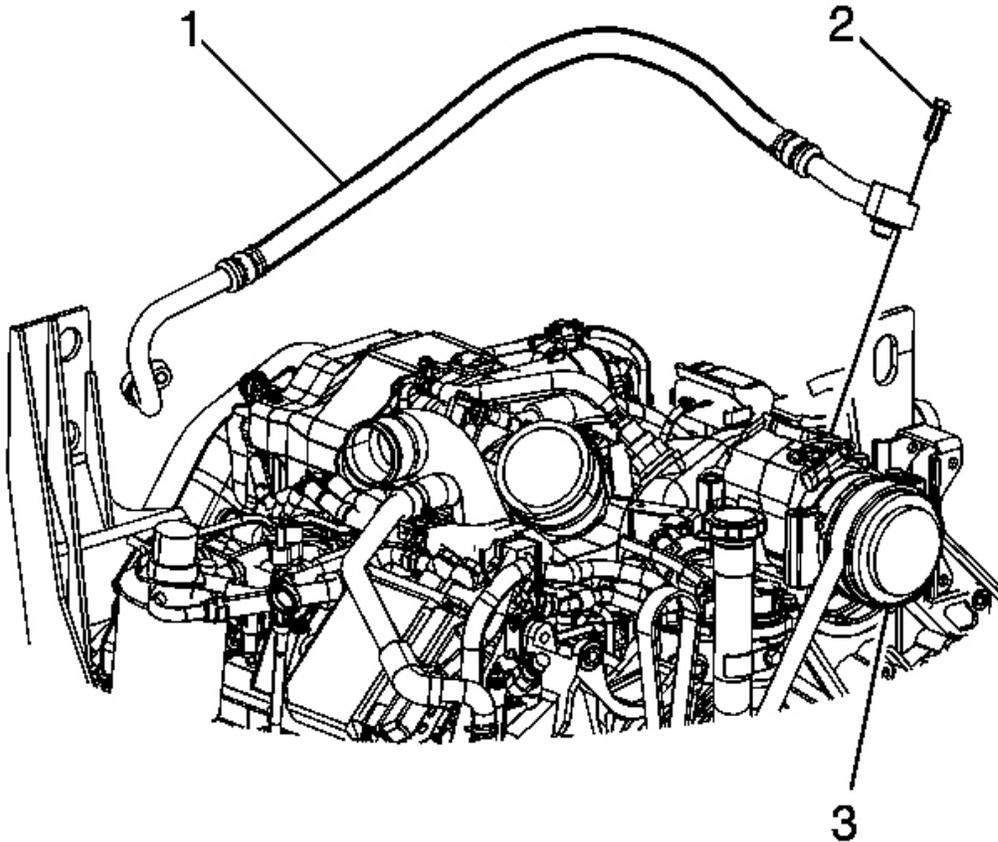
Tighten: Tighten the bolt to 16 N.m (12 lb ft).

Fig. 16: View Of A/C Suction Hose (LB7)
Courtesy of GENERAL MOTORS CORP.

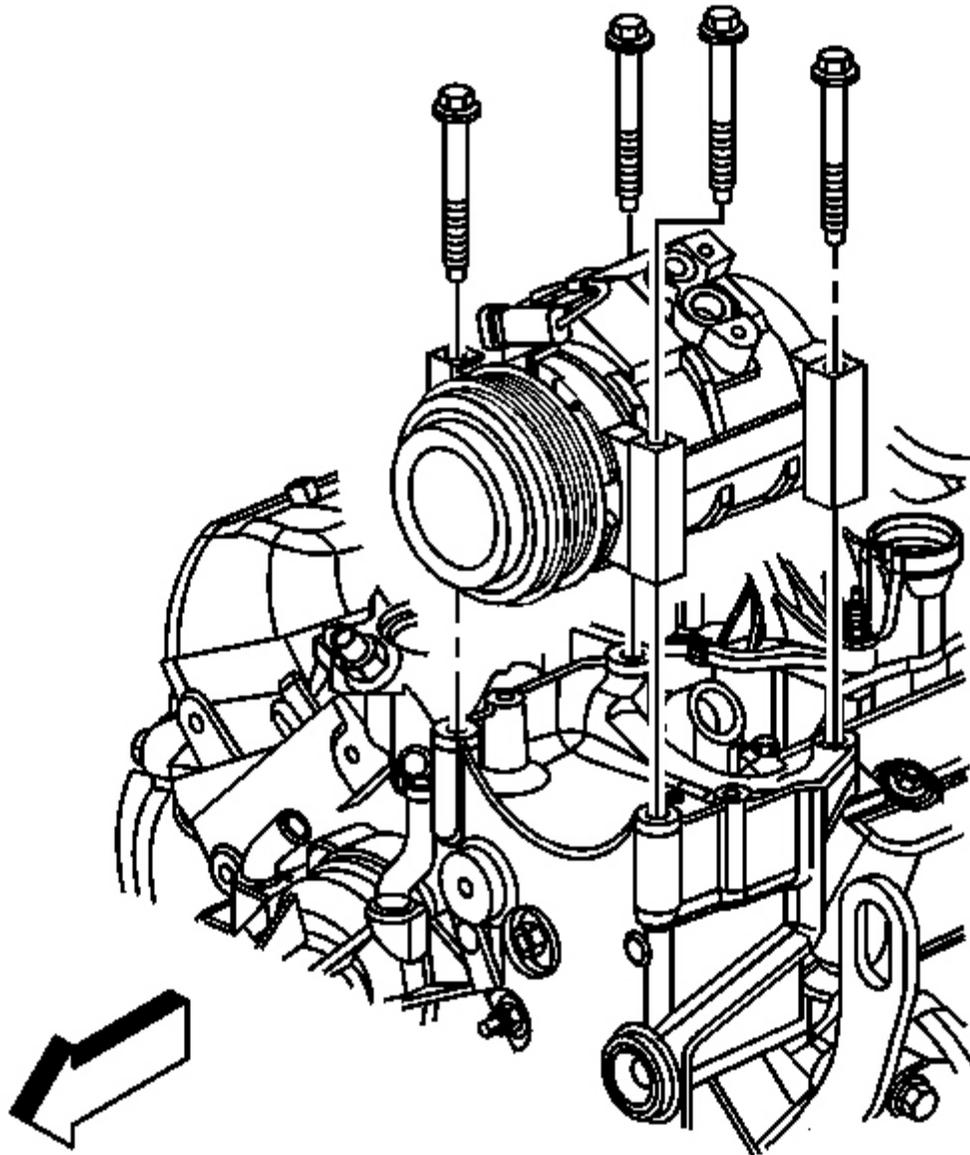
Fig. 19: View Of A/C Compressor & Mounting Bolts
Courtesy of GENERAL MOTORS CORP.

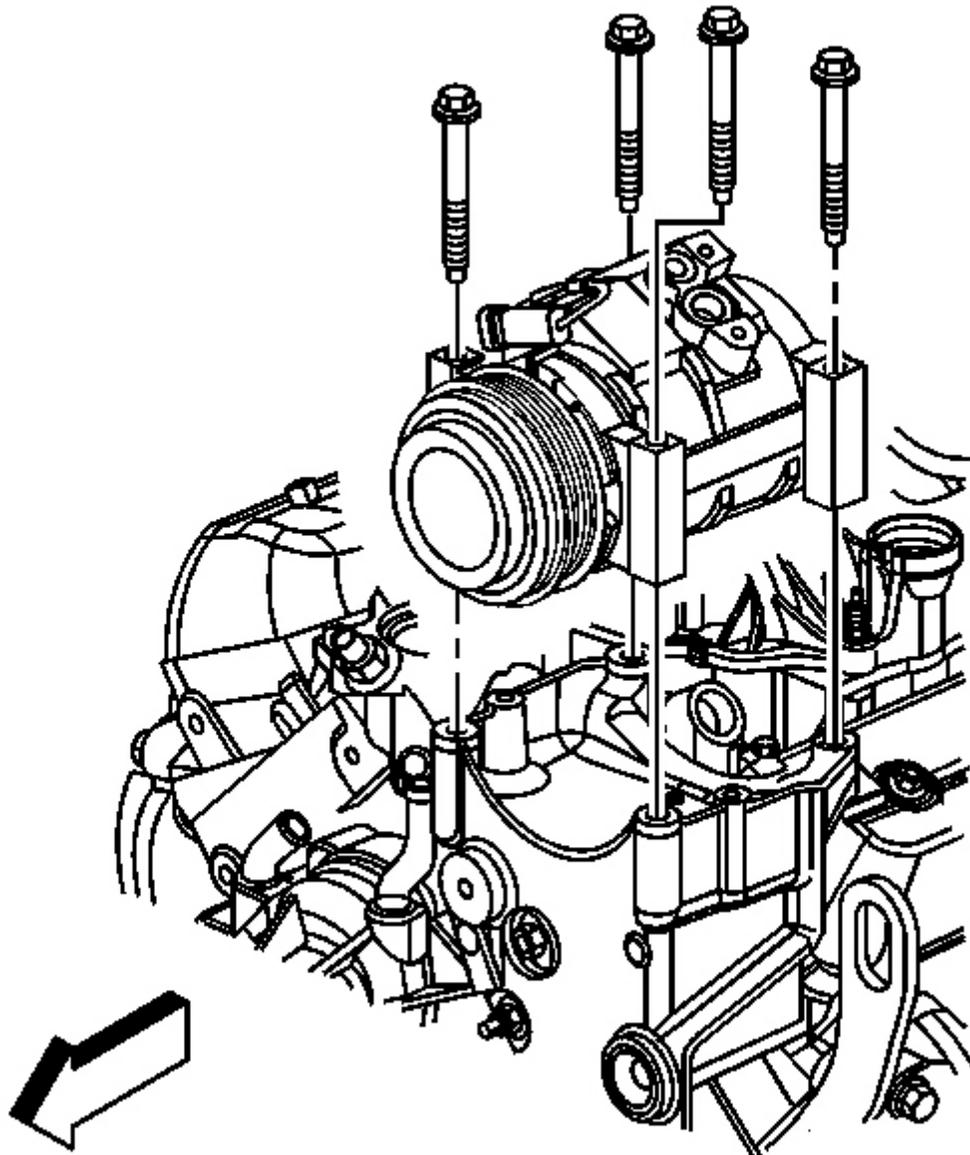
Fig. 20: View Of A/C Compressor & Mounting Bolts
Courtesy of GENERAL MOTORS CORP.

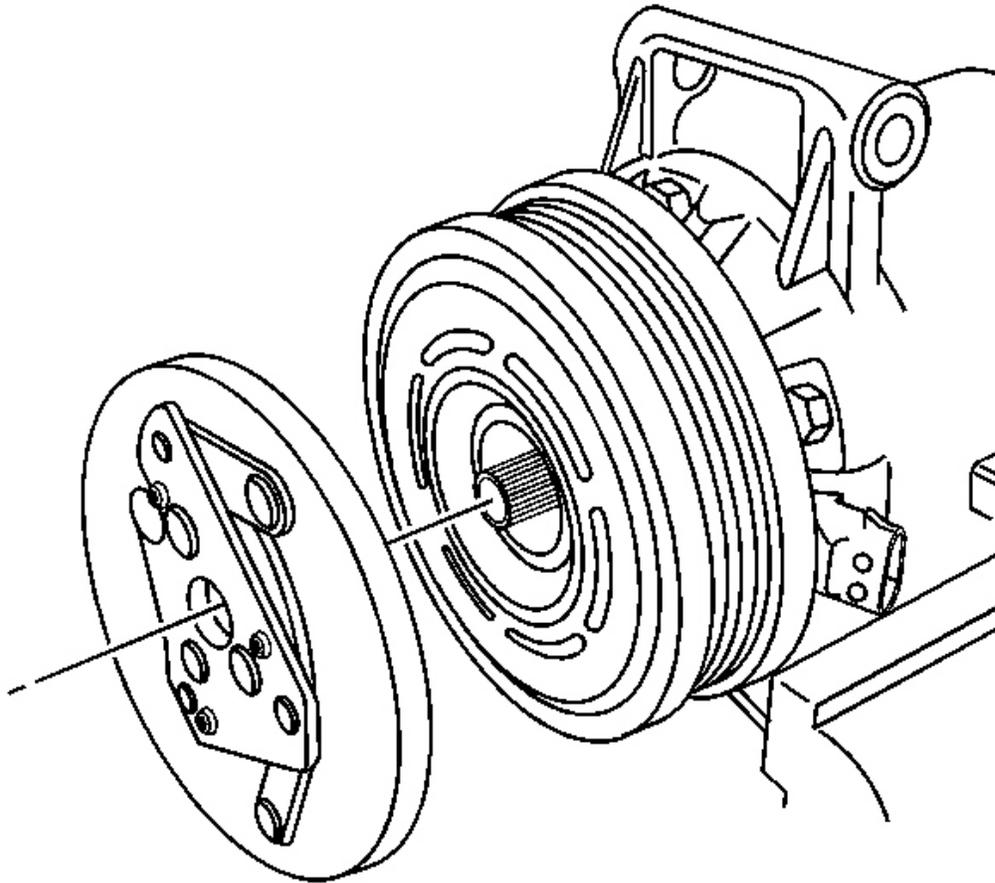
Fig. 25: Identifying Compressor Clutch Plate
Courtesy of GENERAL MOTORS CORP.

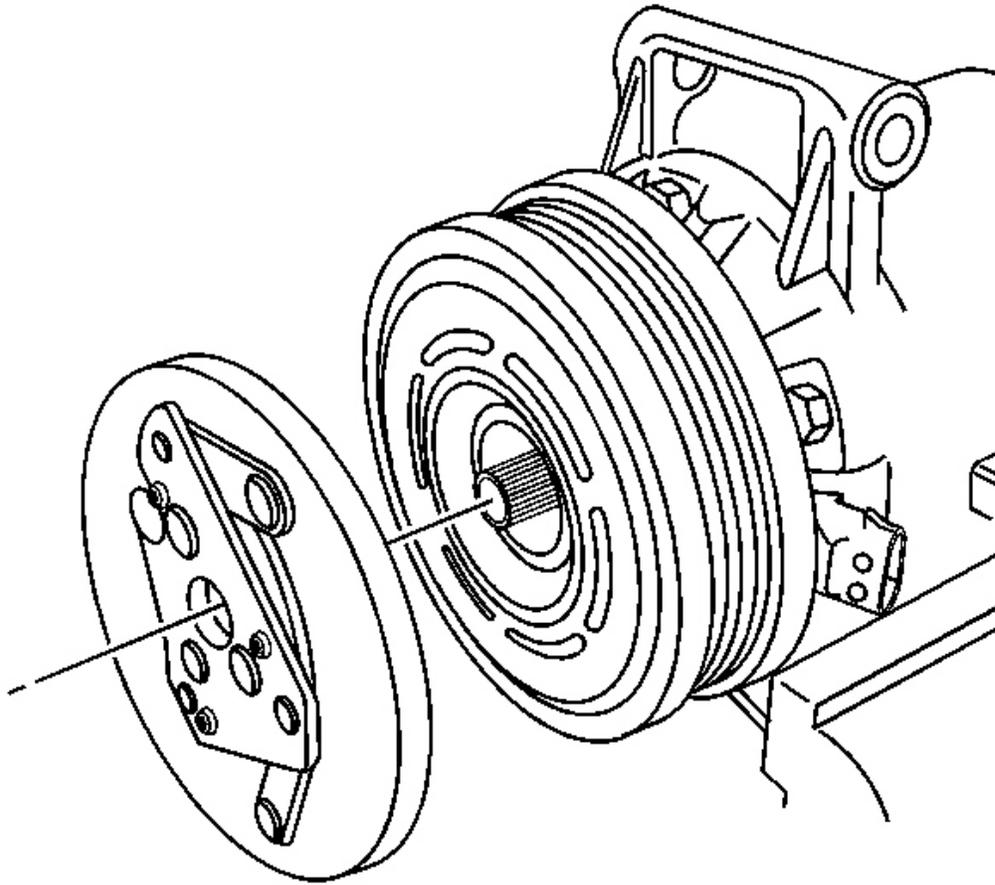
Fig. 31: Identifying Compressor Clutch Plate
Courtesy of GENERAL MOTORS CORP.

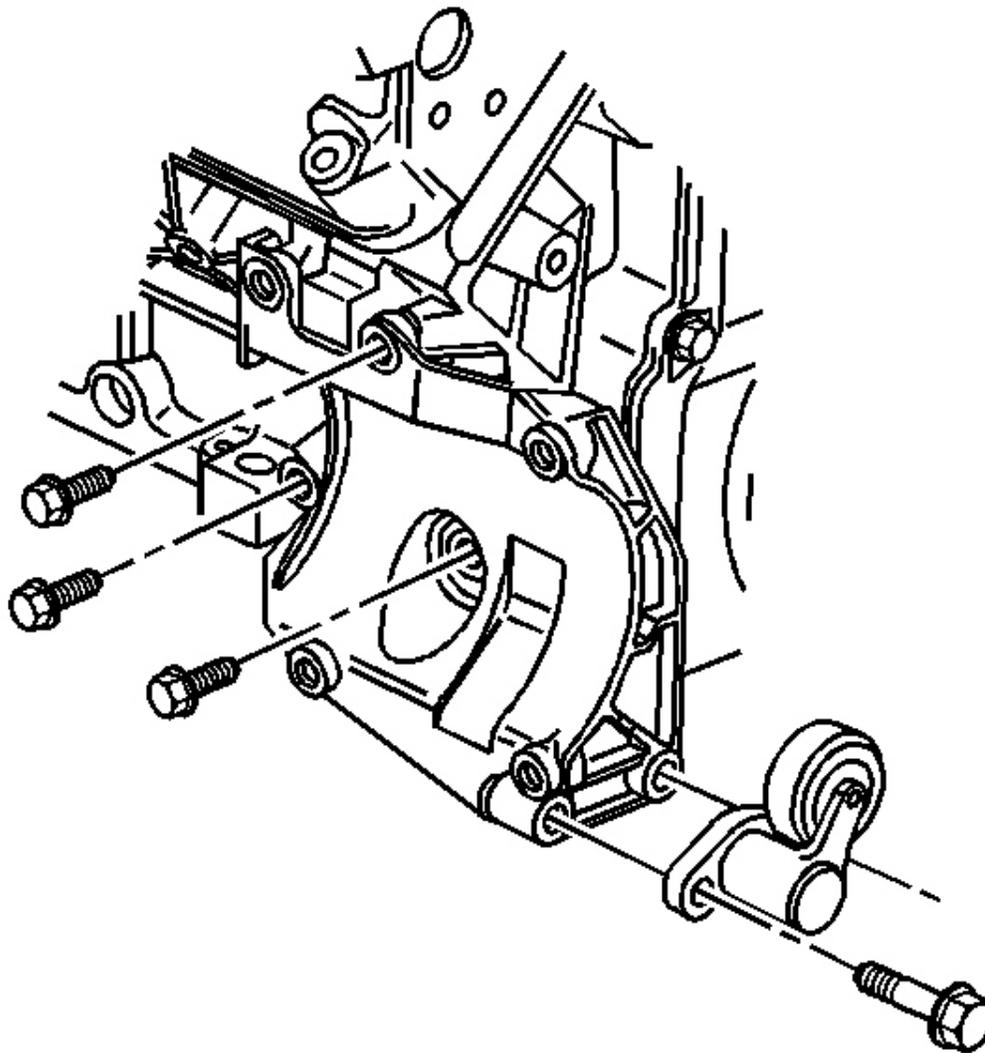
Fig. 34: A/C Compressor Bracket Mounting Bolts
Courtesy of GENERAL MOTORS CORP.

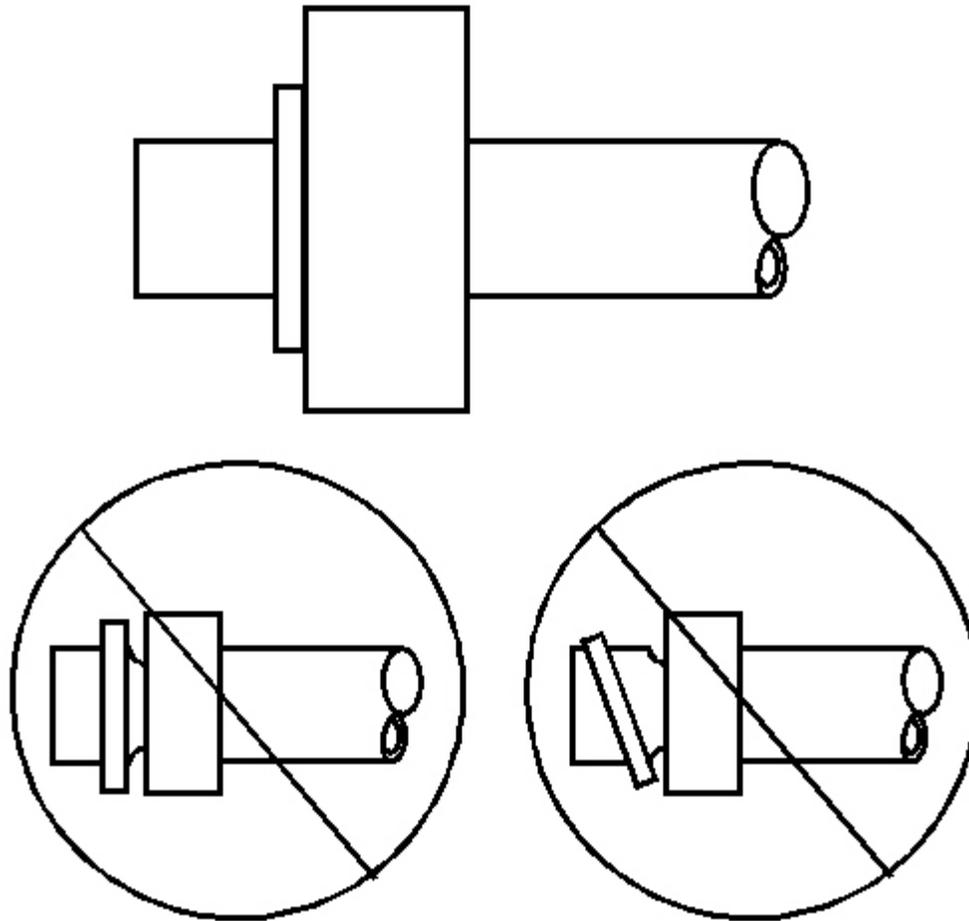
Fig. 36: Identifying Good And Bad Sealing Washer Positions
Courtesy of GENERAL MOTORS CORP.

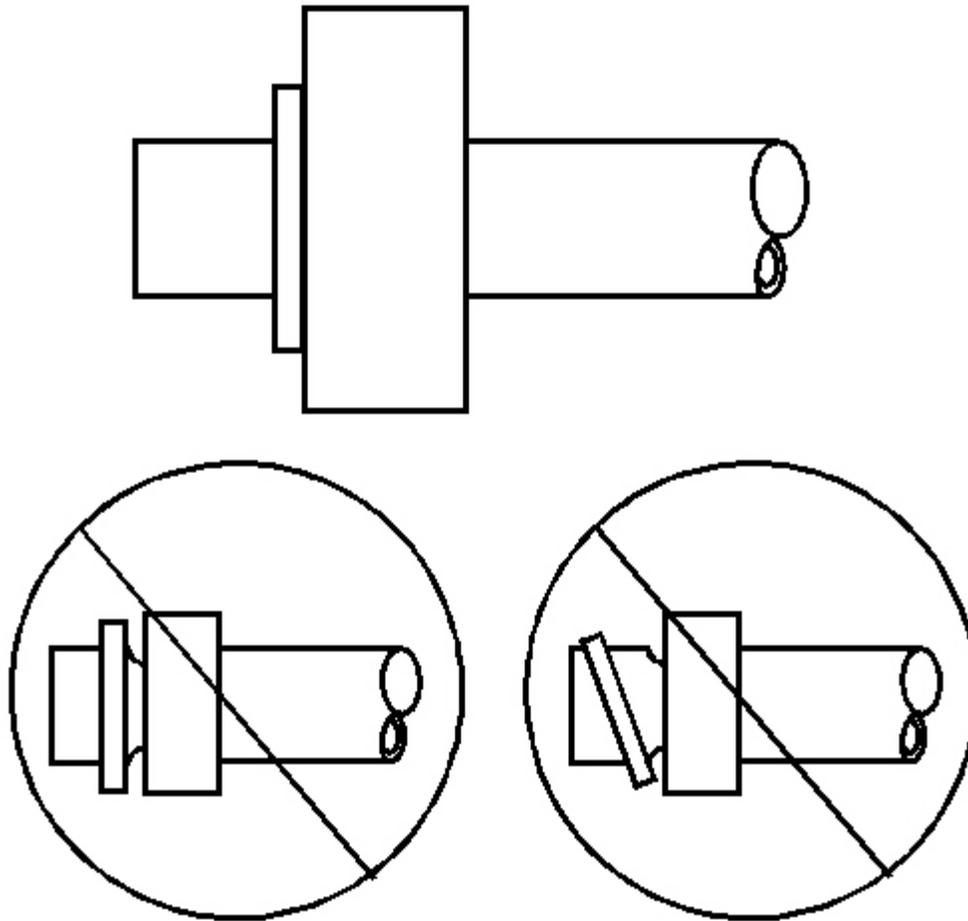
Fig. 37: Identifying Good And Bad Sealing Washer Positions
Courtesy of GENERAL MOTORS CORP.

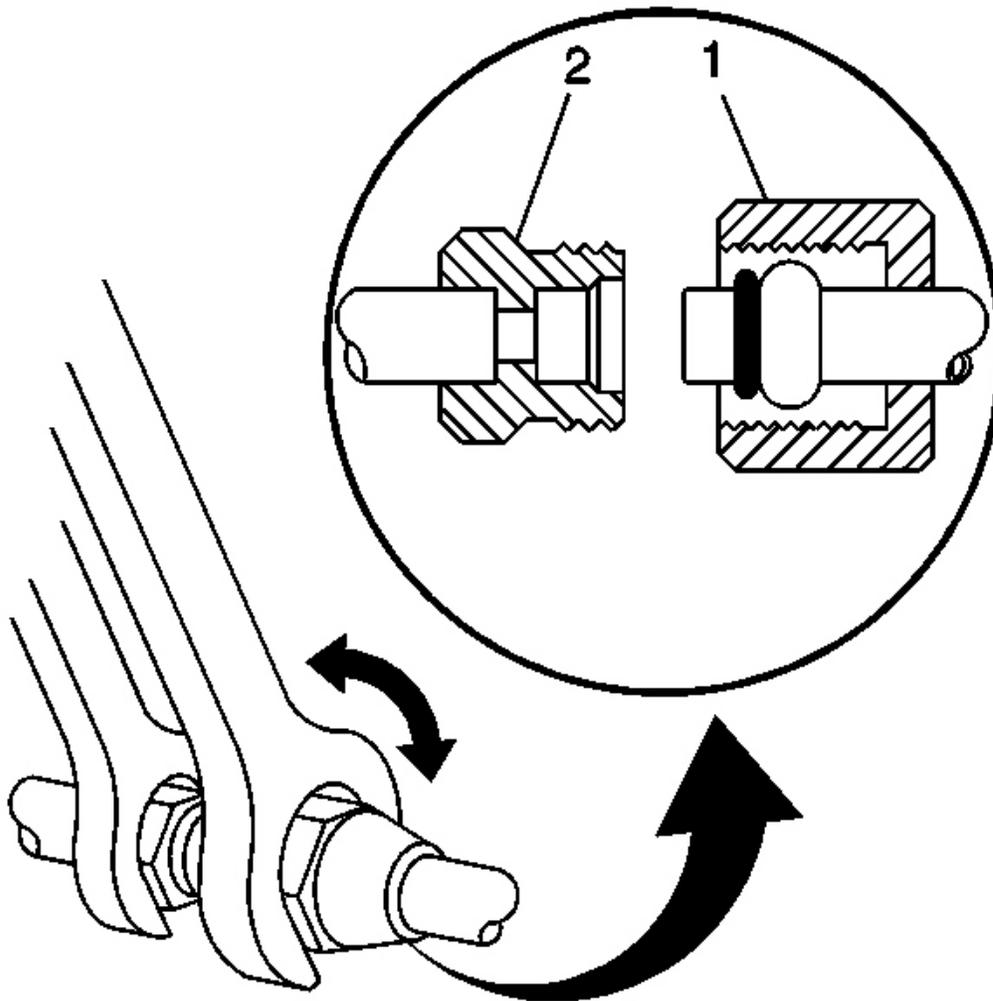
Fig. 38: Disassembling/Reassembling A/C Line Fittings
Courtesy of GENERAL MOTORS CORP.

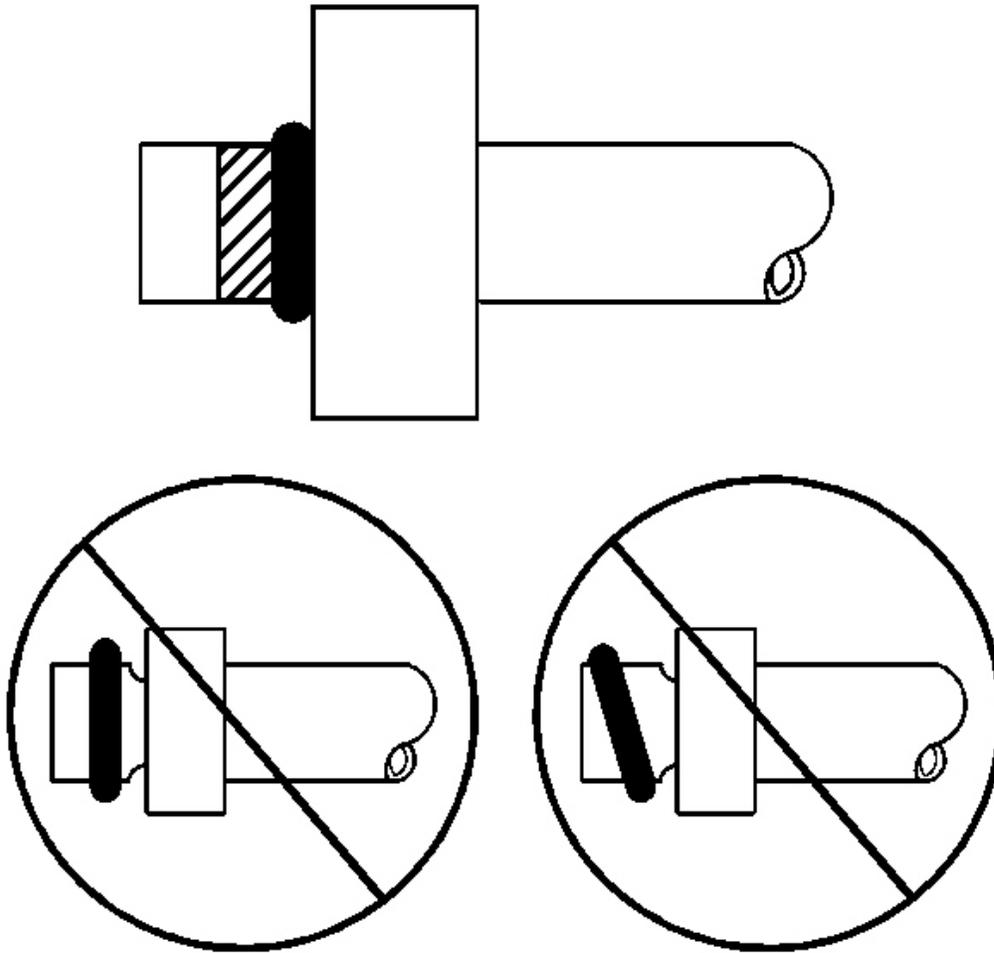
Fig. 39: Identifying Proper Seating Of A/C Refrigerant O-Ring
Courtesy of GENERAL MOTORS CORP.

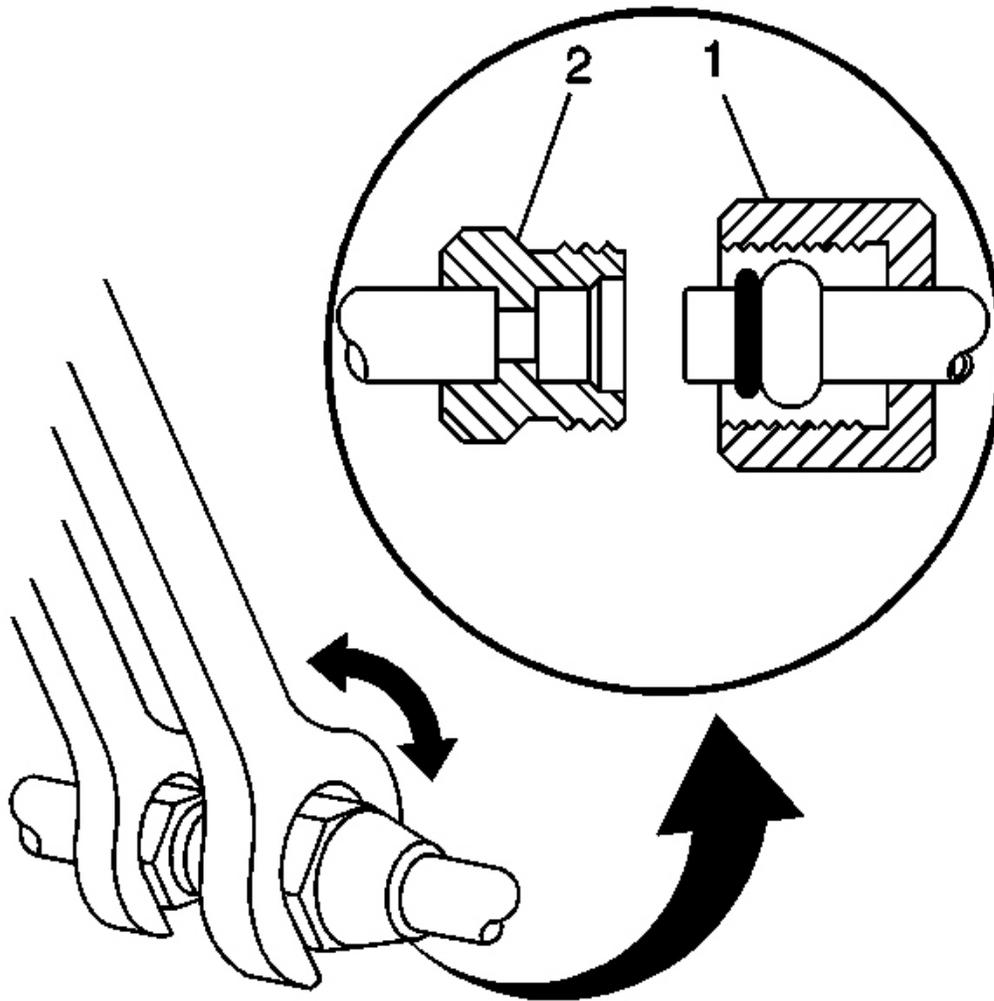
Fig. 40: Disassembling/Reassembling A/C Line Fittings
Courtesy of GENERAL MOTORS CORP.

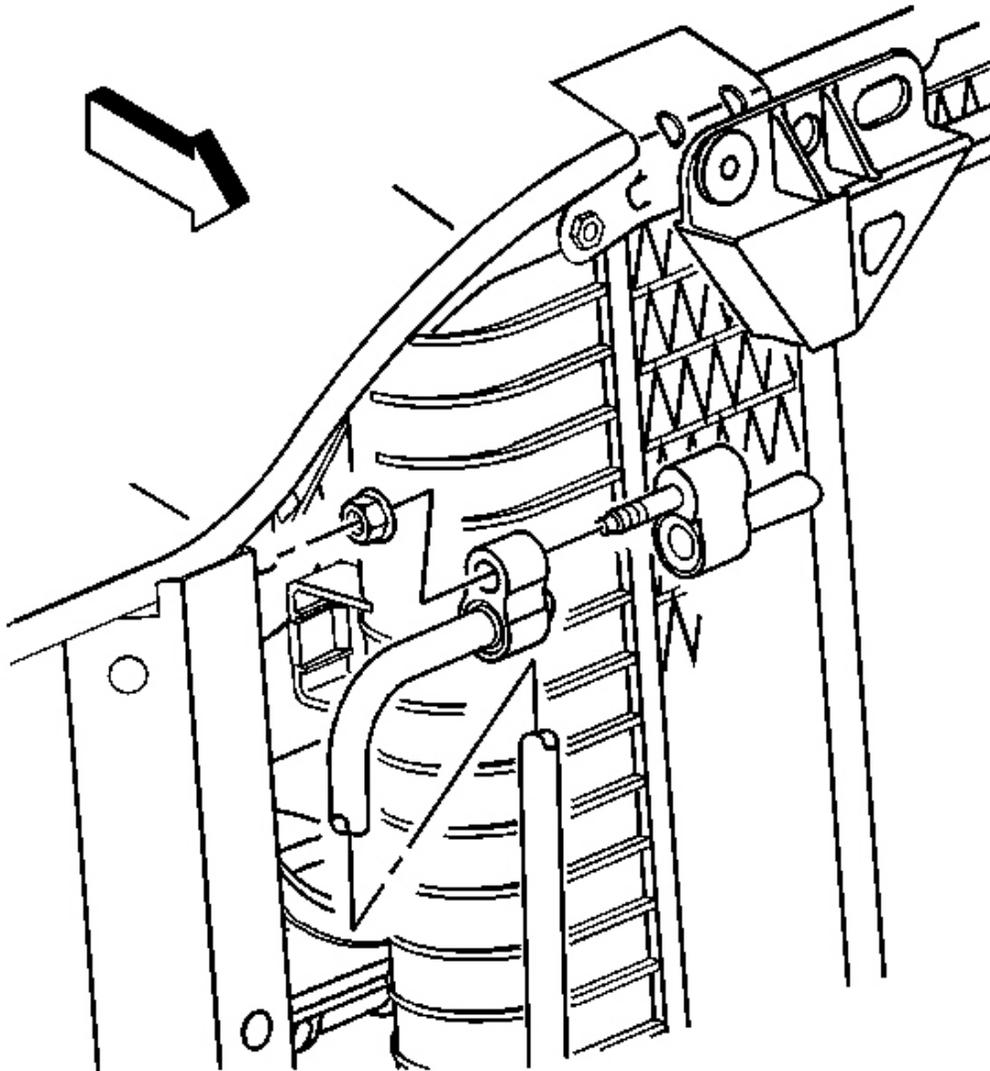
2. Remove the discharge hose mounting bolt (2) from the A/C compressor.
3. Remove the discharge hose (1) from the A/C compressor.
4. Remove the upper radiator baffle. Refer to **Radiator Air Upper Baffle and Deflector Replacement** .

Fig. 42: View Of Discharge Hose At Condenser
Courtesy of GENERAL MOTORS CORP.

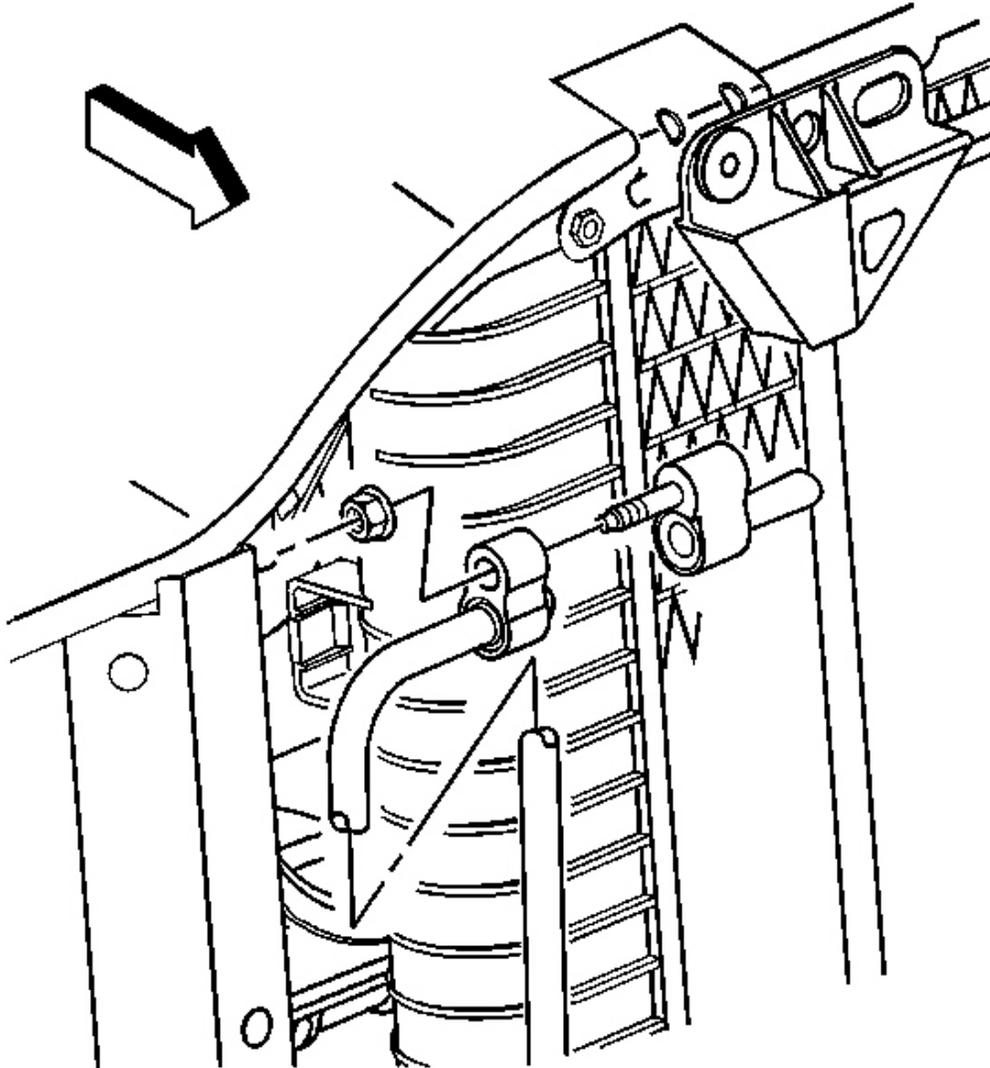
Fig. 44: View Of Discharge Hose At Condenser
Courtesy of GENERAL MOTORS CORP.

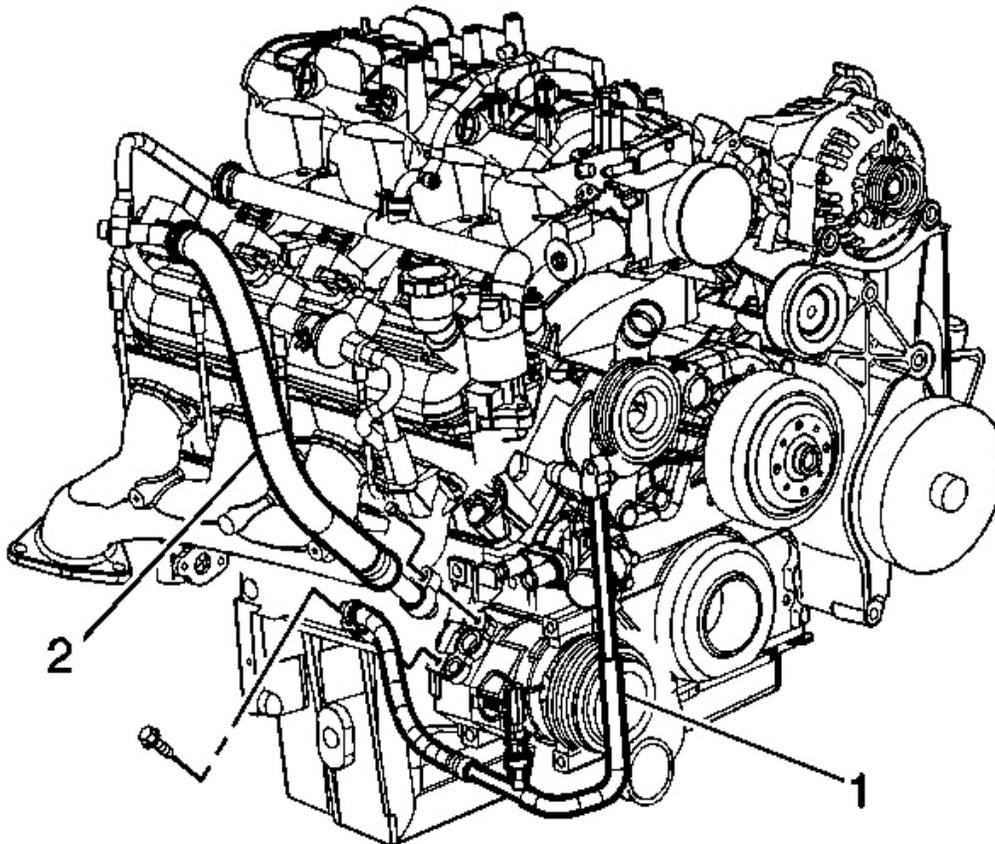
Fig. 45: Identifying Suction/Discharge Hoses To A/C Compressor
Courtesy of GENERAL MOTORS CORP.
