2008 Chevrolet Silverado 1500

2008 HVAC Heating, Ventilation, and Air Conditioning - Cab & Chassis Sierra, Cab & Chassis Silverado, Sierra & Silverado

SPECIFICATIONS

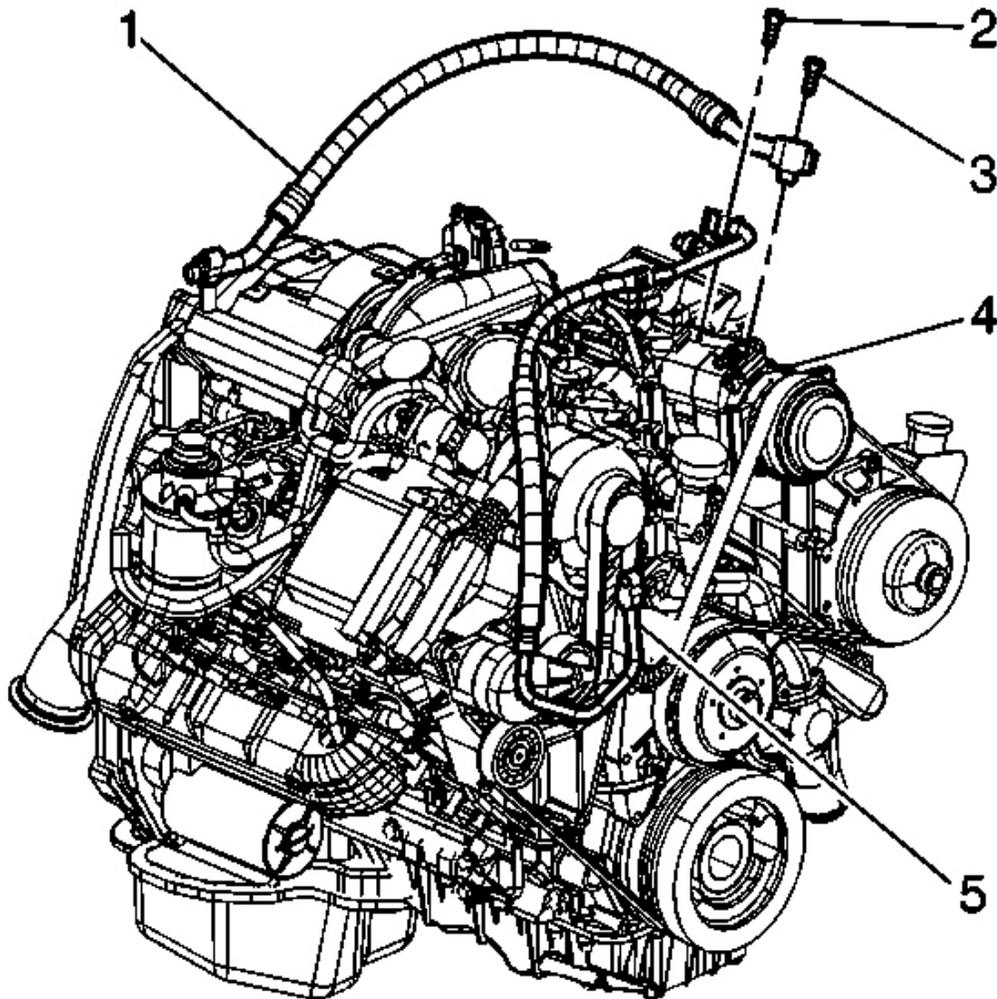
Fig. 46: View Of Discharge Hose & Connectors
Courtesy of GENERAL MOTORS CORP.

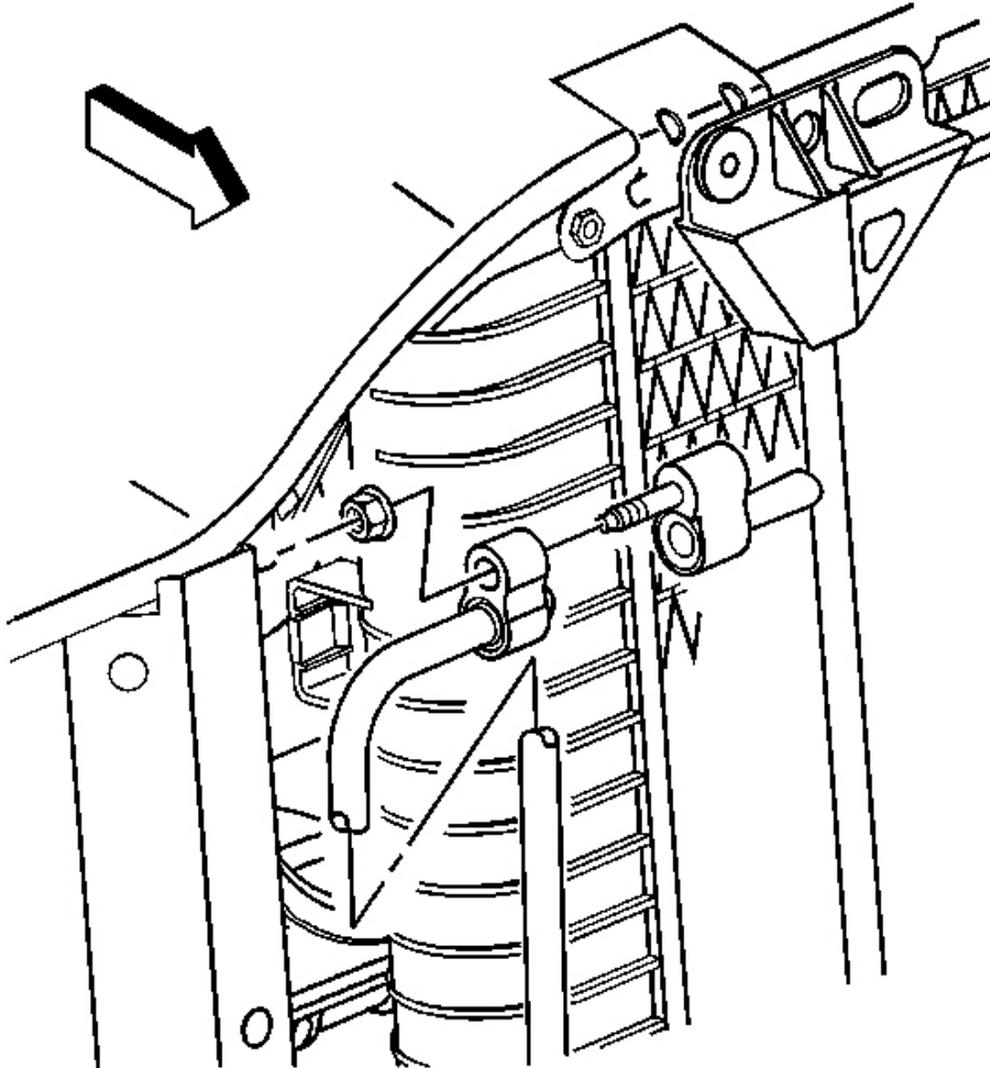
Fig. 47: View Of Discharge Hose At Condenser
Courtesy of GENERAL MOTORS CORP.

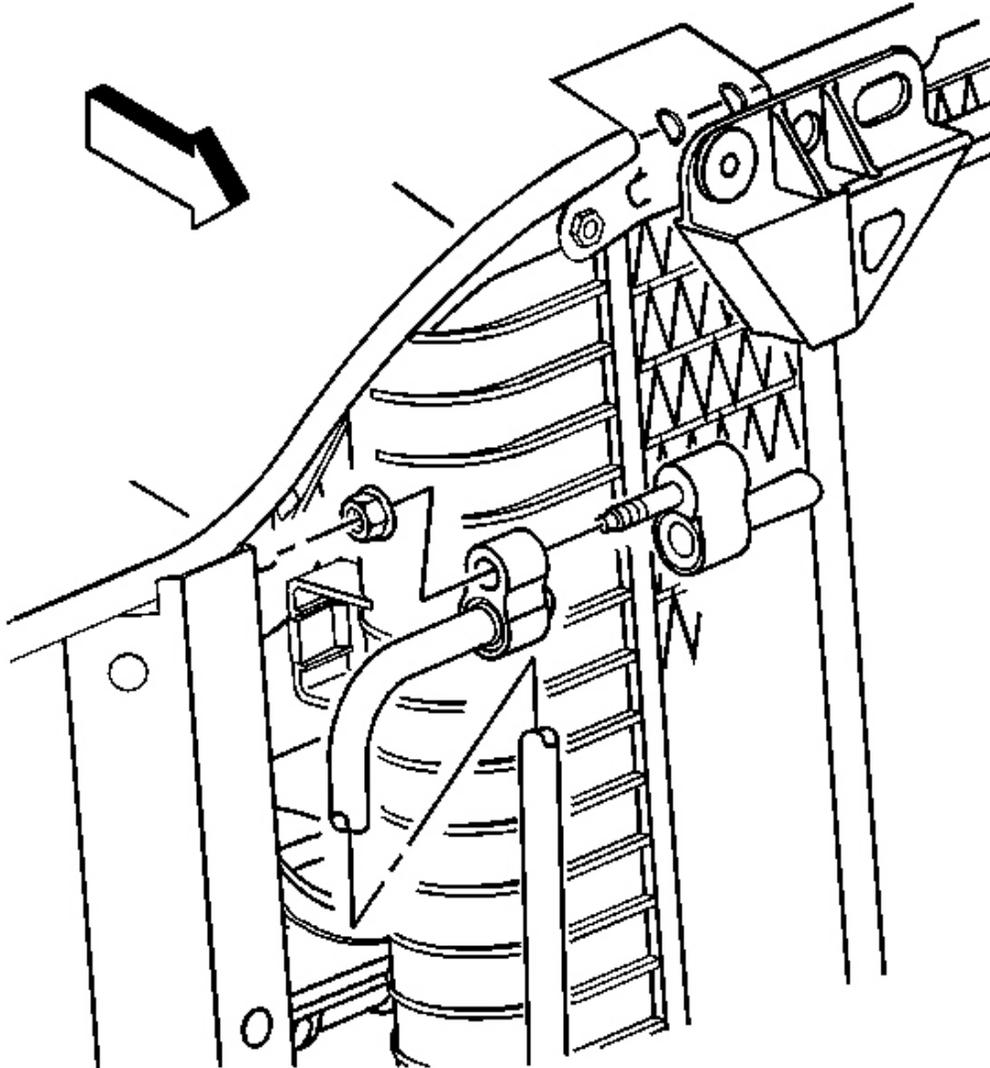
Fig. 48: View Of Discharge Hose At Condenser
Courtesy of GENERAL MOTORS CORP.

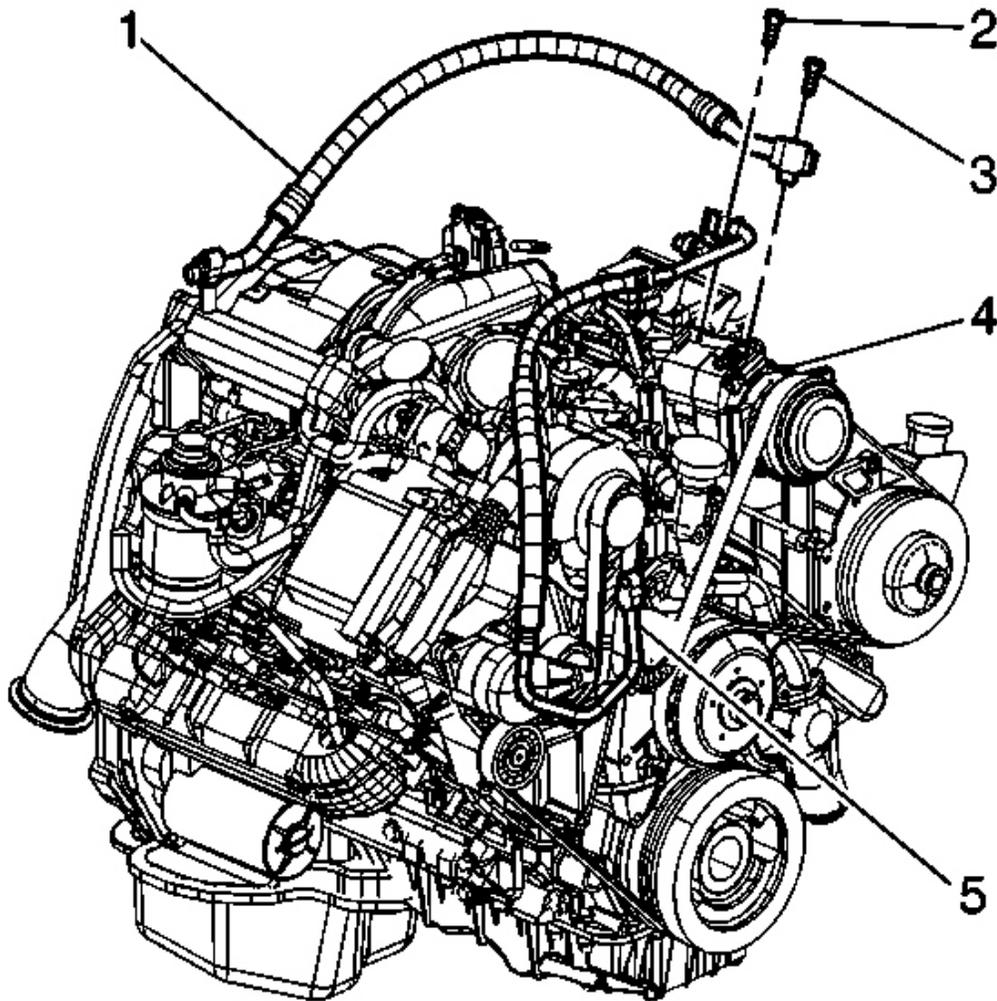
Fig. 49: View Of Discharge Hose & Connectors
Courtesy of GENERAL MOTORS CORP.

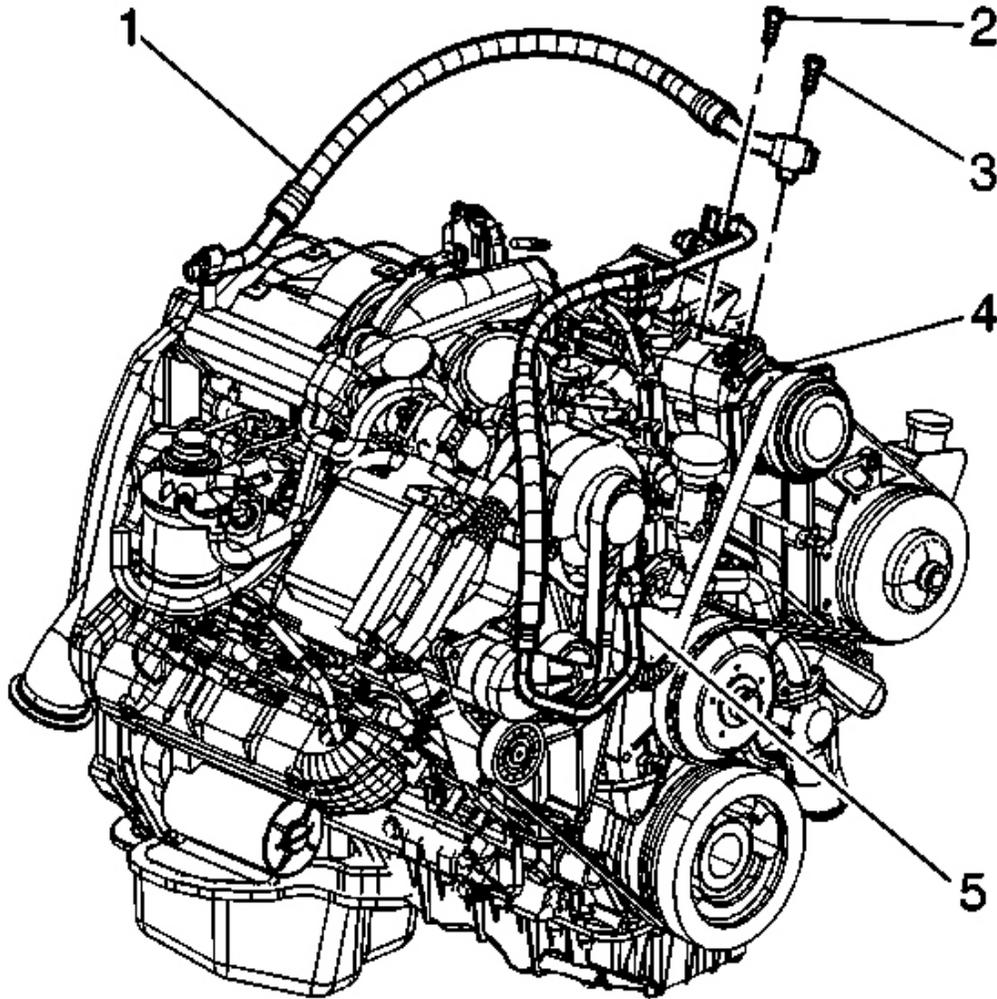
Fig. 51: View Of Discharge Hose & Connectors
Courtesy of GENERAL MOTORS CORP.

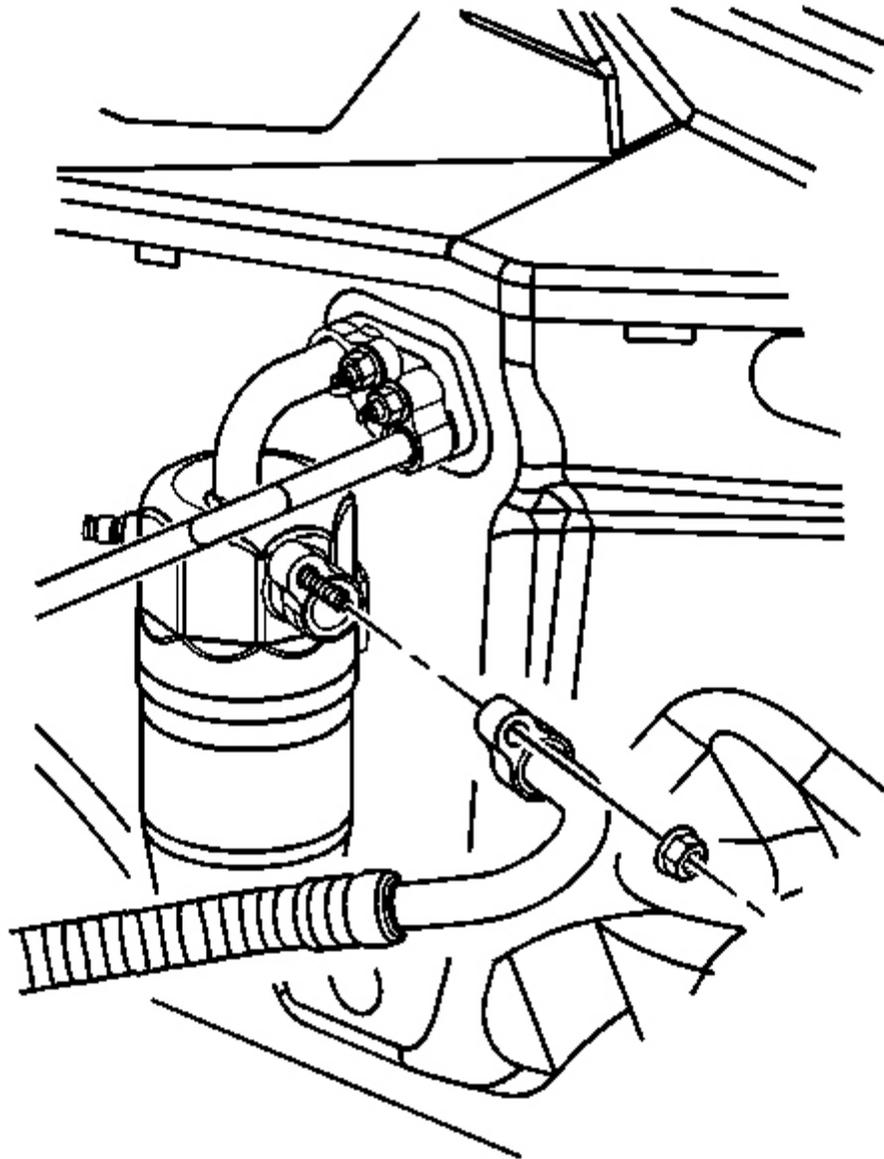
Fig. 52: Removing/Installing Suction Hose From Accumulator
Courtesy of GENERAL MOTORS CORP.

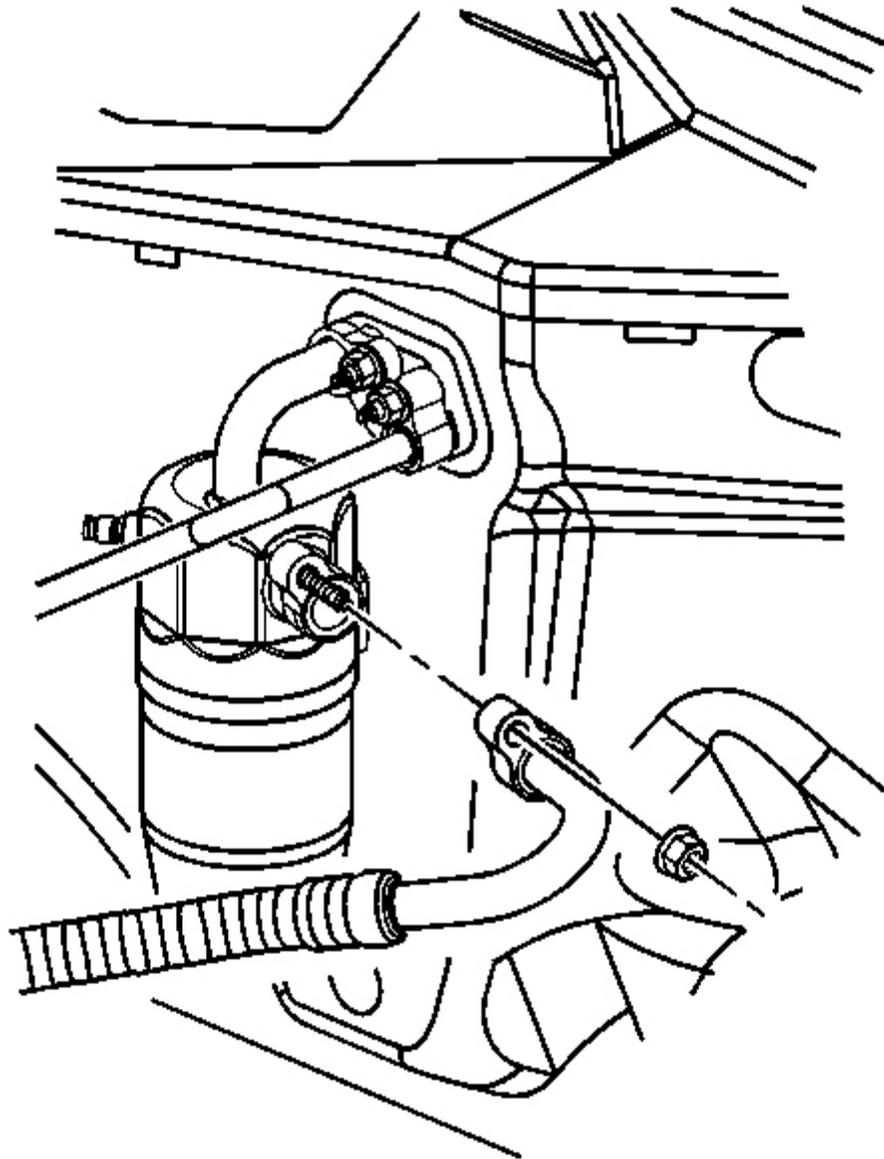
Fig. 53: Removing/Installing Suction Hose From Accumulator
Courtesy of GENERAL MOTORS CORP.

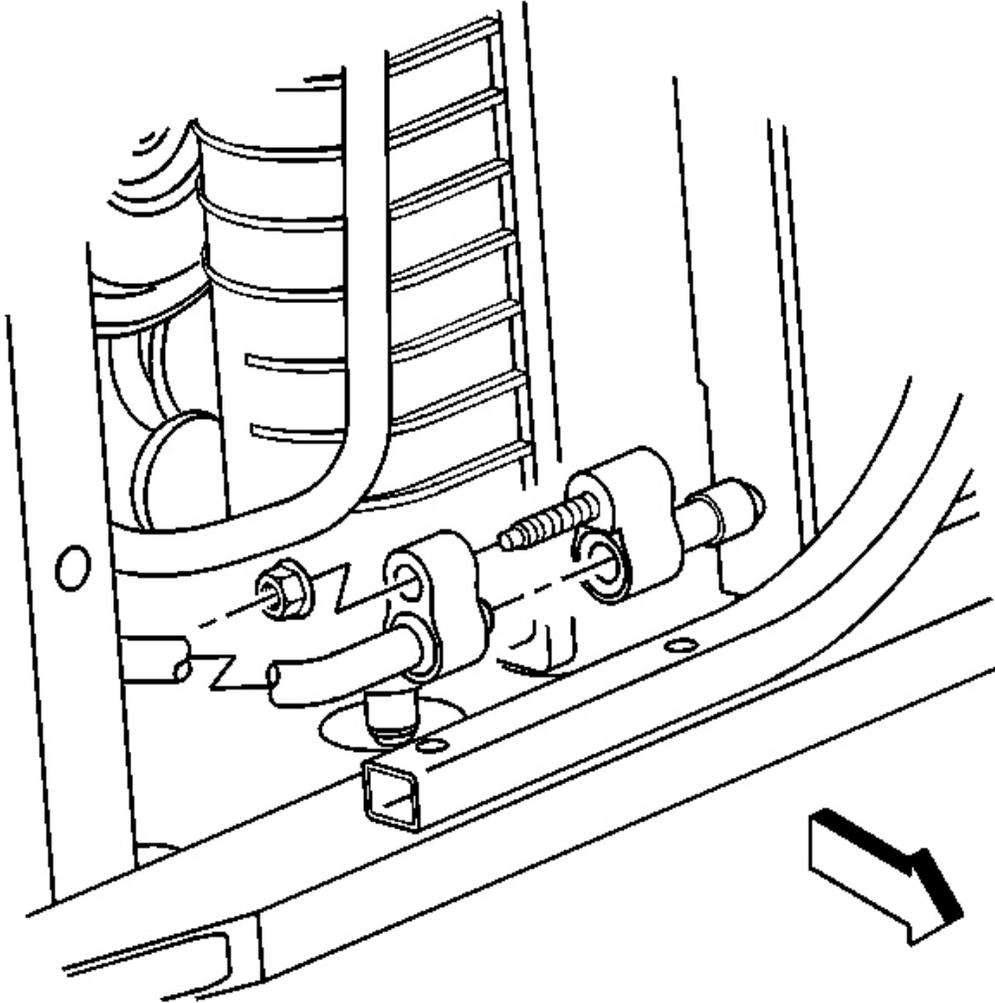
Fig. 56: Evaporator Tube To Condenser
Courtesy of GENERAL MOTORS CORP.

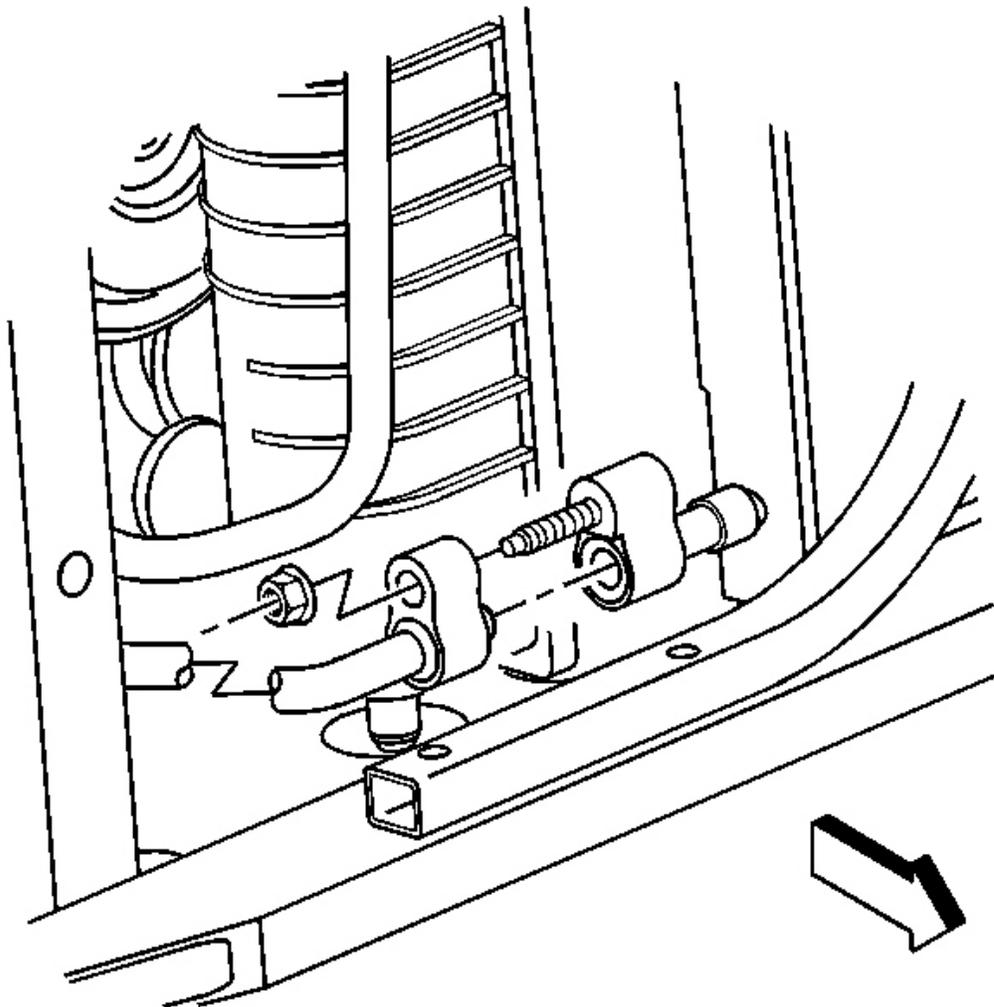
Fig. 57: Evaporator Tube To Condenser
Courtesy of GENERAL MOTORS CORP.

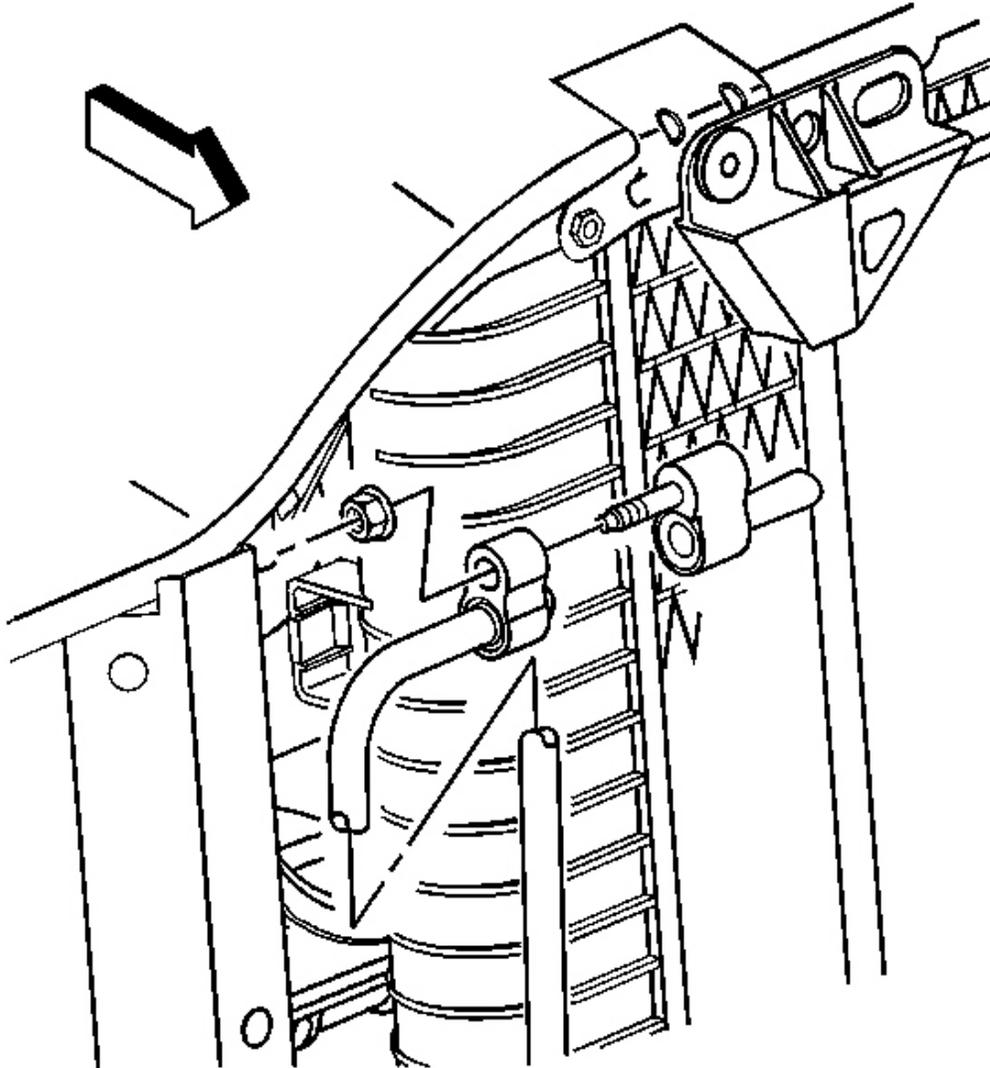
Fig. 65: View Of Discharge Hose At Condenser
Courtesy of GENERAL MOTORS CORP.

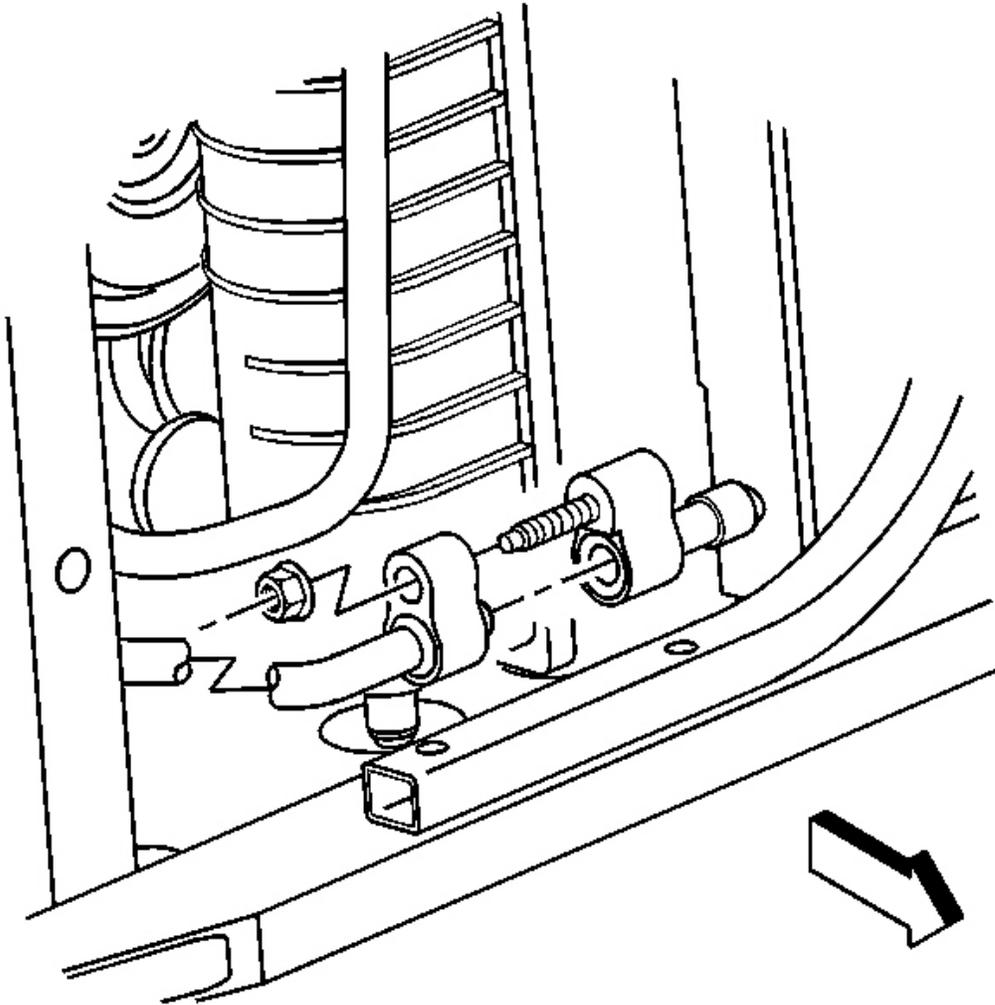
Fig. 66: Evaporator Tube To Condenser
Courtesy of GENERAL MOTORS CORP.

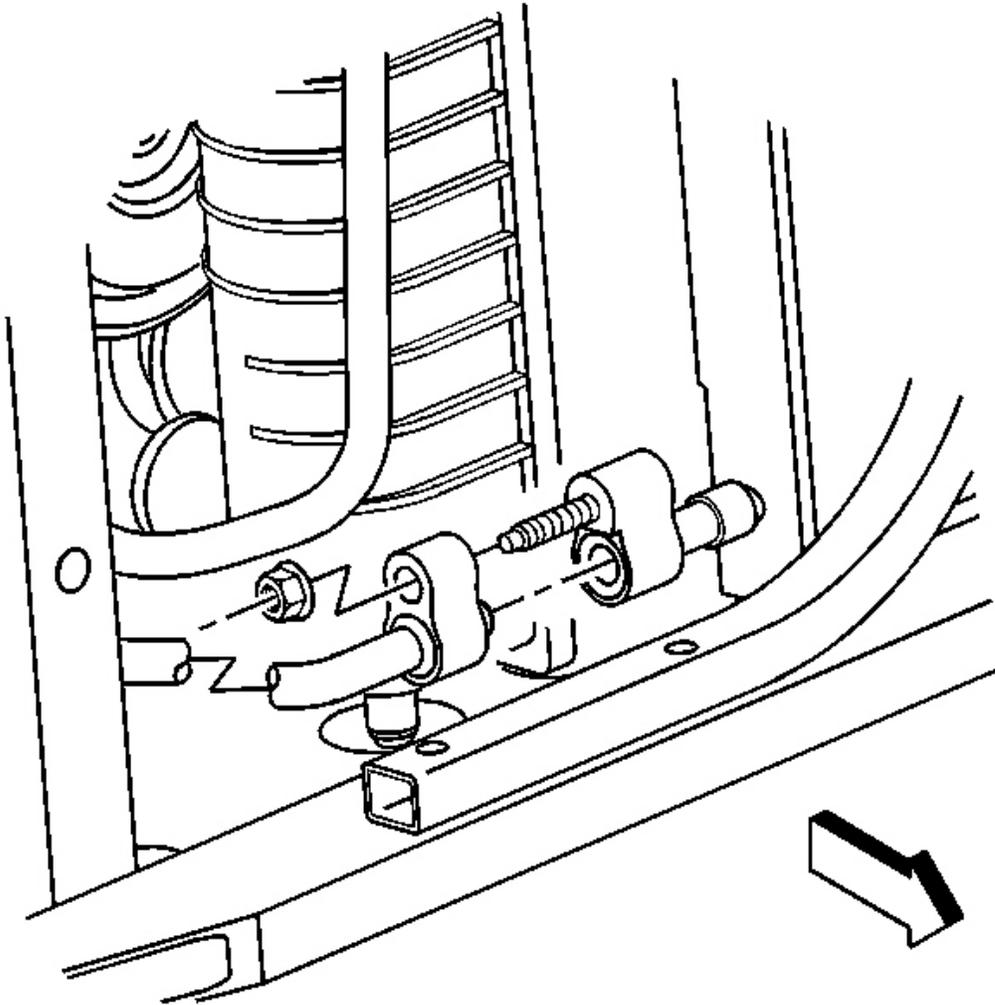
Fig. 67: Evaporator Tube To Condenser
Courtesy of GENERAL MOTORS CORP.

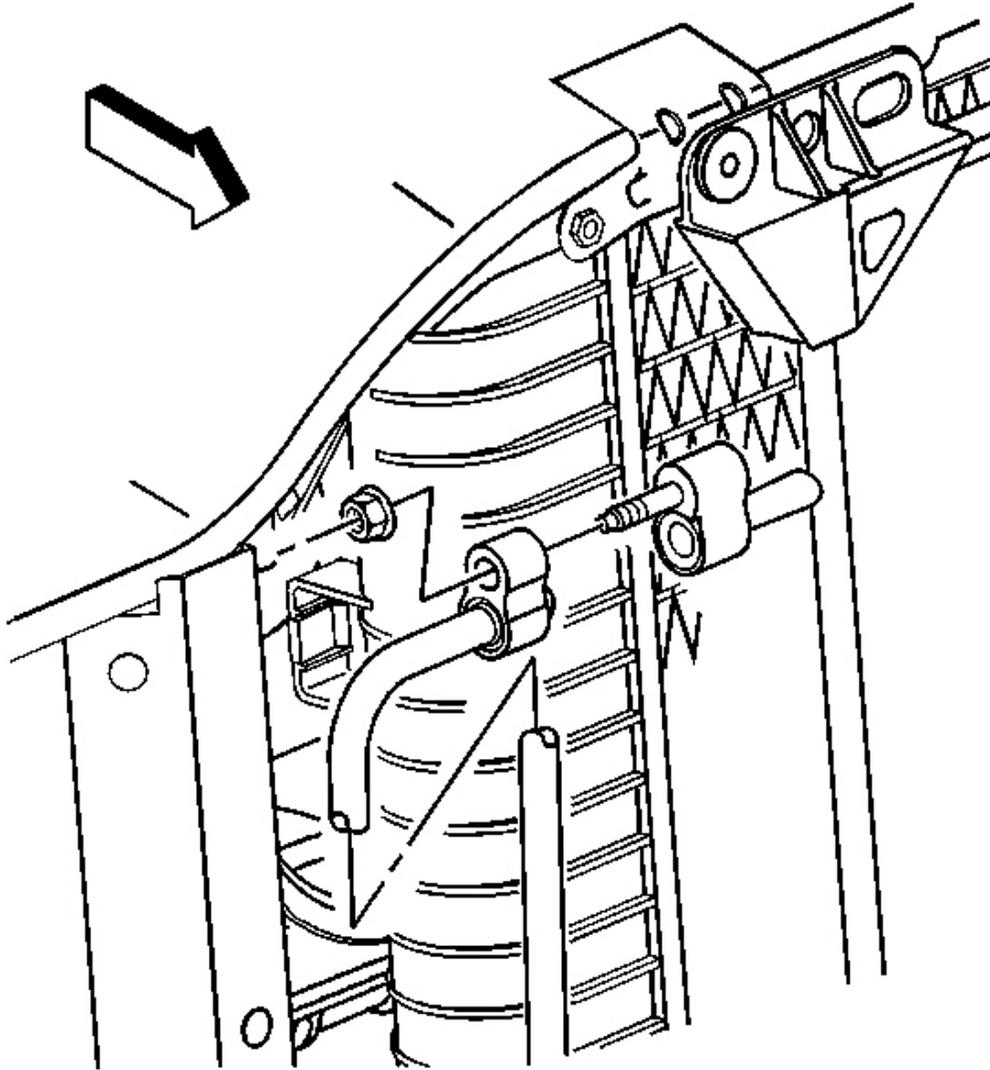
Fig. 68: View Of Discharge Hose At Condenser
Courtesy of GENERAL MOTORS CORP.

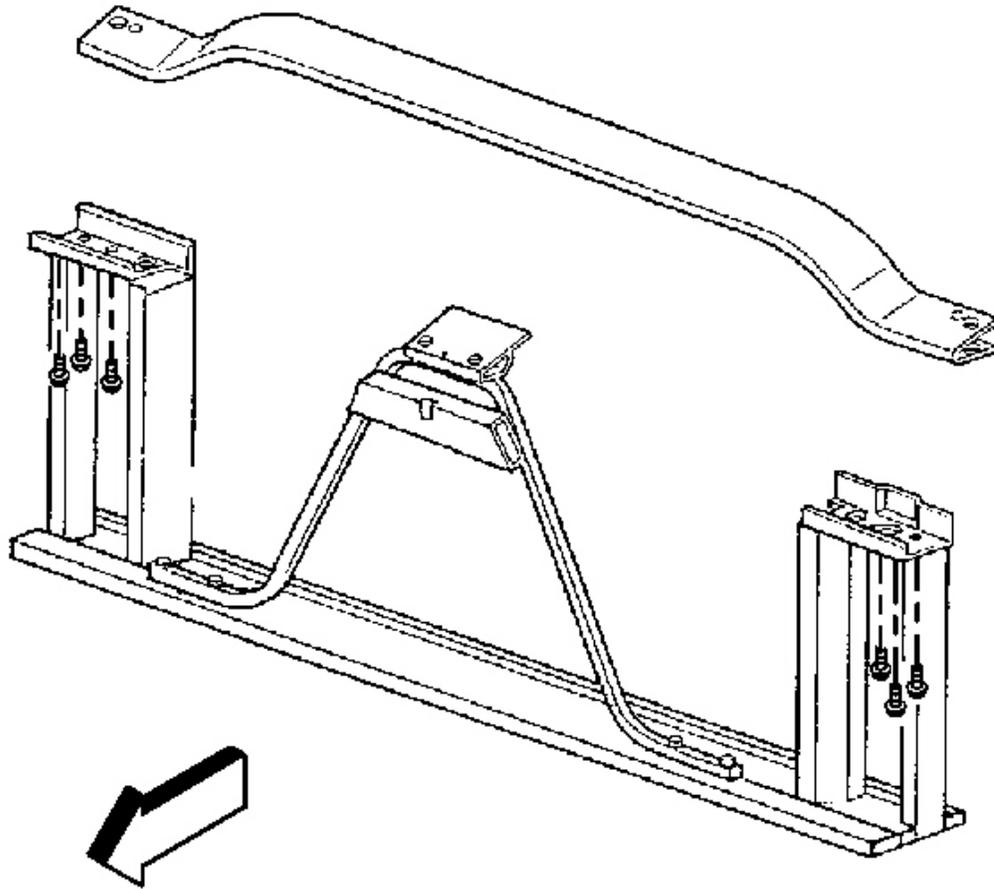
Fig. 69: Tie Bar & Bolts

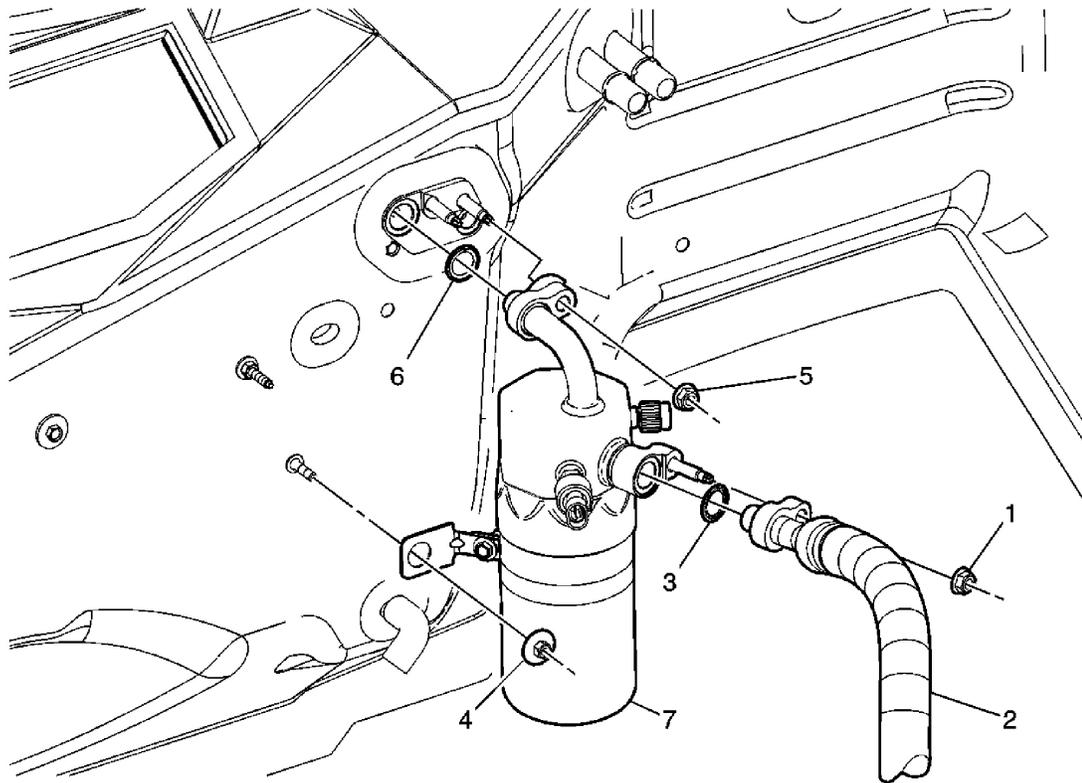
Fig. 71: View Of Accumulator & Components
 Courtesy of GENERAL MOTORS CORP.

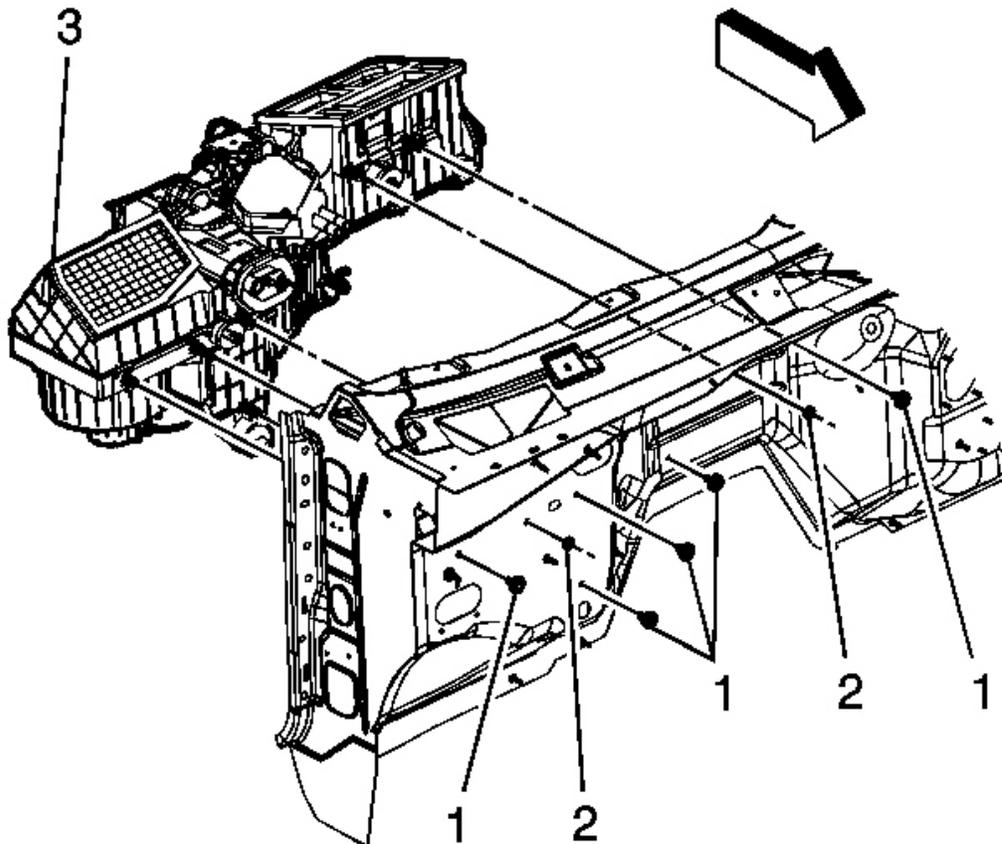
Fig. 73: View Of HVAC Module, Nuts & Bolts
Courtesy of GENERAL MOTORS CORP.

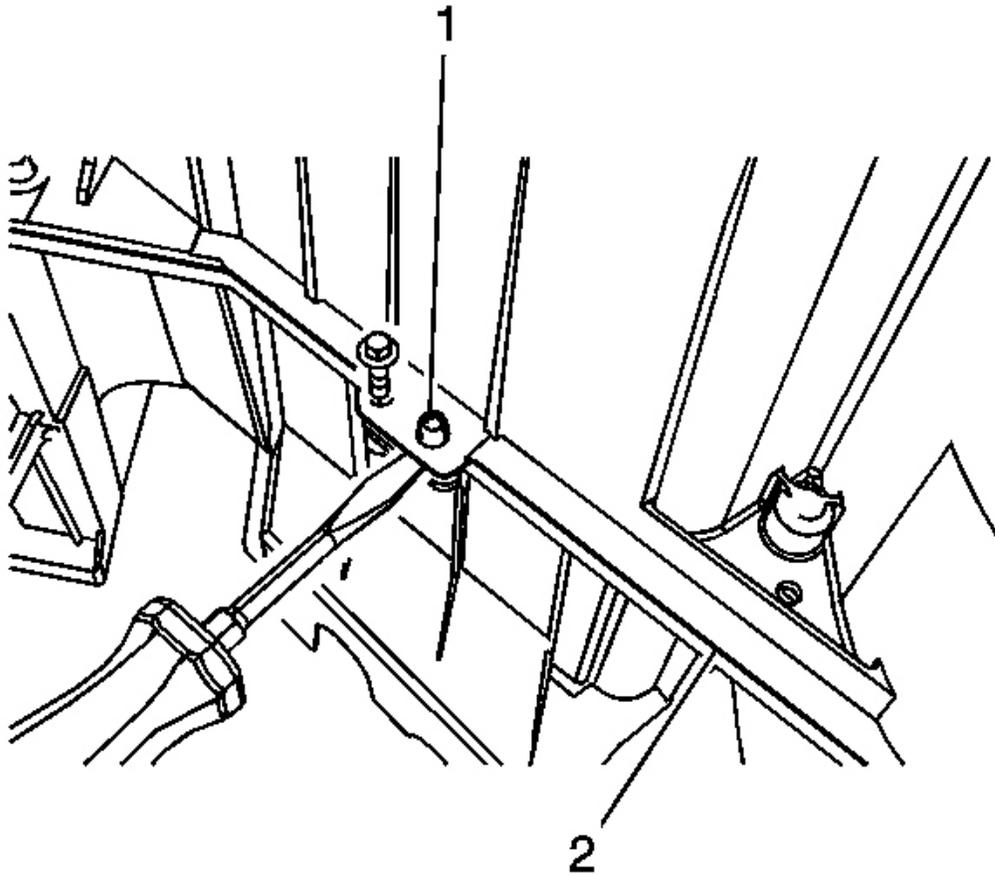
Fig. 76: Heat Stakes

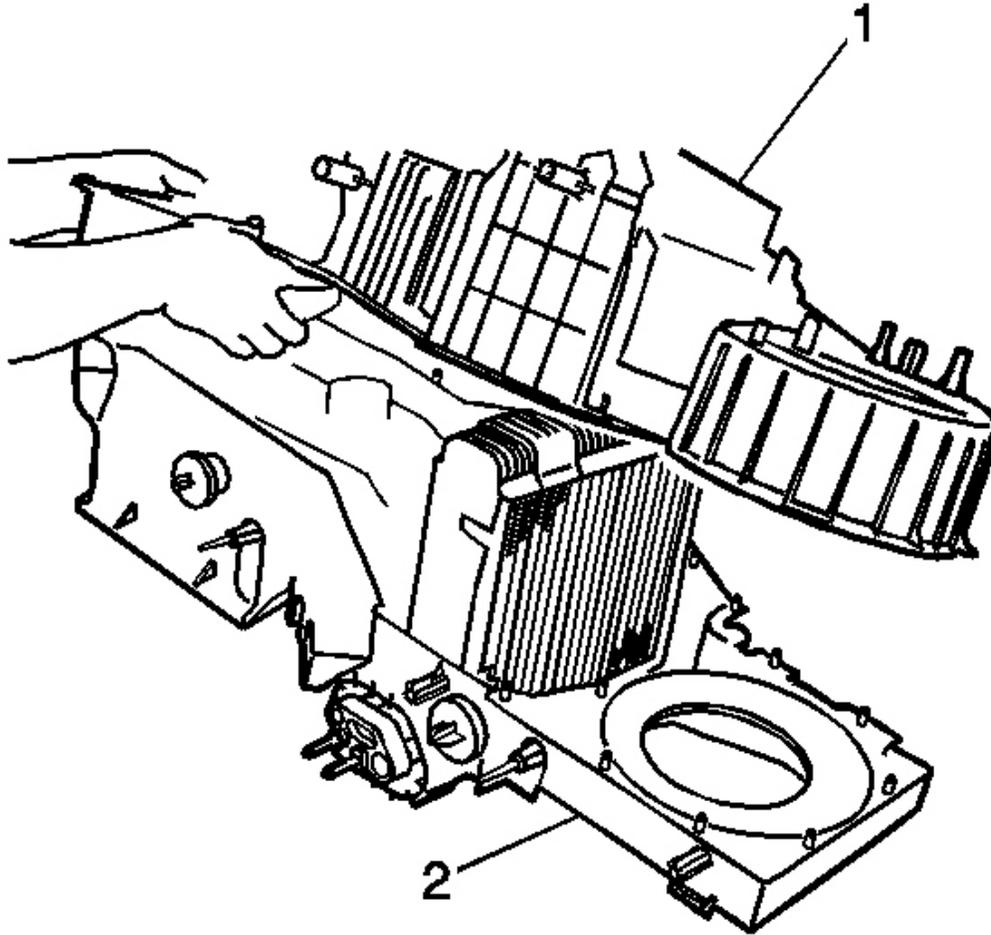
Fig. 77: View Of Upper & Lower HVAC Module Assemblies (Delphi)
Courtesy of GENERAL MOTORS CORP.

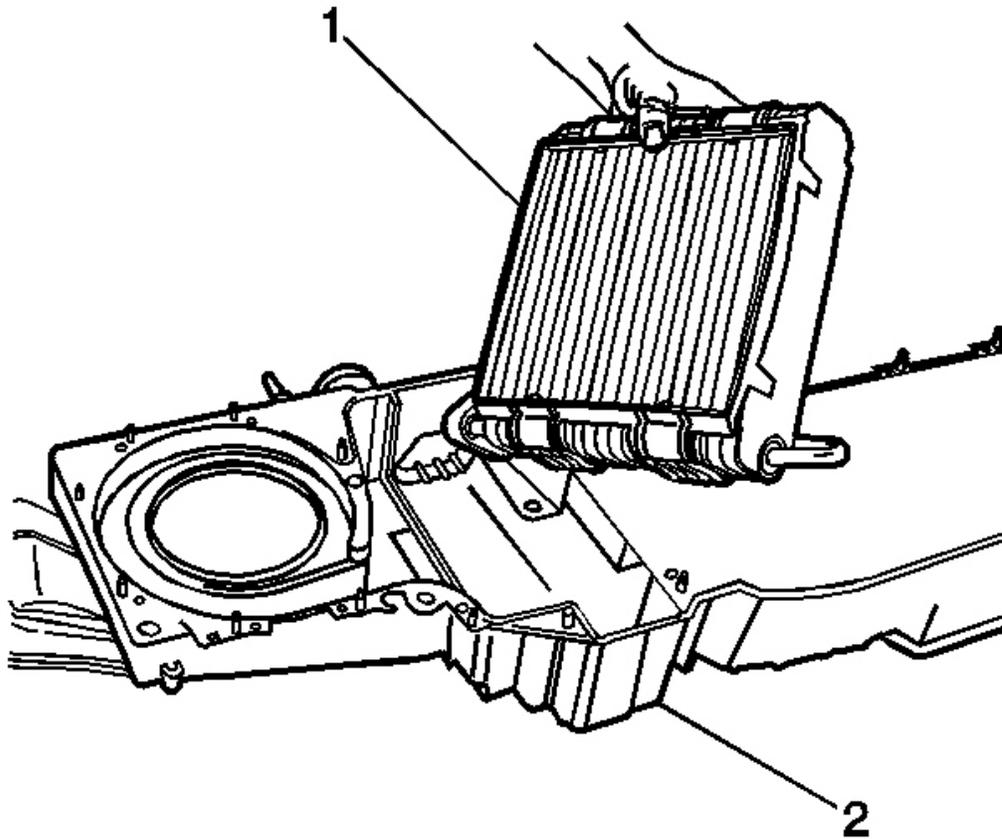
Fig. 78: View Of Evaporator Core (Delphi)
Courtesy of GENERAL MOTORS CORP.

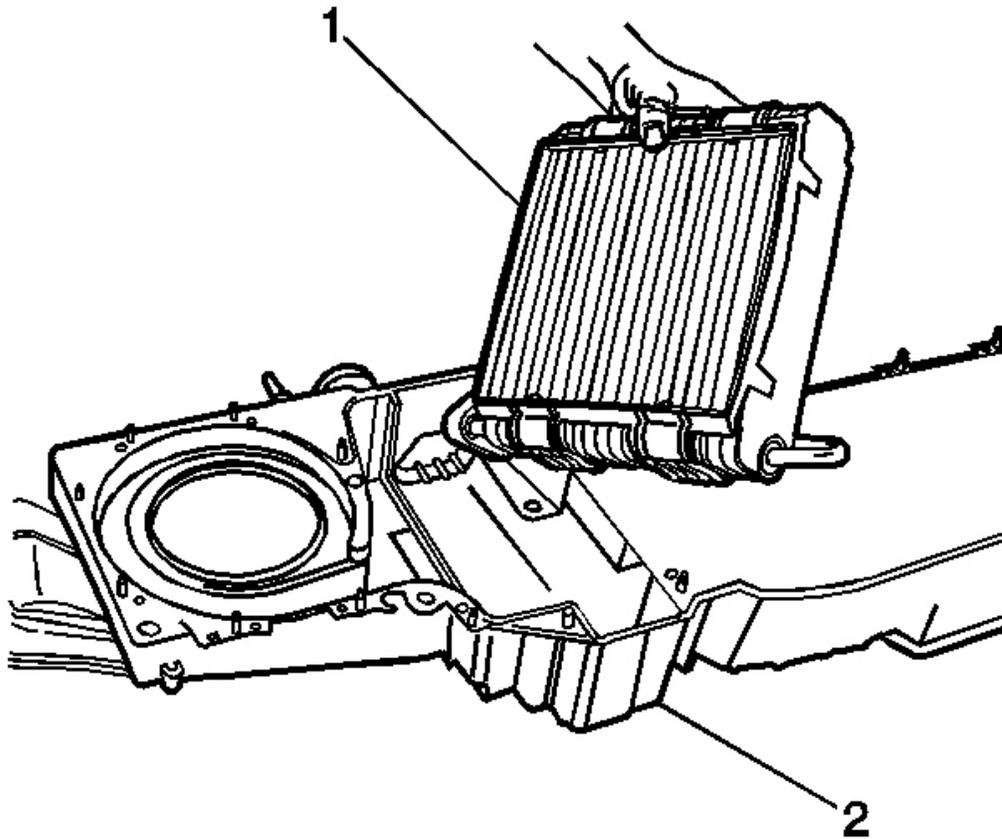
Fig. 79: View Of Evaporator Core (Delphi)
Courtesy of GENERAL MOTORS CORP.

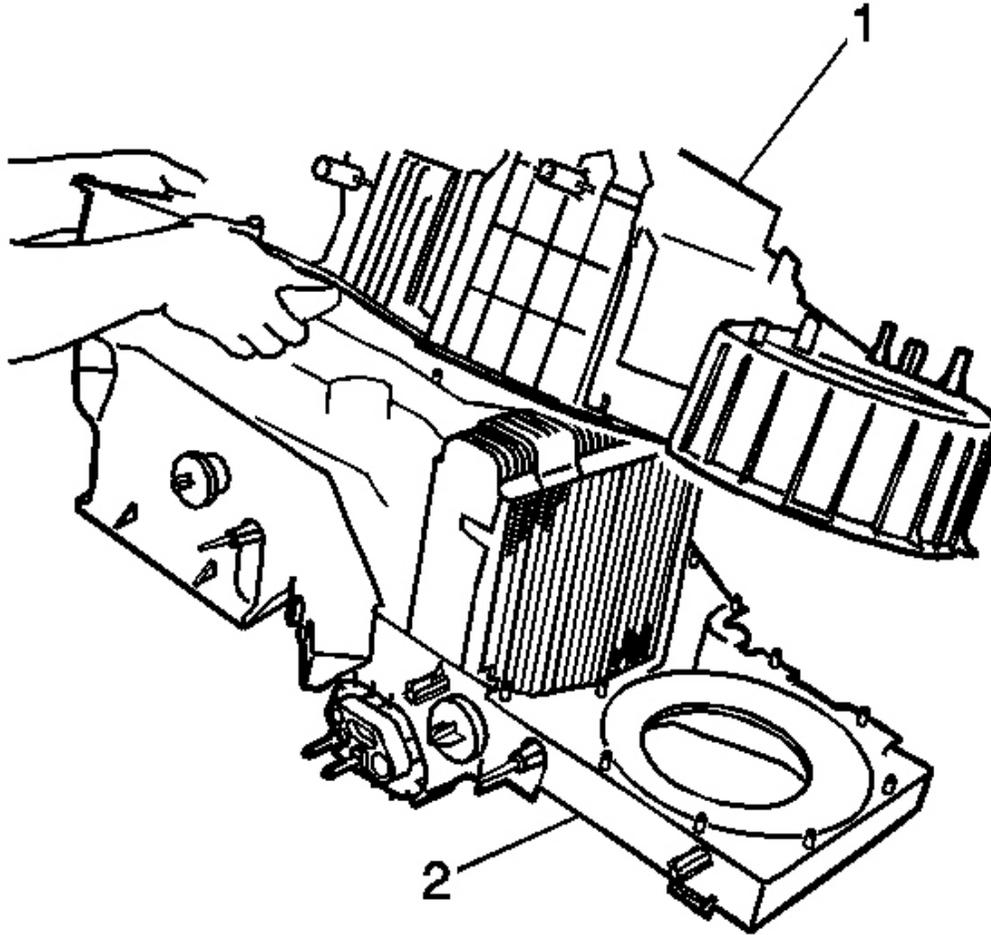
Fig. 80: View Of Upper & Lower HVAC Module Assemblies (Delphi)
Courtesy of GENERAL MOTORS CORP.

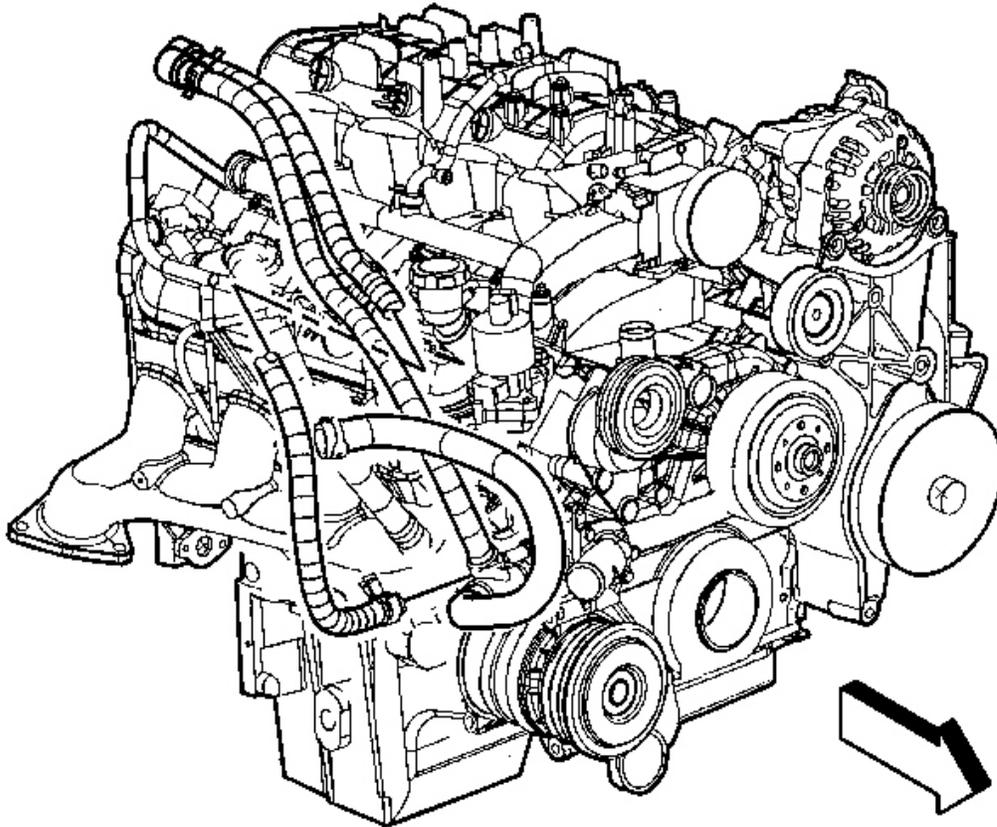
Fig. 85: View Of Inlet & Outlet Heater Hoses (LR4, LM7, LQ4)
Courtesy of GENERAL MOTORS CORP.

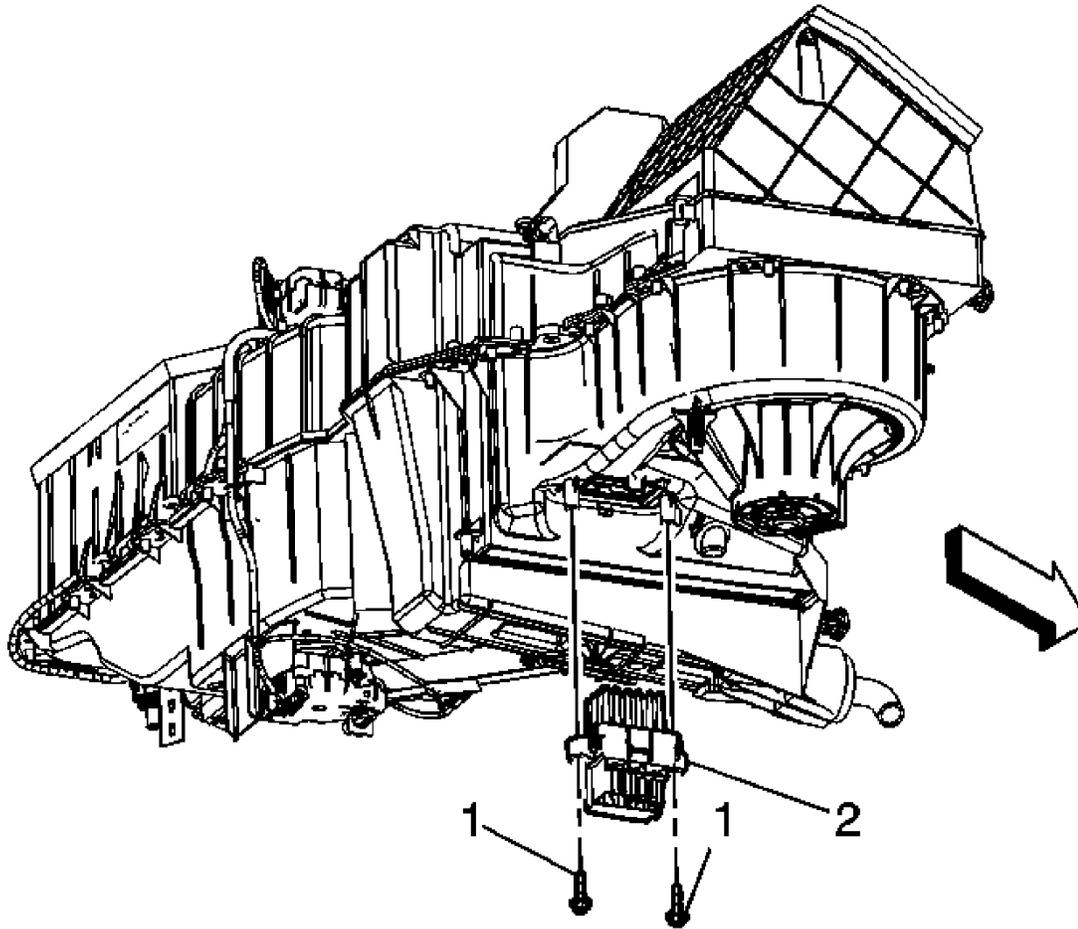
Fig. 96: View Of Blower Motor Control Module & Screws
Courtesy of GENERAL MOTORS CORP.
