2008 Chevrolet Silverado 1500

2008 HVAC Heating, Ventilation, and Air Conditioning - Cab & Chassis Sierra, Cab & Chassis Silverado, Sierra & Silverado

SPECIFICATIONS

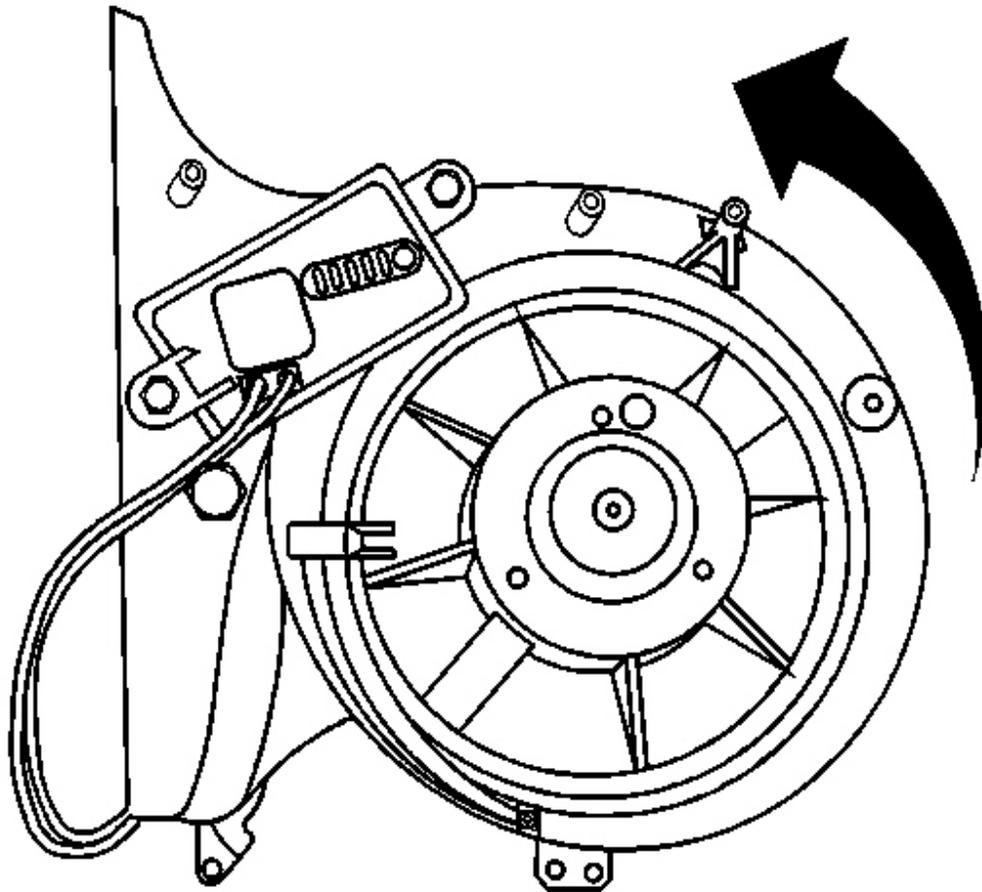
Fig. 97: Disengaging Blower Motor (Delphi)
Courtesy of GENERAL MOTORS CORP.

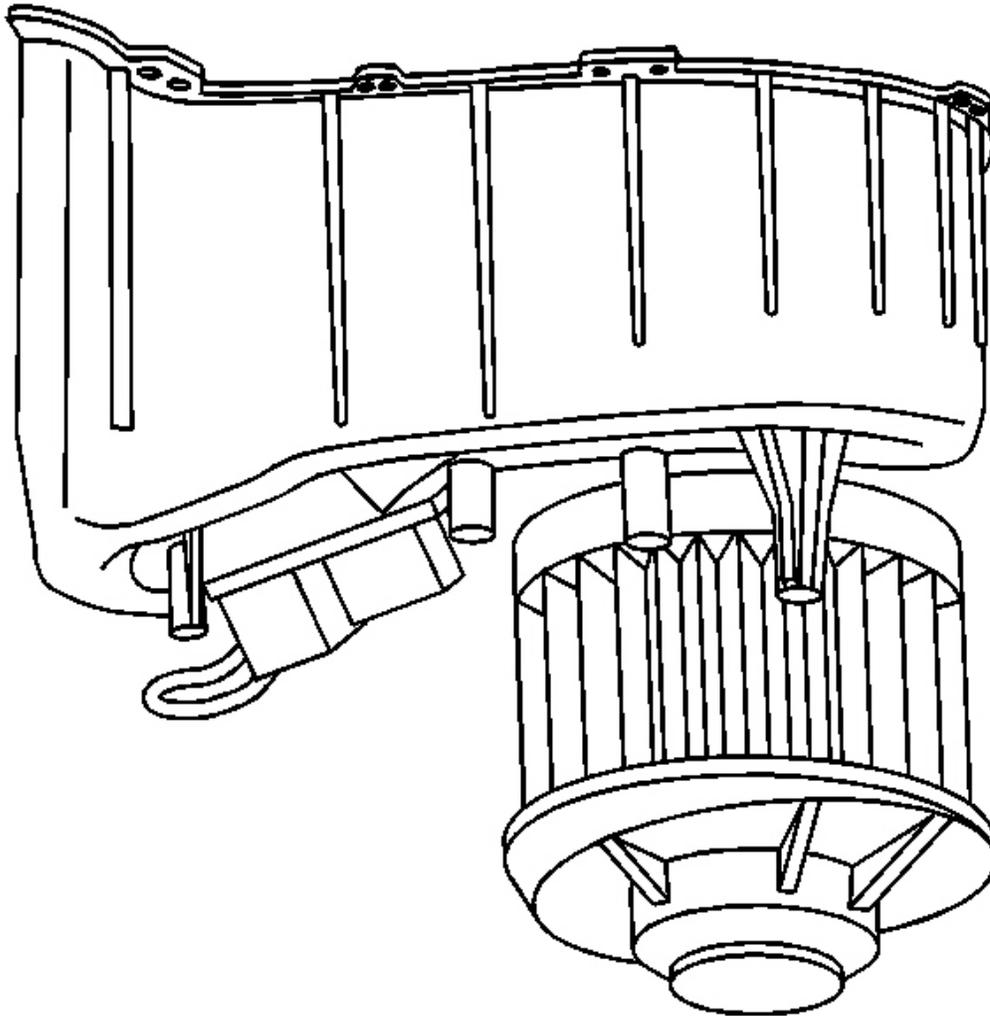
Fig. 98: View Of Blower Motor (Delphi)
Courtesy of GENERAL MOTORS CORP.

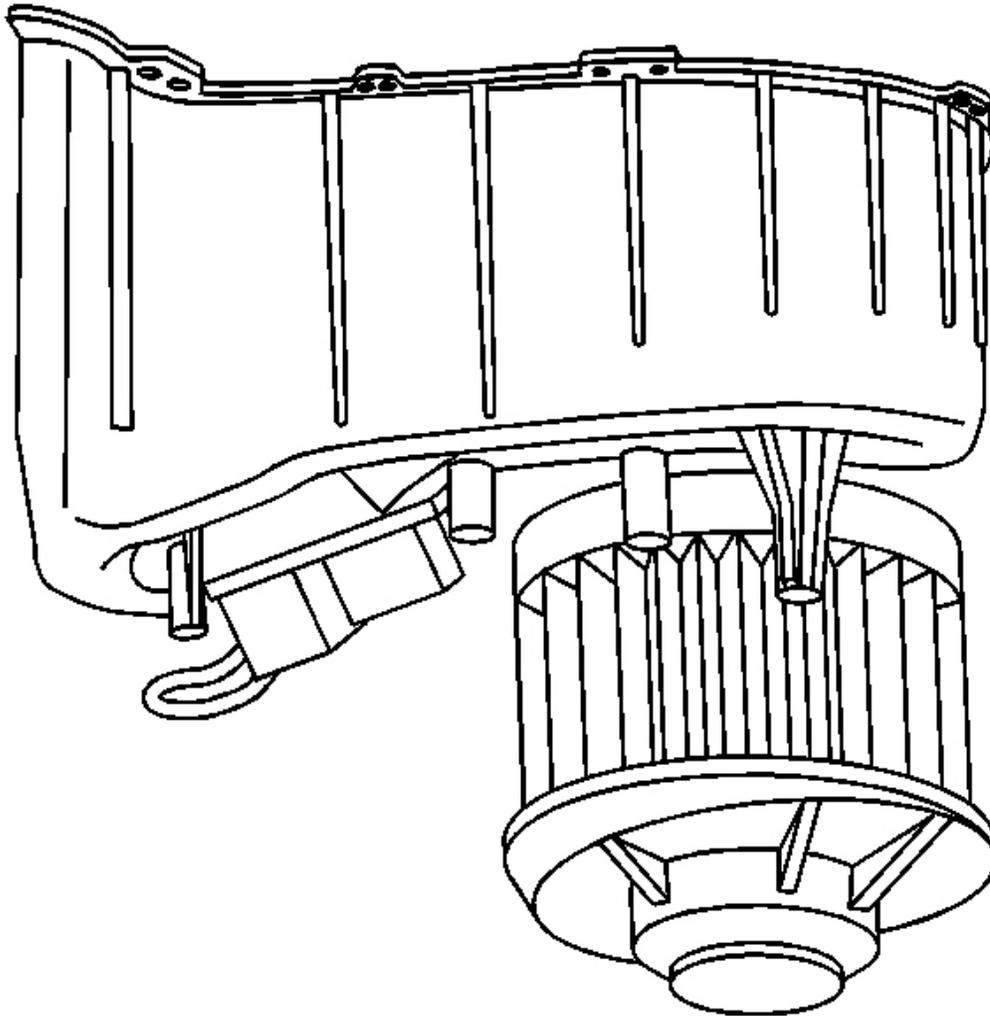
Fig. 99: View Of Blower Motor (Delphi)
Courtesy of GENERAL MOTORS CORP.

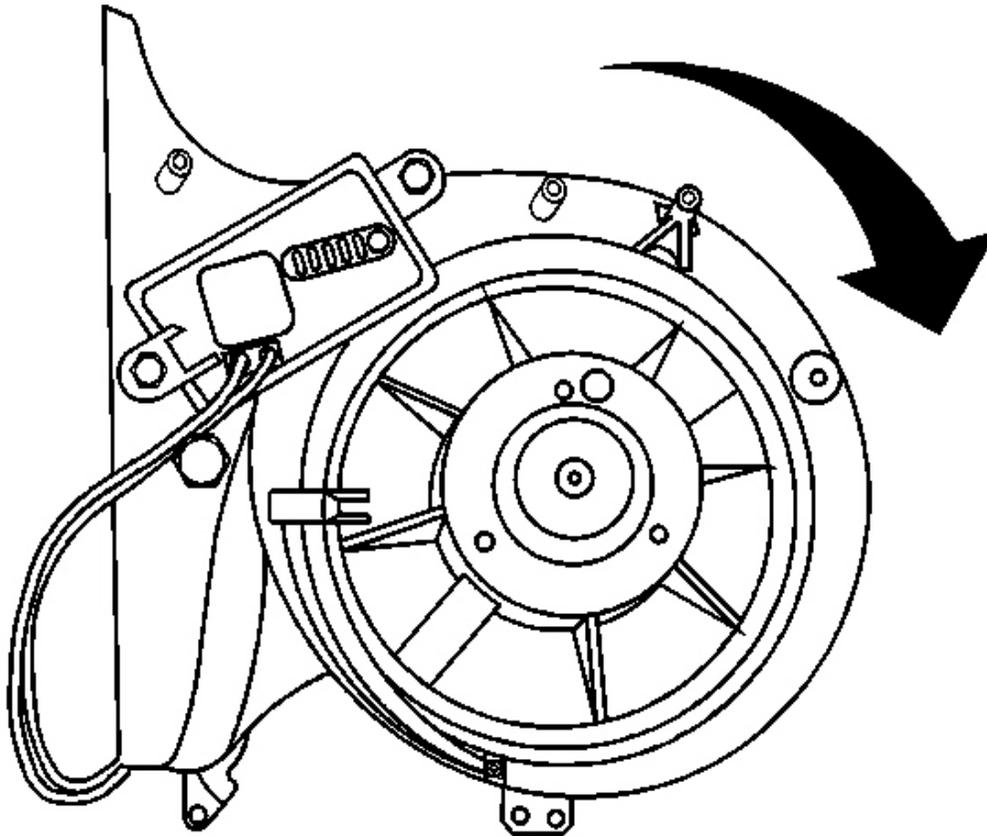
Fig. 100: Turning Blower Assembly Clockwise (Delphi)
Courtesy of GENERAL MOTORS CORP.

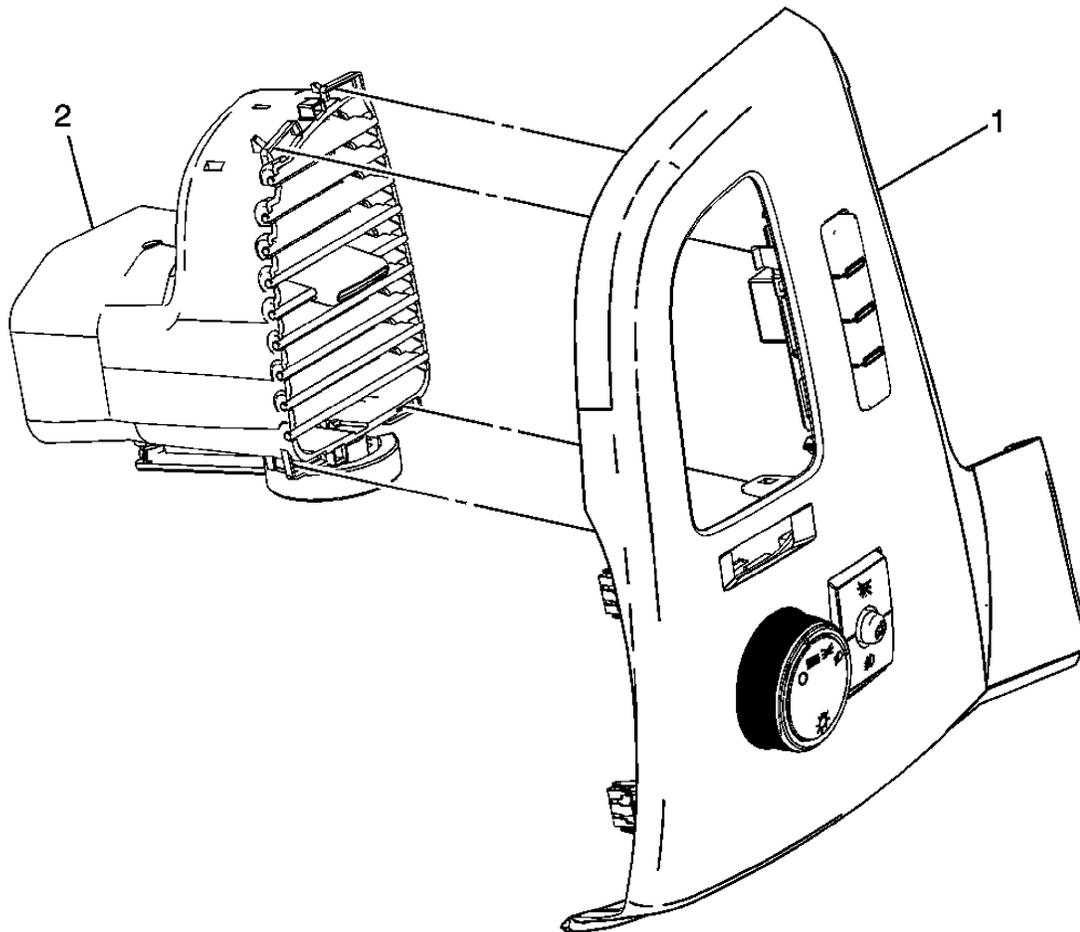
Fig. 103: View Of Instrument Panel Trim Plate & Air Outlet Assembly
Courtesy of GENERAL MOTORS CORP.

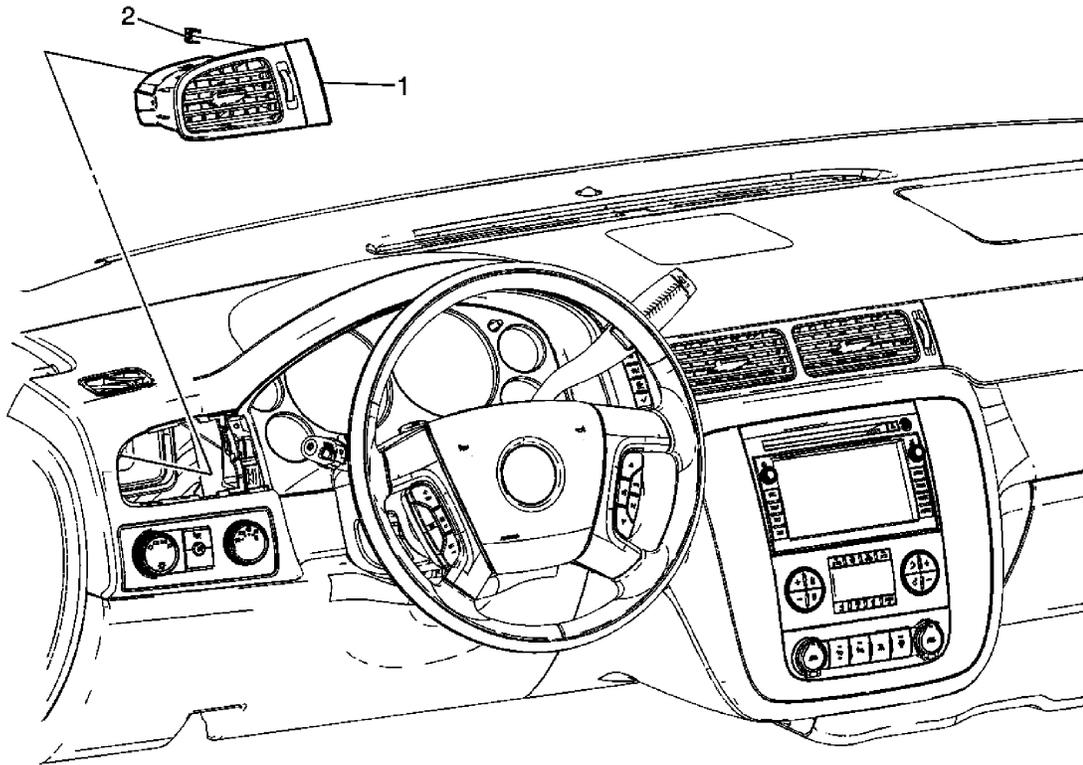
Fig. 104: View Of Instrument Panel Air Deflector & Retainer Clip
Courtesy of GENERAL MOTORS CORP.

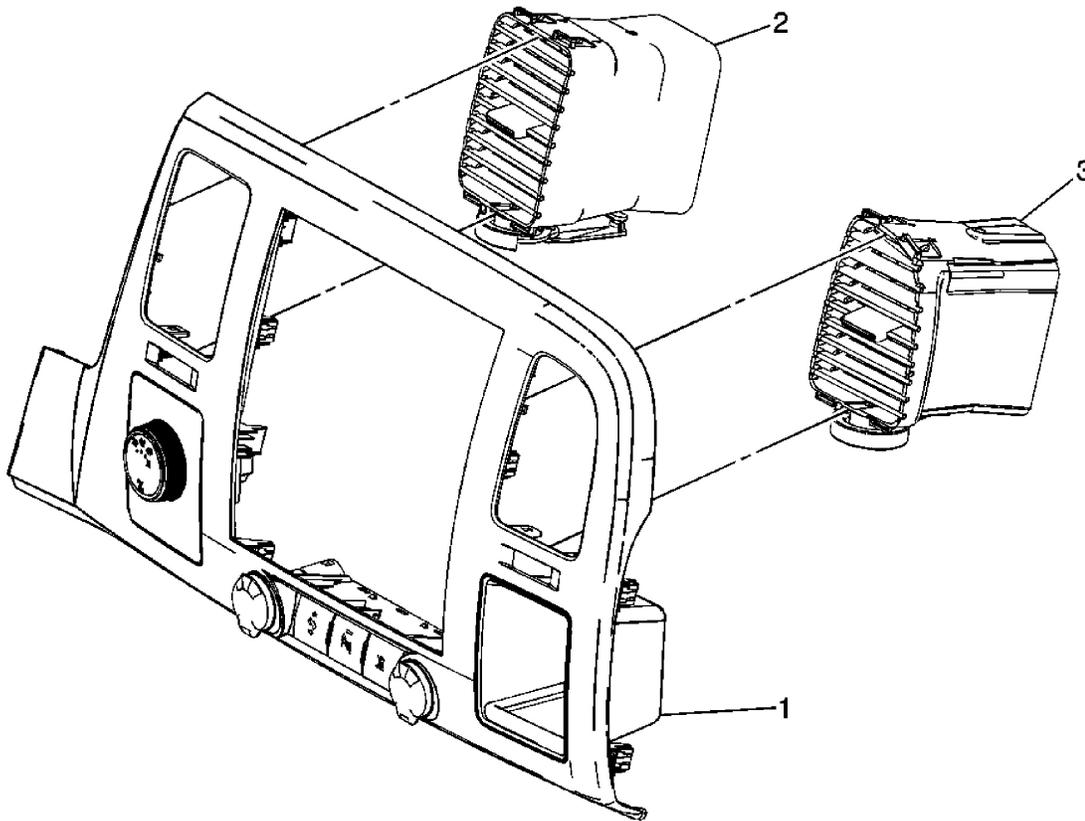
Fig. 105: View Of Instrument Panel Accessory Trim Plate & Air Outlet Assemblies
Courtesy of GENERAL MOTORS CORP.

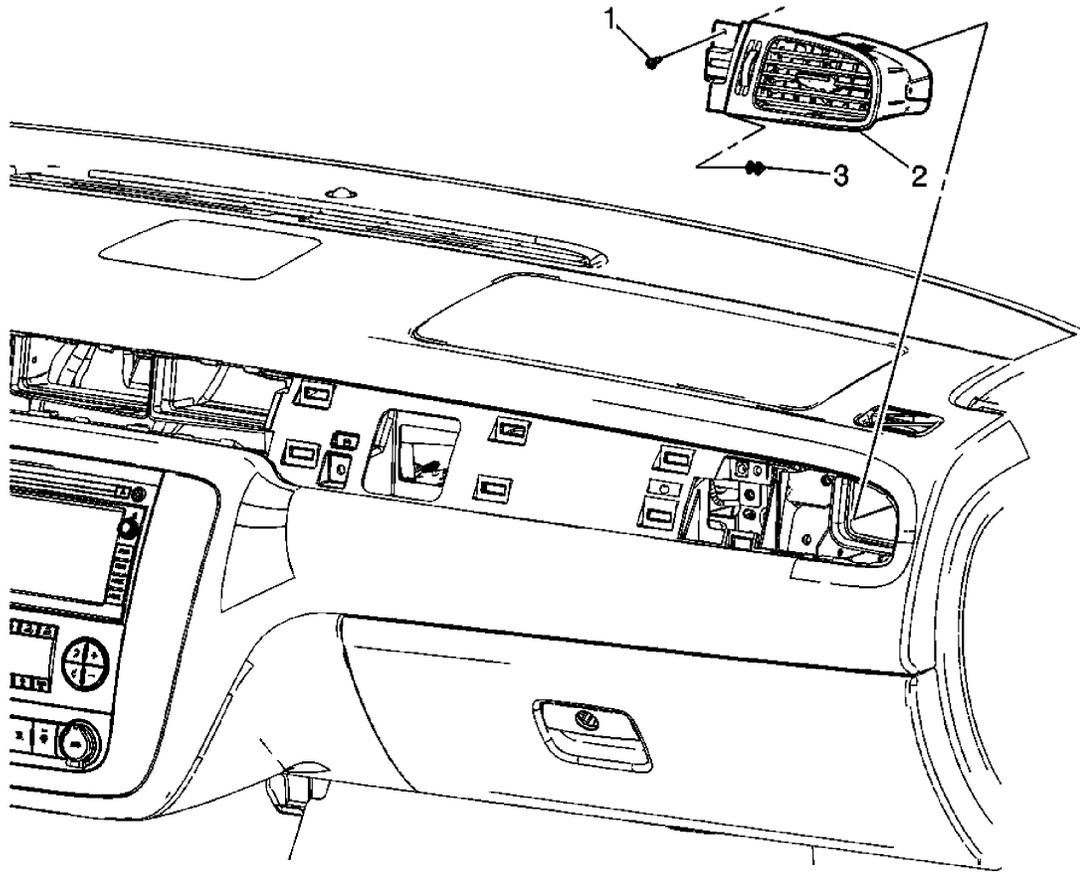
Fig. 108: View Of Instrument Panel Air Deflector & Components
 Courtesy of GENERAL MOTORS CORP.

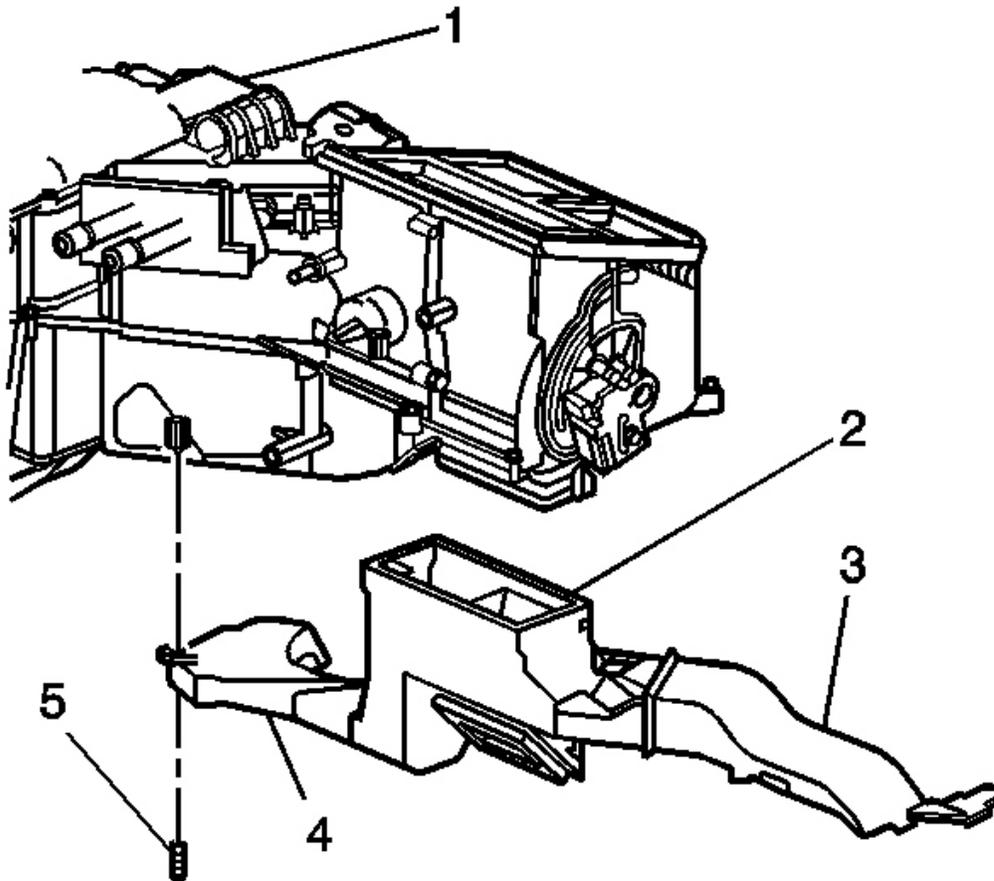
Fig. 109: View Of Floor Air Outlet Duct
Courtesy of GENERAL MOTORS CORP.

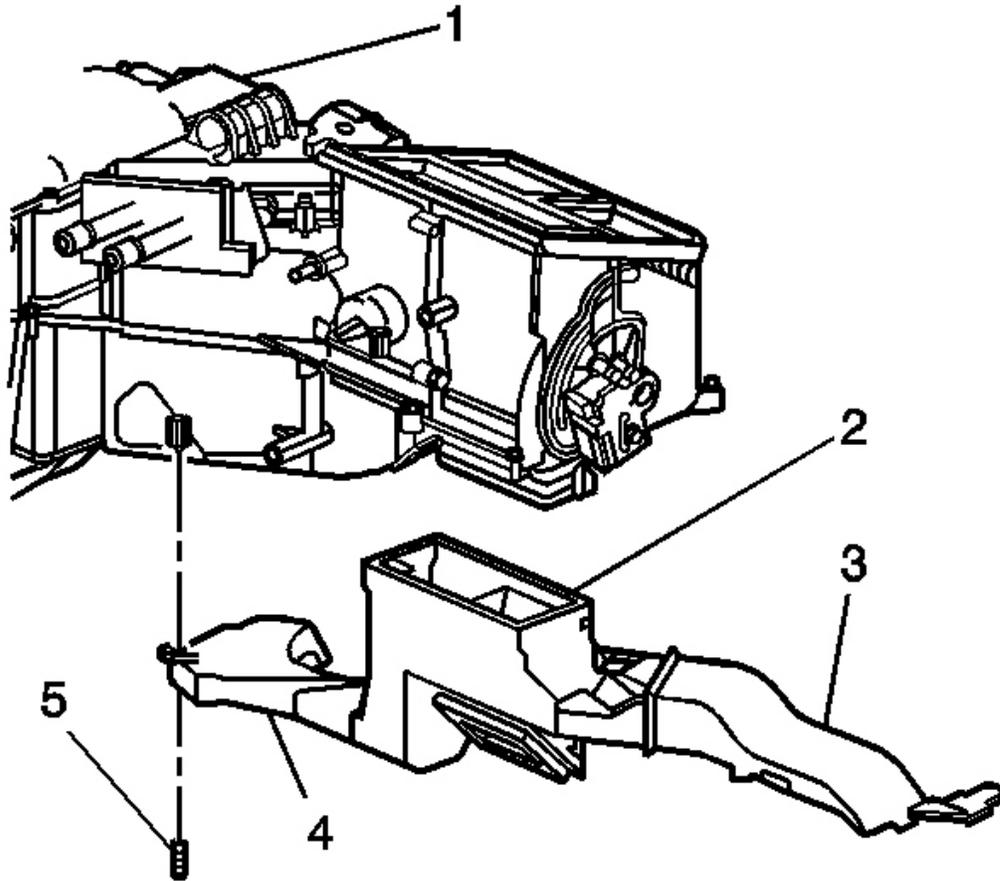
Fig. 110: View Of Floor Air Outlet Duct
Courtesy of GENERAL MOTORS CORP.

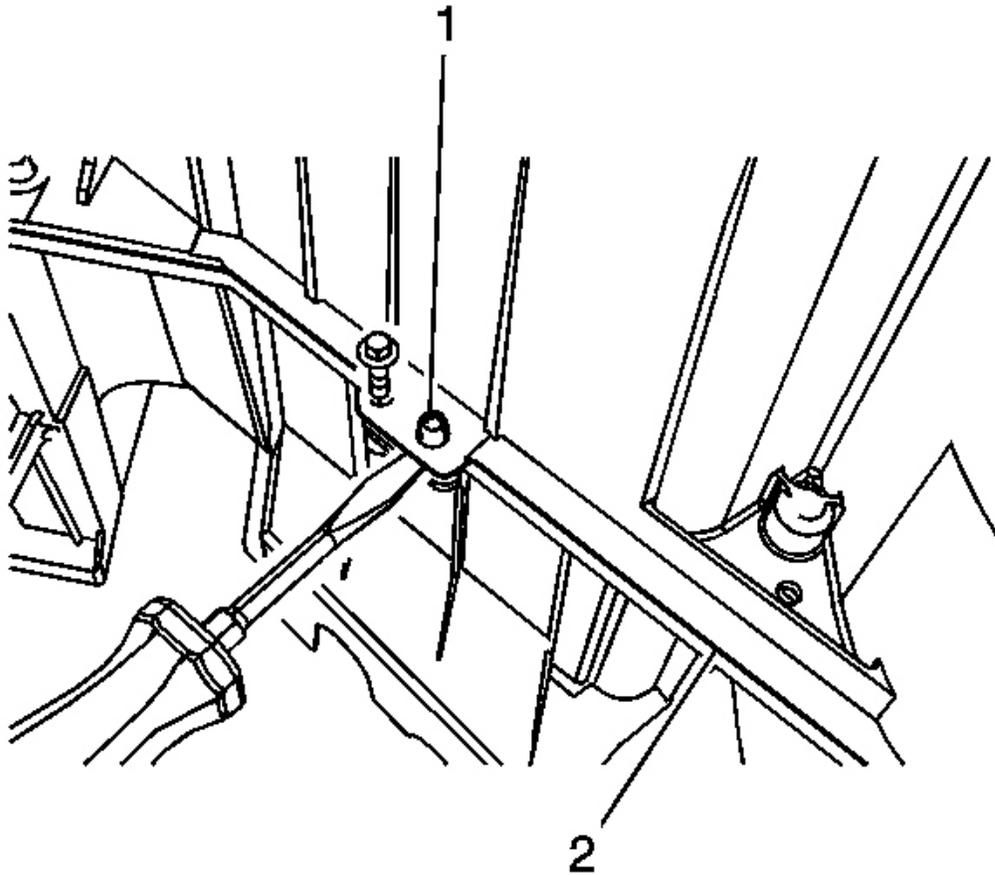
Fig. 112: Heat Stakes

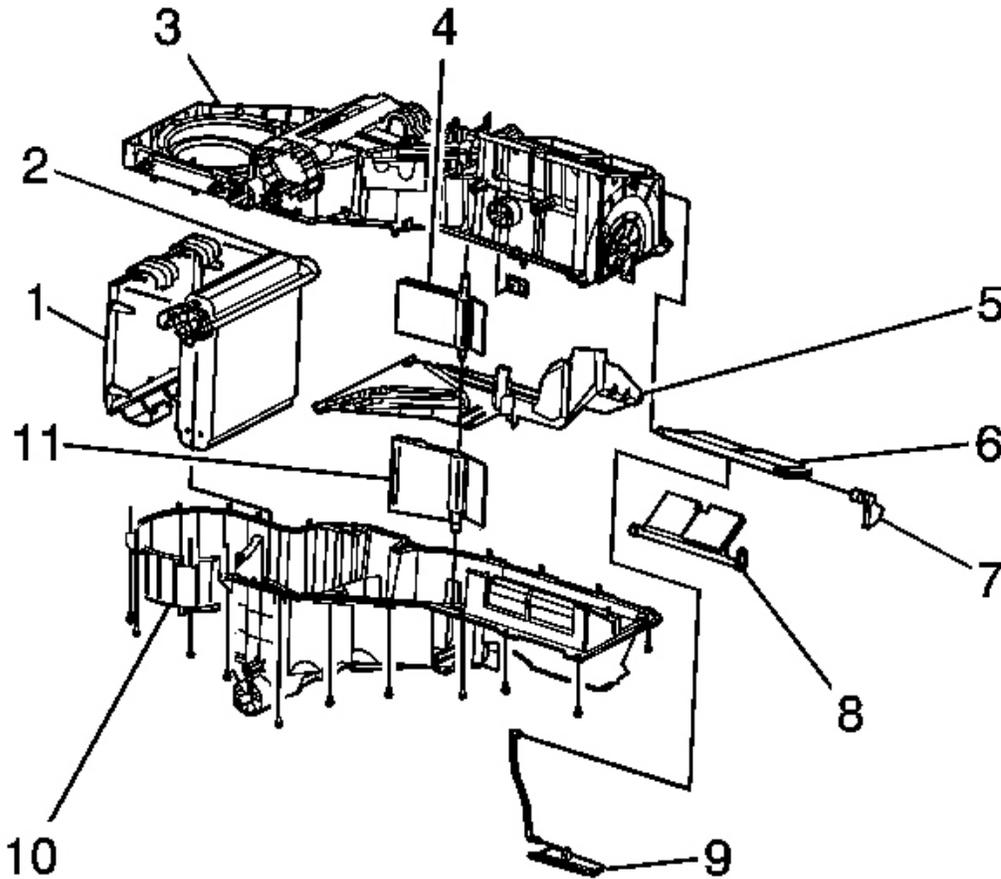
Fig. 113: Exploded View Of HVAC Module Assembly
Courtesy of GENERAL MOTORS CORP.

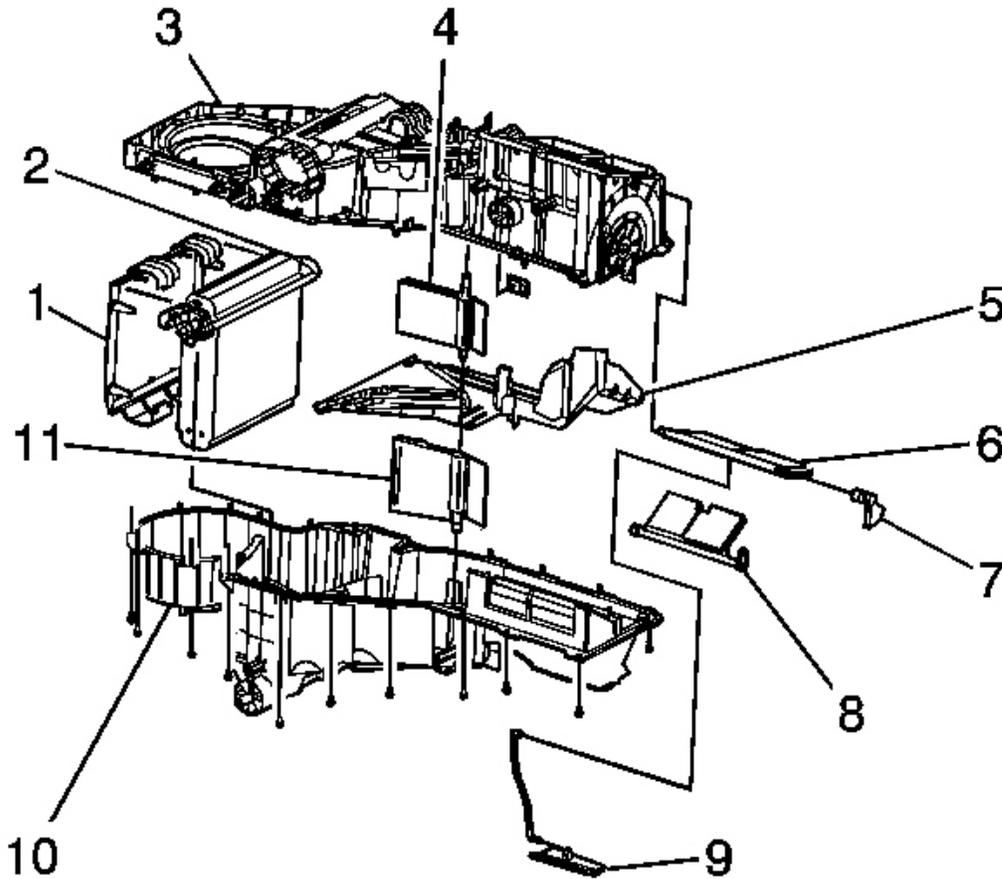
Fig. 114: Exploded View Of HVAC Module Assembly
Courtesy of GENERAL MOTORS CORP.

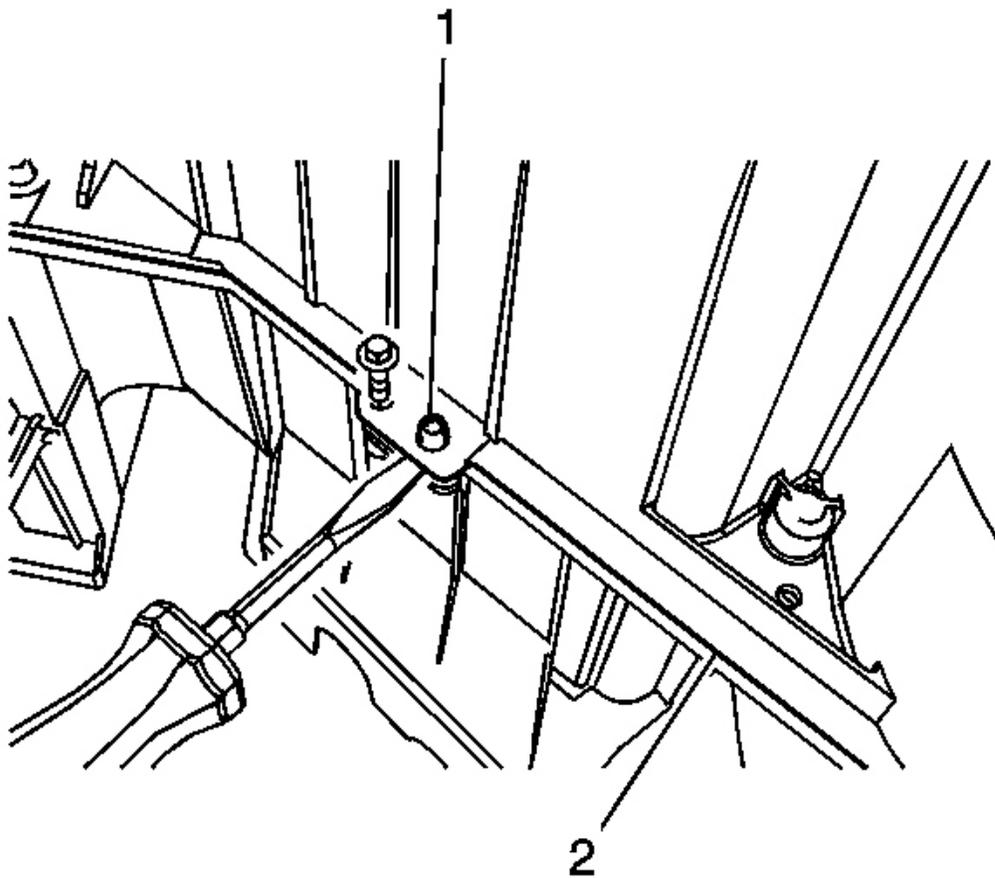
Fig. 115: Heat Stakes
Courtesy of GENERAL MOTORS CORP.

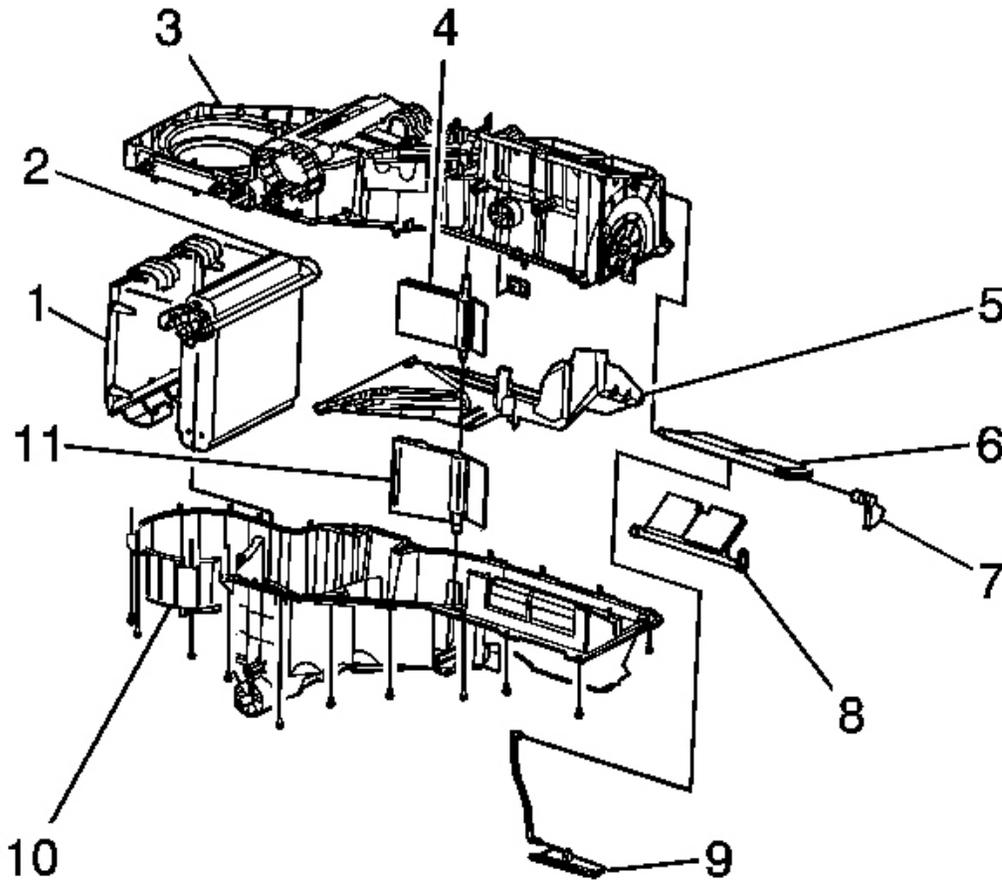
Fig. 116: Exploded View Of HVAC Module Assembly
Courtesy of GENERAL MOTORS CORP.

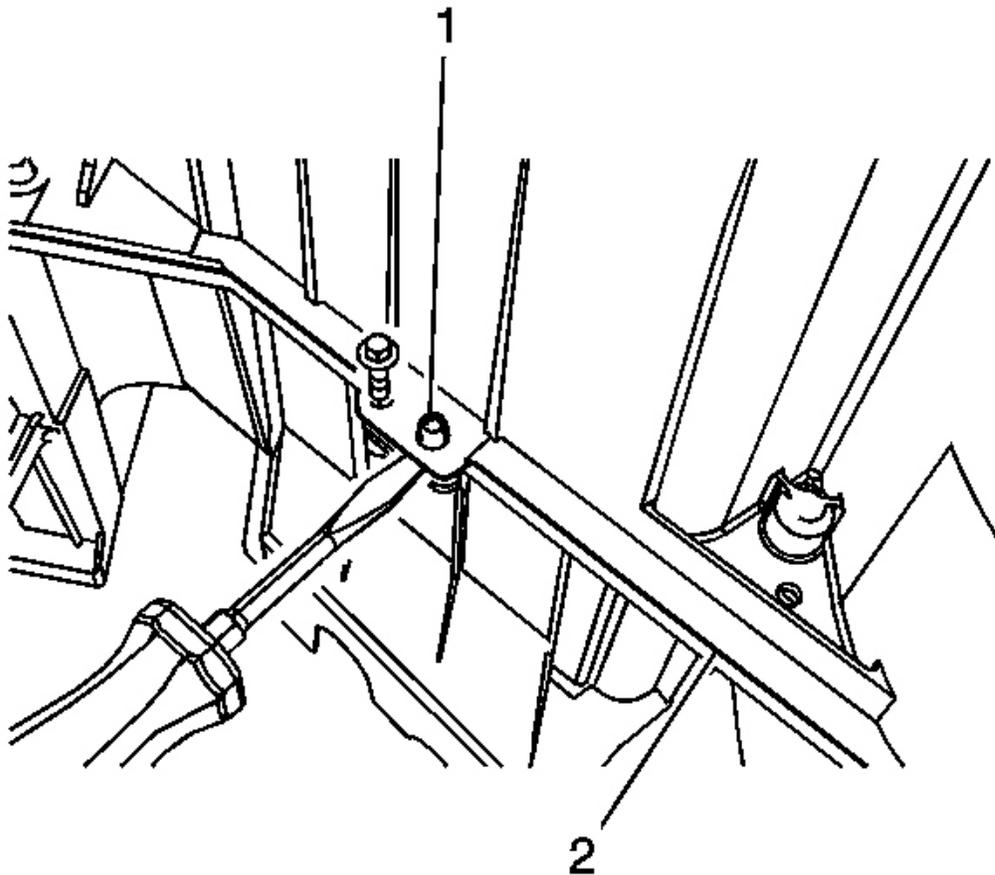
Fig. 118: Heat Stakes
Courtesy of GENERAL MOTORS CORP.

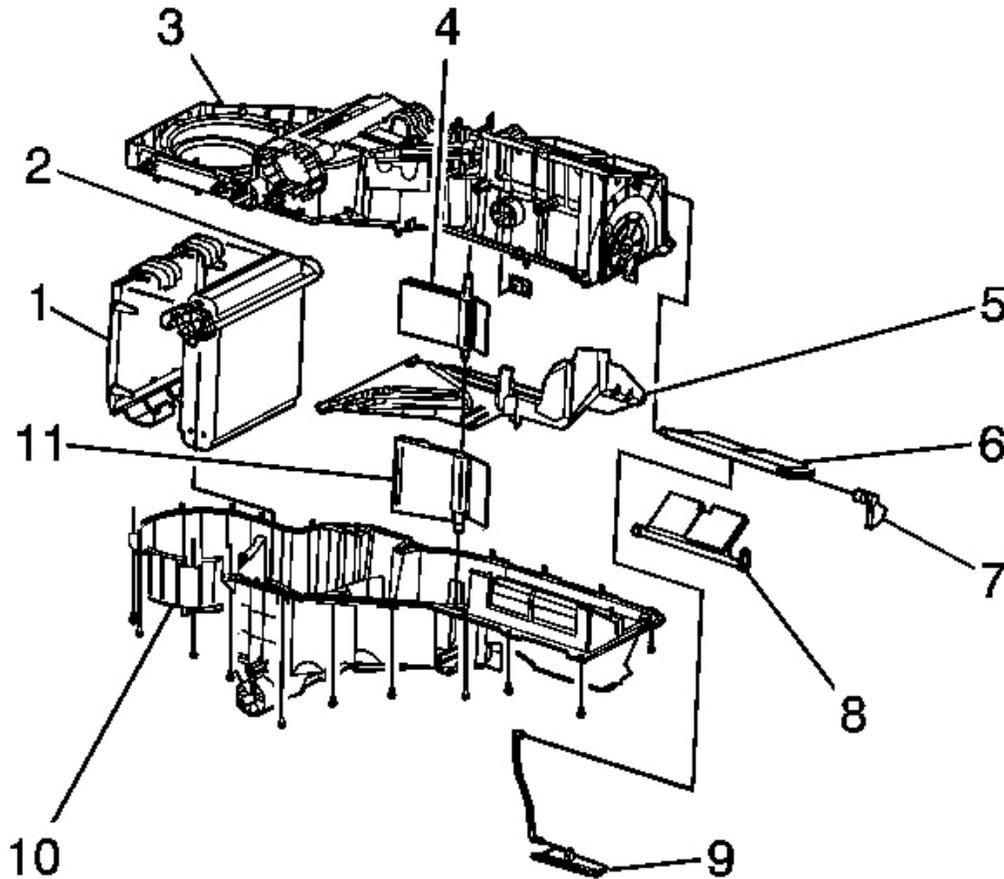
Fig. 119: Exploded View Of HVAC Module Assembly
Courtesy of GENERAL MOTORS CORP.

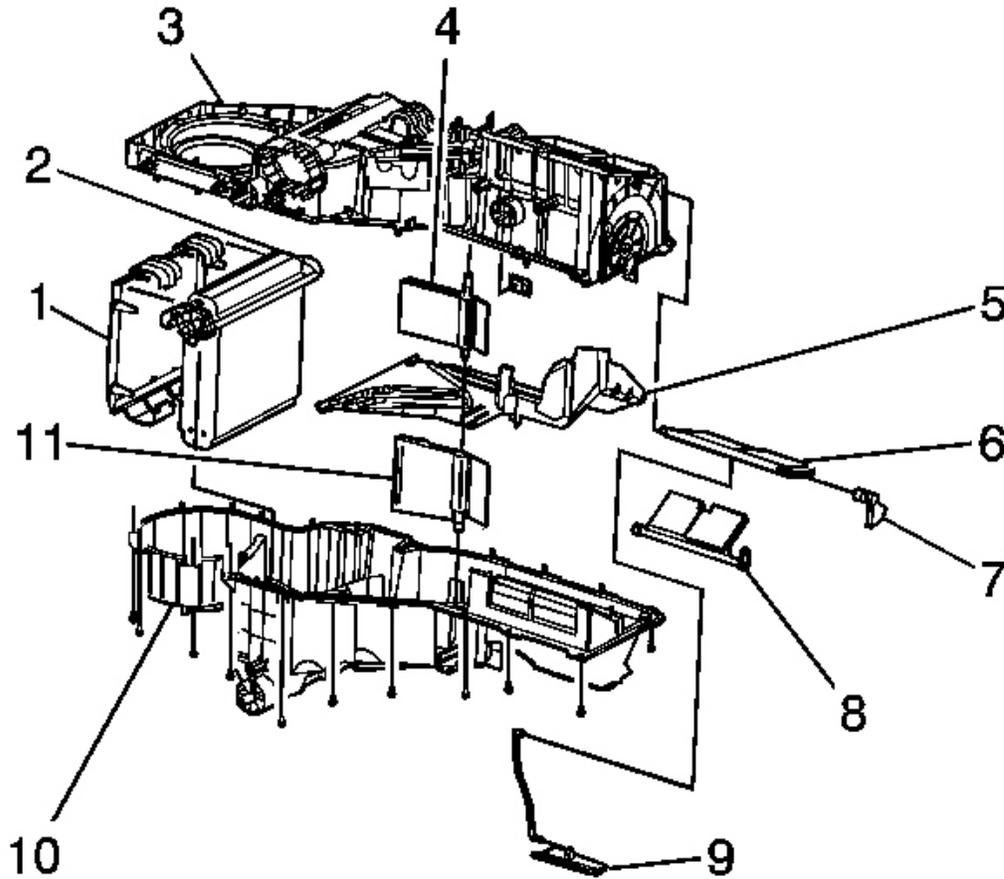
Fig. 120: Exploded View Of HVAC Module Assembly
Courtesy of GENERAL MOTORS CORP.

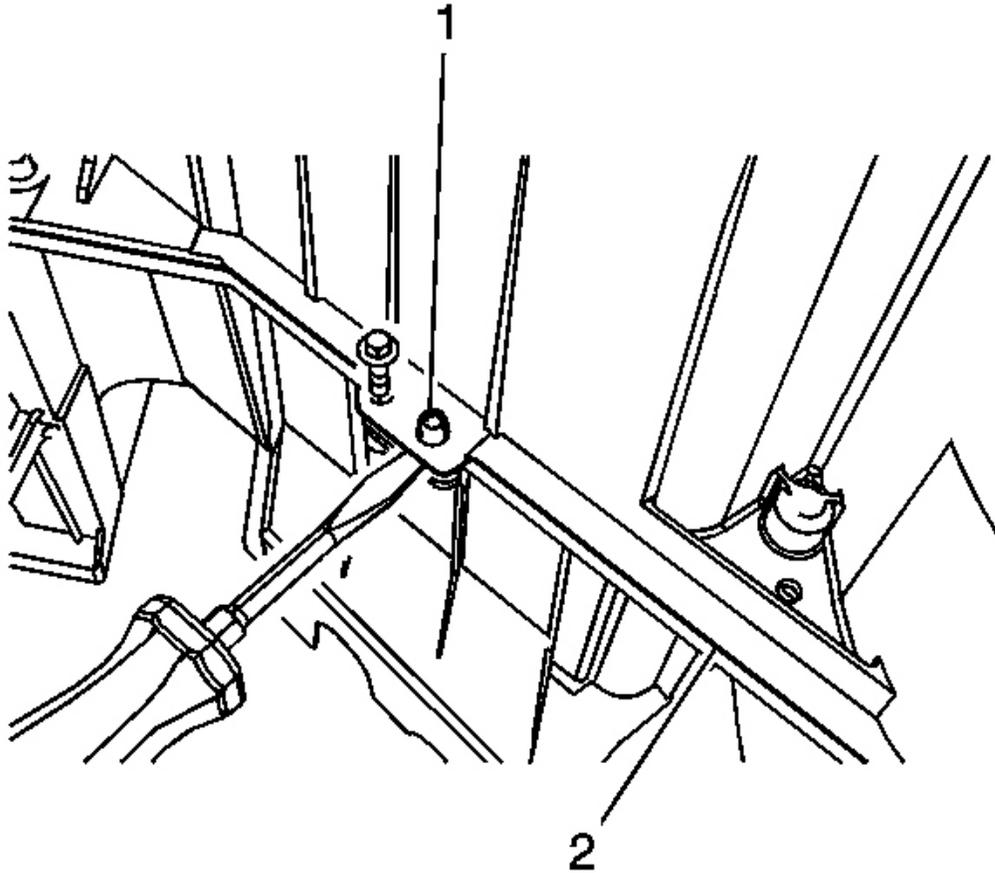
Fig. 121: Heat Stakes

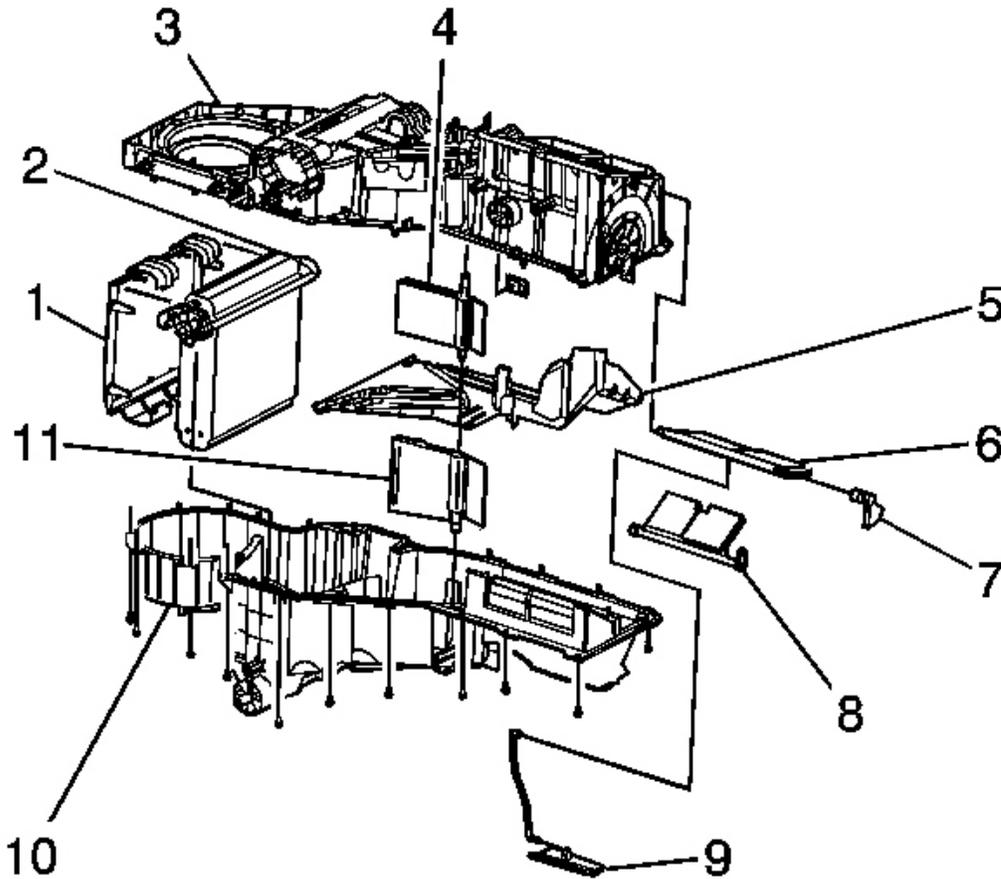
Fig. 122: Exploded View Of HVAC Module Assembly
Courtesy of GENERAL MOTORS CORP.

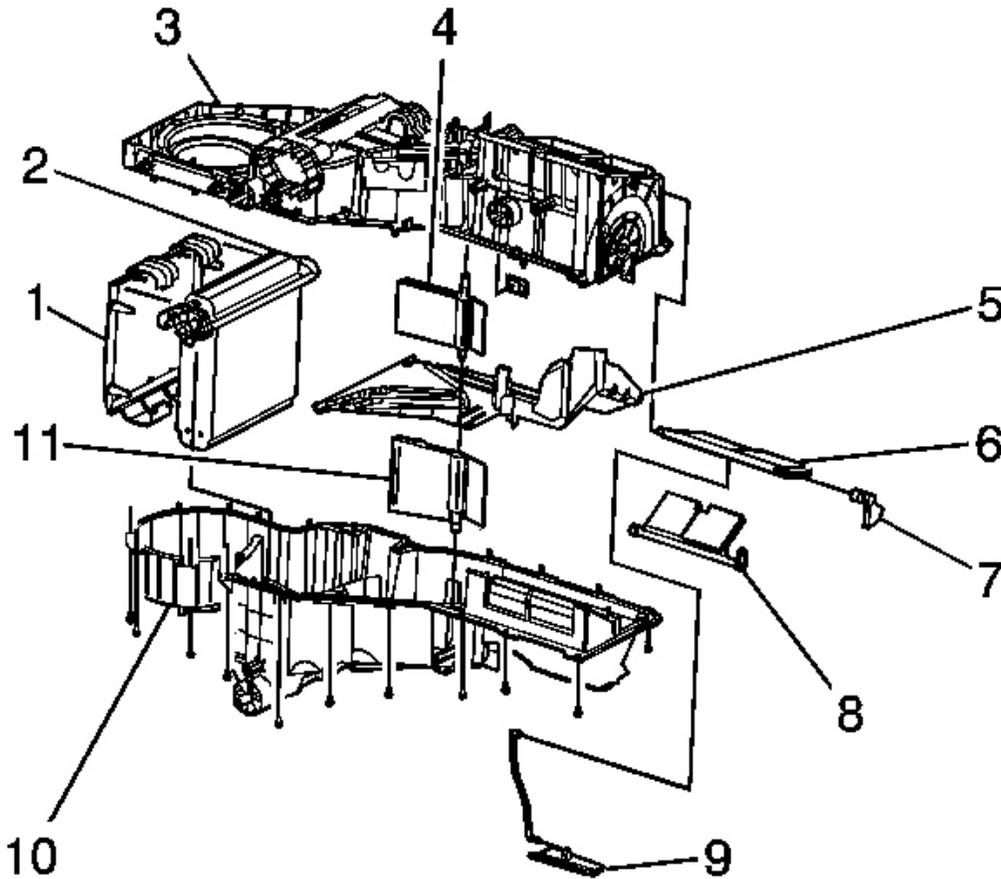
Fig. 123: Exploded View Of HVAC Module Assembly
Courtesy of GENERAL MOTORS CORP.

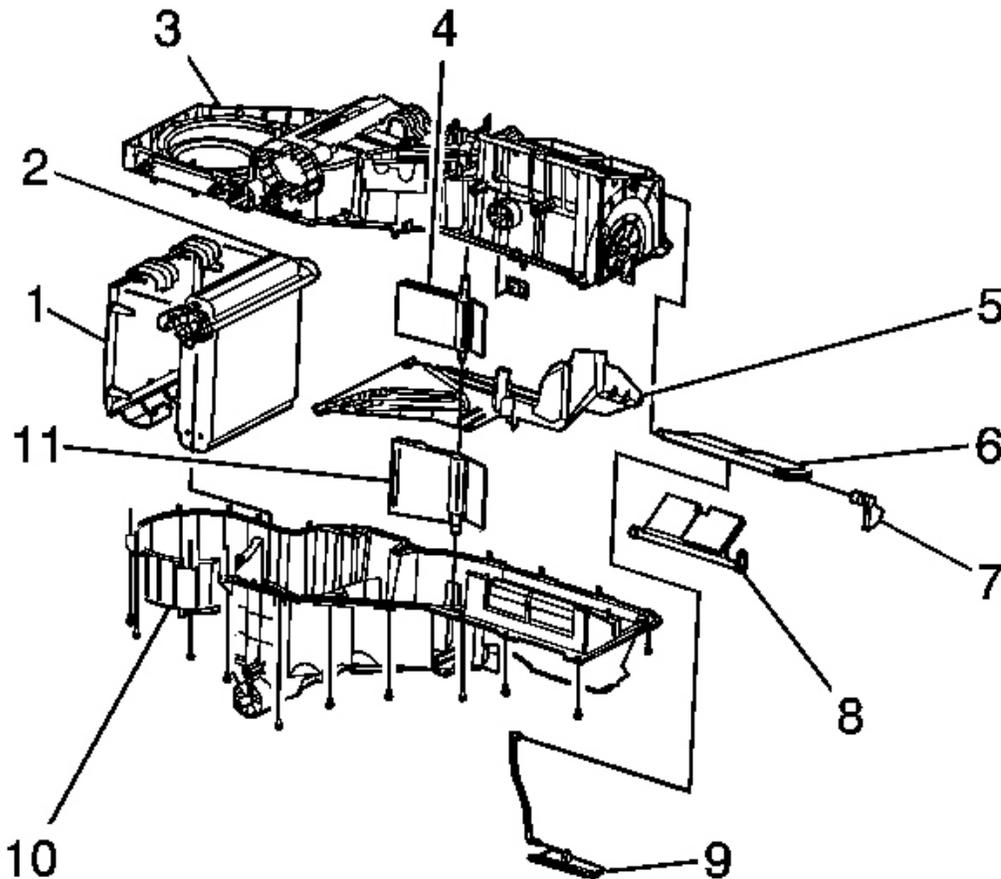
Fig. 125: Exploded View Of HVAC Module Assembly
Courtesy of GENERAL MOTORS CORP.

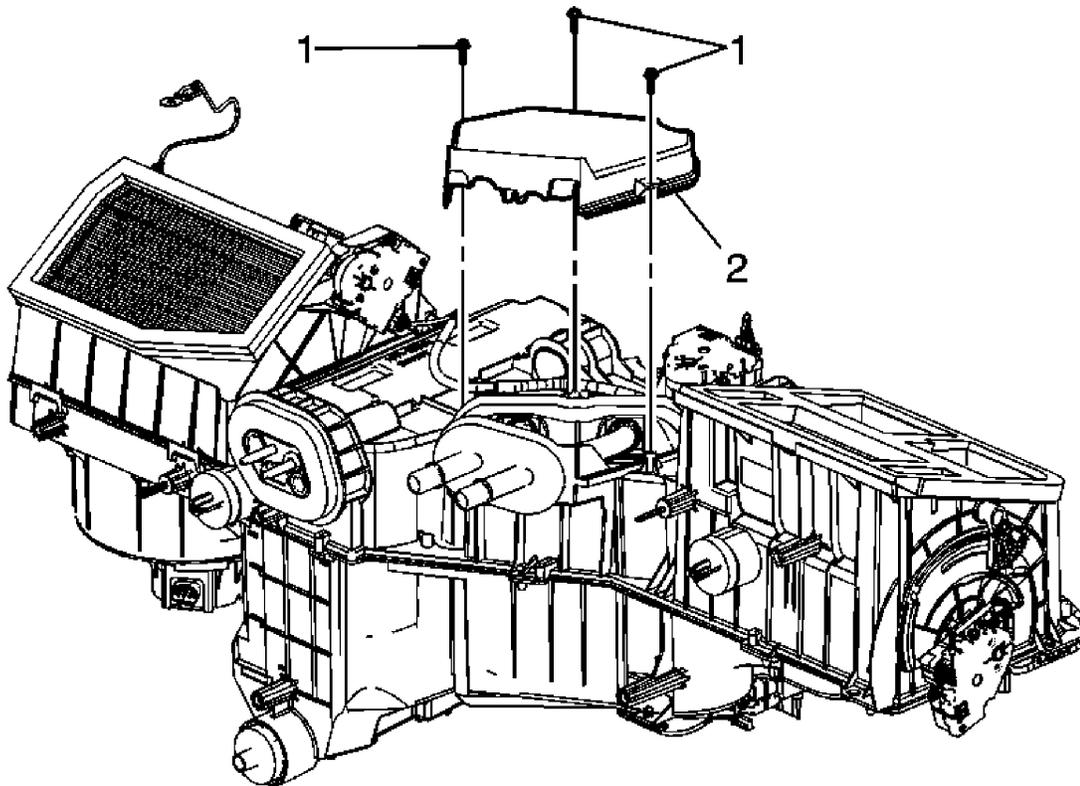
Fig. 127: View Of Heater Core Cover & Screw
Courtesy of GENERAL MOTORS CORP.

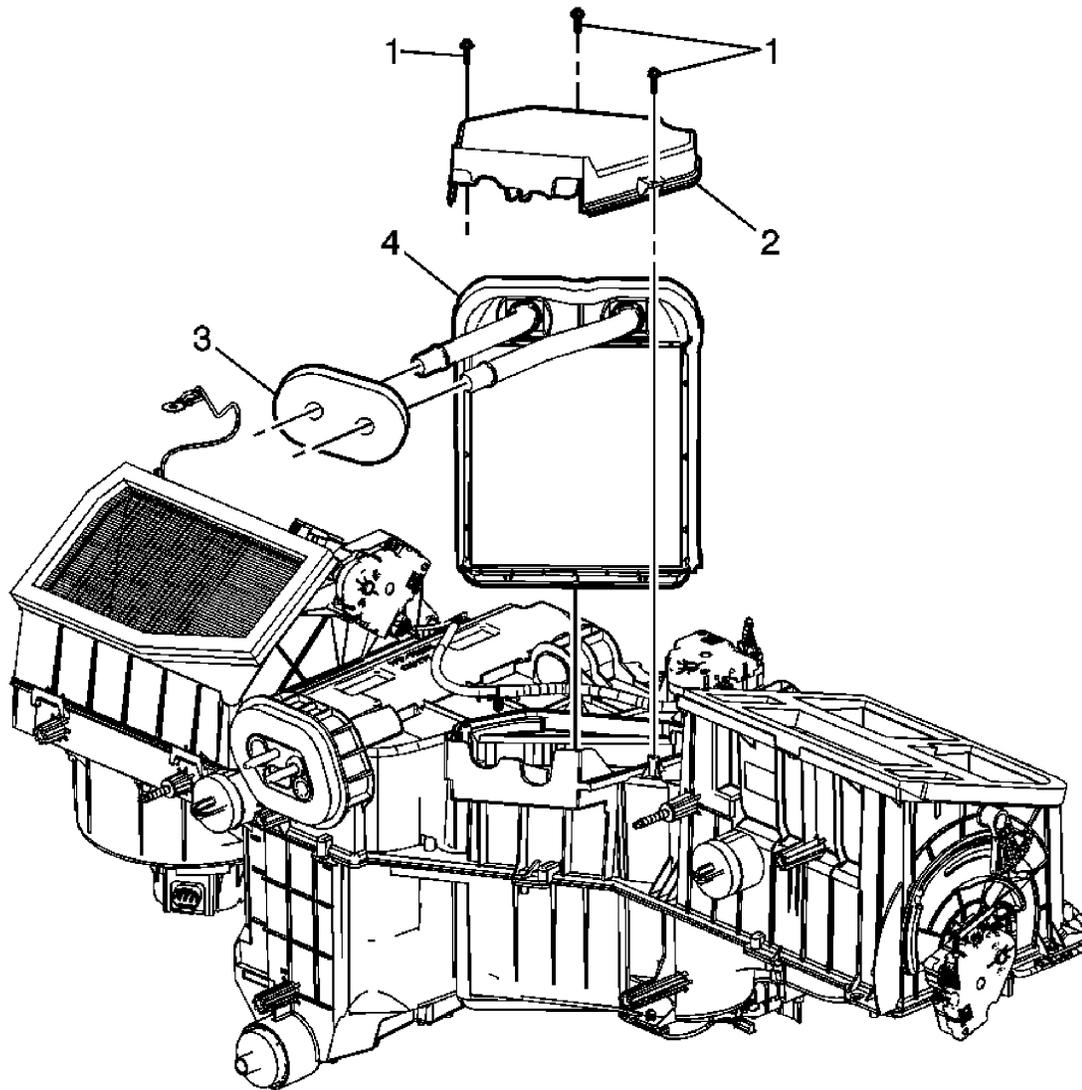
Fig. 128: View Of Heater Core & Components
Courtesy of GENERAL MOTORS CORP.
